Monterey Wastewater Treatment Facility Improvements Project

Project Definition

PREPARED FOR: JEA

PREPARED BY: CONSTANTINE ENGINEERING, INC

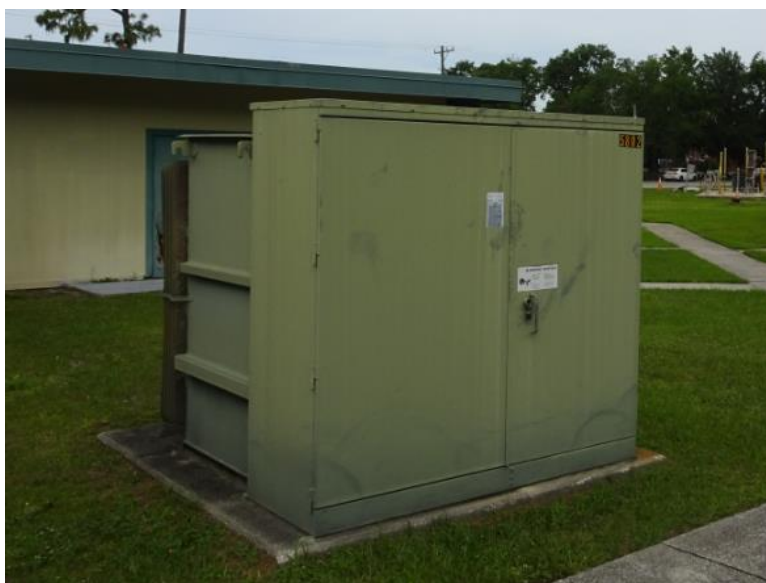
Utility Transformer

Utility power is provided from a 26kV overhead feeder to a step down 480-volt transformer. Maintenance staff and the existing Jacobs report detailed a single phasing event, as well as over/under voltage events which previously occurred from the primary. The recommended relays which are to be implemented by JEA or Jacobs will help protect equipment in the event this occurs in the future. The utility transformer itself was level, with no noticeable signs of corrosion.

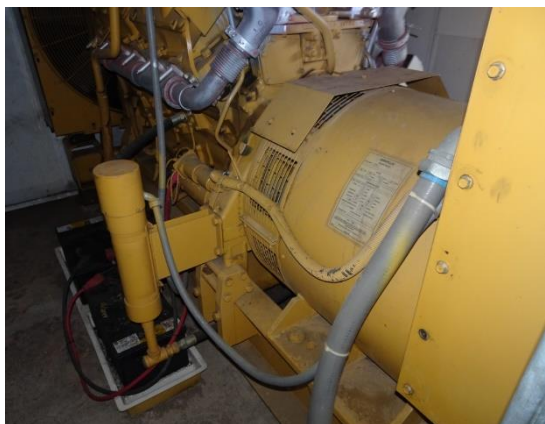
Generator

Located in an outdoor weatherproof enclosure, the Caterpillar 3412 700kW standby generator was installed in 1996. The generator provides power to the automatic transfer switch during utility power outages. Although there are large rust spots and signs of deterioration on the exterior of the enclosure, maintenance staff states the generator operates

The generator is 23 years old and considered to be in “Fair” condition. Existing generators can be repaired instead of being replaced. However, the 3412-model generator is no longer in production so renovation may not be possible. Due to the age of the generator and the difficulties presented due to the unit being obsolete, replacement with a similar generator is recommended.

well. Due to the age of the generator, it is recommended that the generator be exercised regularly. Repainting the enclosure is recommended.

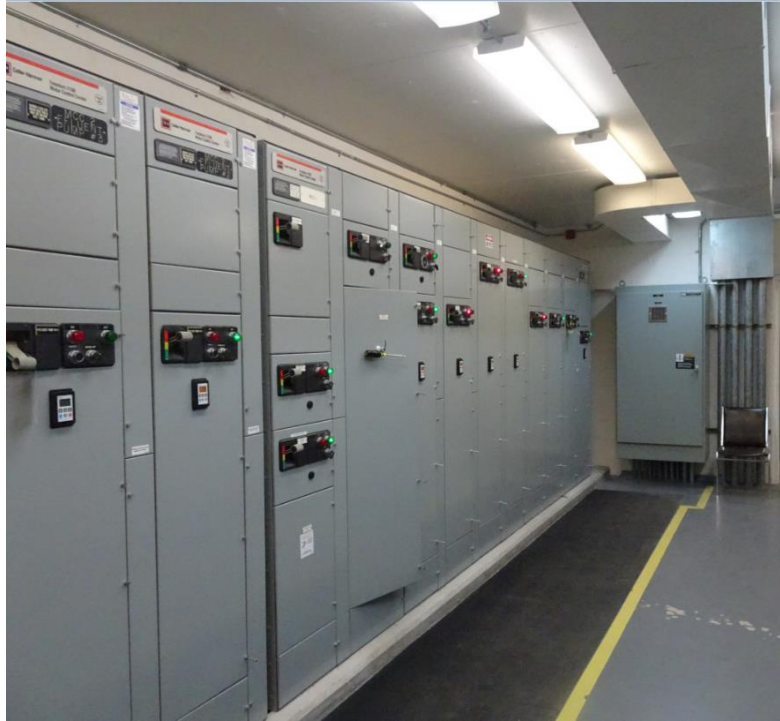
The 480V Switchgear, MCC-1, MCC-2, MCC-3, and the automatic transfer switch were installed in 1996 and are in good working condition. The panelboards and associated transformers in this room are of the same age and in good working condition. MCC-3 has adequate capacity for planned plant upgrades including an additional centrifuge and ancillary equipment. The air conditioning in the room seems adequate for the heat generated by the electrical equipment and variable frequency drives (VFD) in the room.

Left to Right: MCC-2, MCC-1, Automatic Transfer Switch

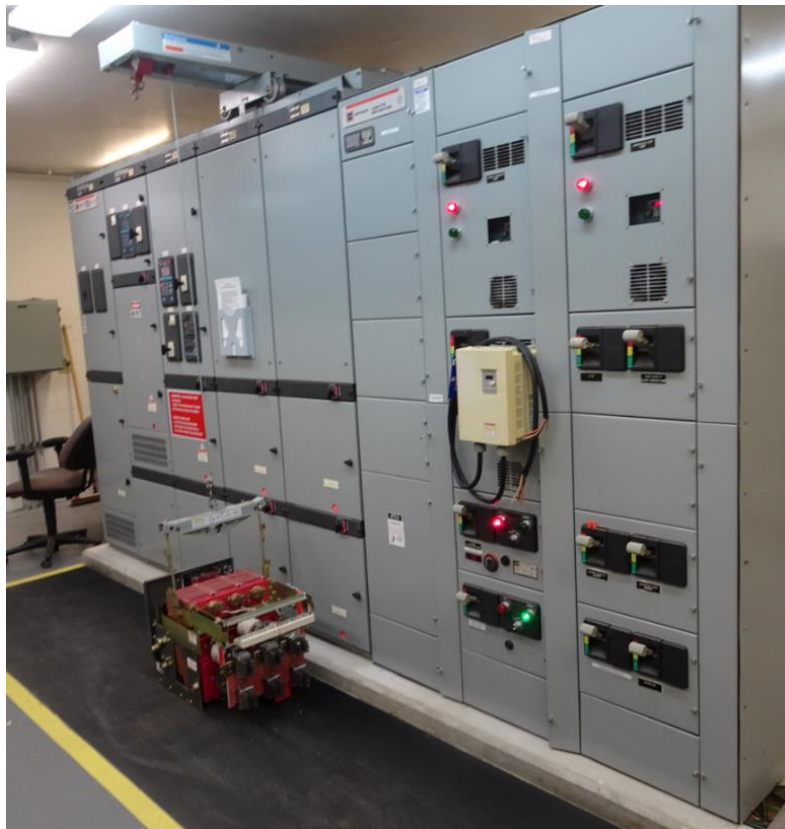
The 480V Switchgear 3000A main circuit breaker was serviced and replaced approximately 6 months ago per the existing Jacobs’ report recommendation. The generator circuit breaker is scheduled to be serviced soon, and so are the 1200A and 800-amp feeder circuit breakers. However, there are no spare circuit breakers for the switchgear. Constantine Engineering highly recommends purchasing spare circuit breakers in the event of a critical failure of the other circuit breakers.

Left to Right: 480-volt Switchgear and MCC-3

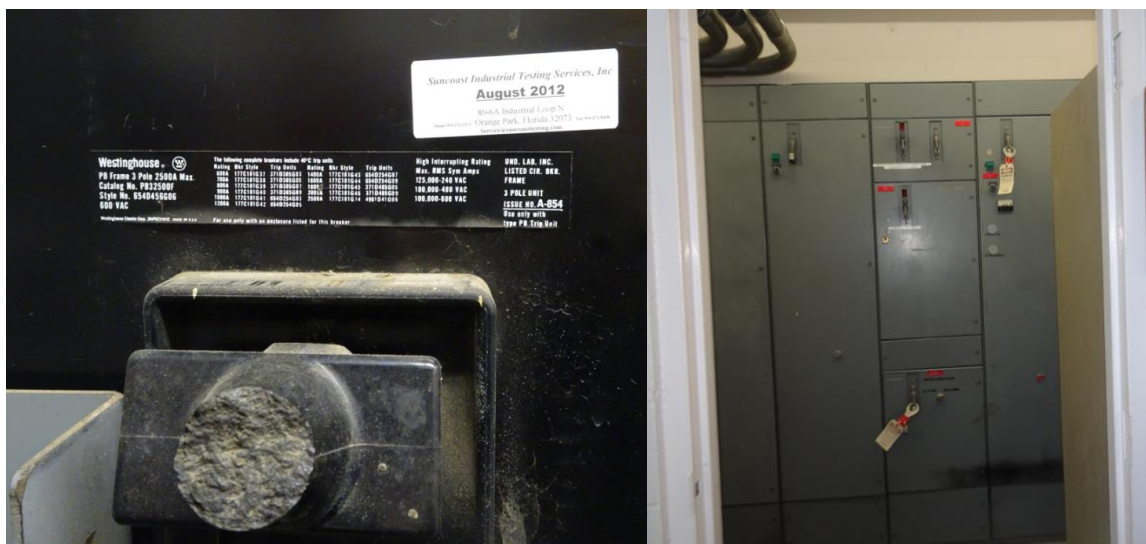
Existing MCC

The motor control center known as the “Existing MCC” in this building is in poor condition and should be replaced. The motor control center main circuit breaker handle is broken off and cannot properly be operated, which is a violation of the National Electrical Code (NEC). The handful of active loads in this MCC can be transitioned to MCC-1, MCC-2, and MCC-3 in order to decommission the existing motor control center. In addition, there is a storage cabinet across from “Existing MCC” with only 29” of clearance. This is in violation of NEC Working Clearance, which requires a minimum of 42” for this instance.

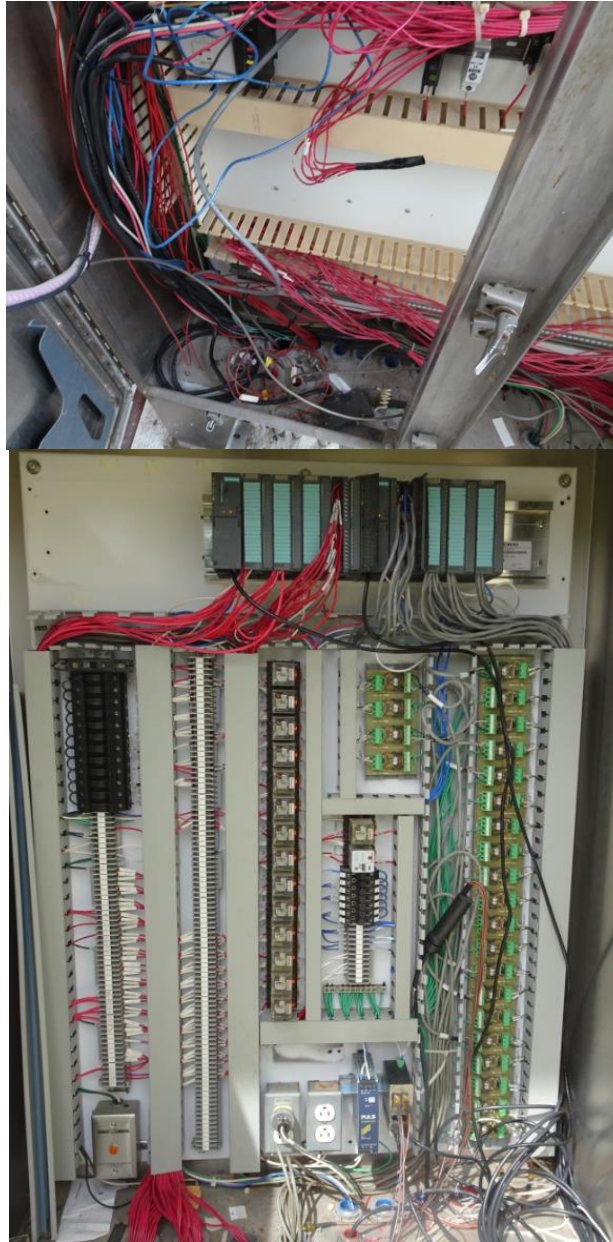
FP-11-1 and FP-11-2

There are two main control panels associated with the Centrifuge: FP-11-1 and FP-11-2. Control panel FP-11-1 was an Allen Bradley control panel at one time, but now acts as a pull box to FP-11-2. Control panel FP-11-2 serves as the new Siemens PLC control panel for the process. FP-11-2 is in “good” condition. It is recommended that the existing wires in FP-11-1 are traced, labelled, and any corroded or abandoned wires are removed. Existing wires should be bundled and tied within the control panel to improve the working conditions.

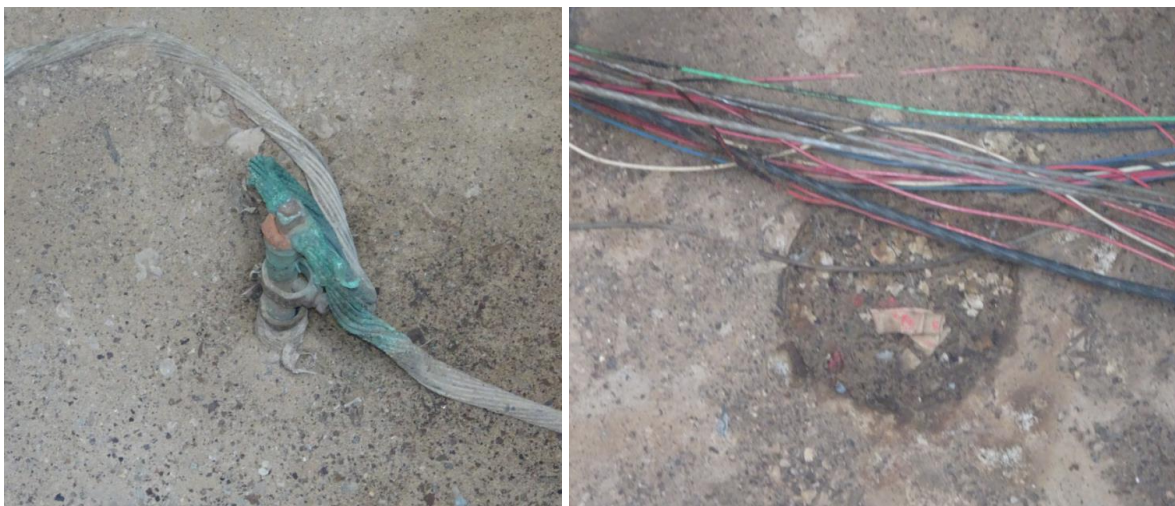
Manholes

All manholes were mostly clean with adequate racks for most of the conductors. Constantine recommends all conductors be placed on racks and grounded to the common ground rod.

The sumps appeared full and should be kept free of debris. The ground rod connections had signs of oxidation and/or corrosion on the spot-checked manholes. It is recommended that a full 3-point fall of potential method grounding test be performed on the grounding systems. In addition, any ground with corrosion should be repaired with a recommended exothermic weld.

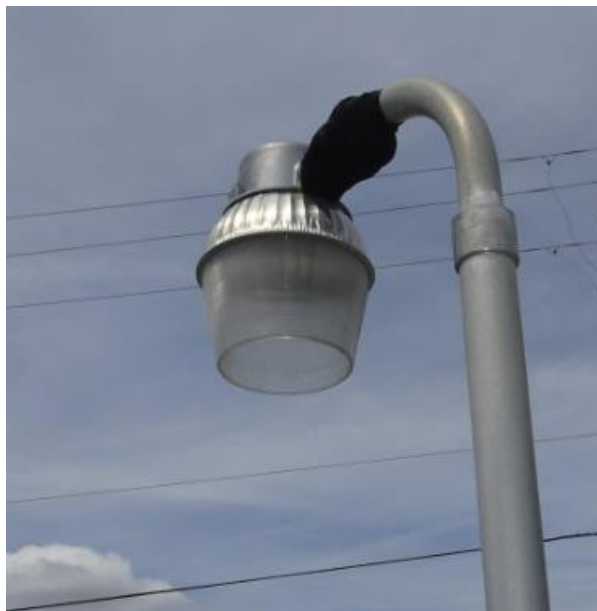
Existing Lighting

The entire site is composed of high-pressure sodium lighting, with exception to the top of the Centrifuge platform which contains LED lighting. While high pressure sodium is fairly efficient, removal and replacement with full-cutoff LED lighting throughout the site is recommended to save cost.

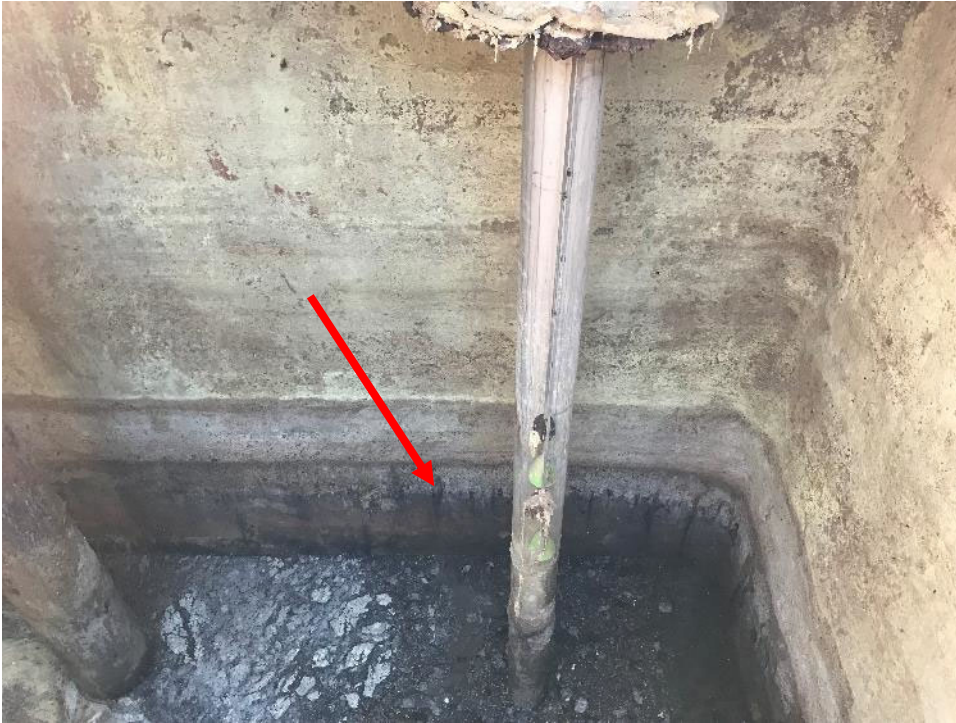
Photograph #1: View within pump station wet well. Note: Visible wall reinforcement and missing/failed coating system.

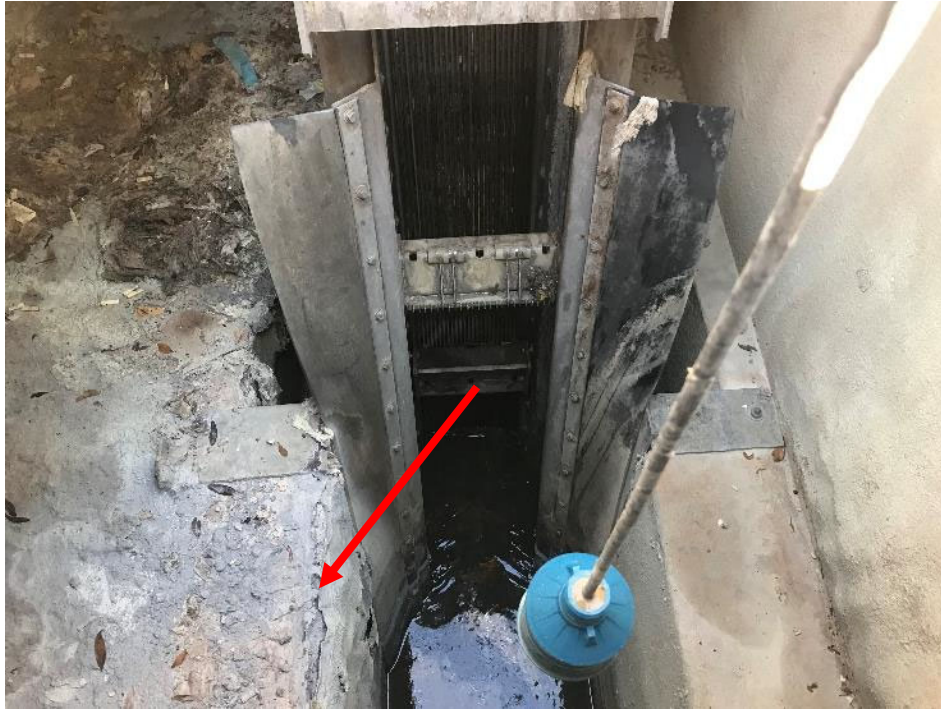
Photograph #3: View within screening channel. Note: Spalled concrete and failing coating system on channel wall.

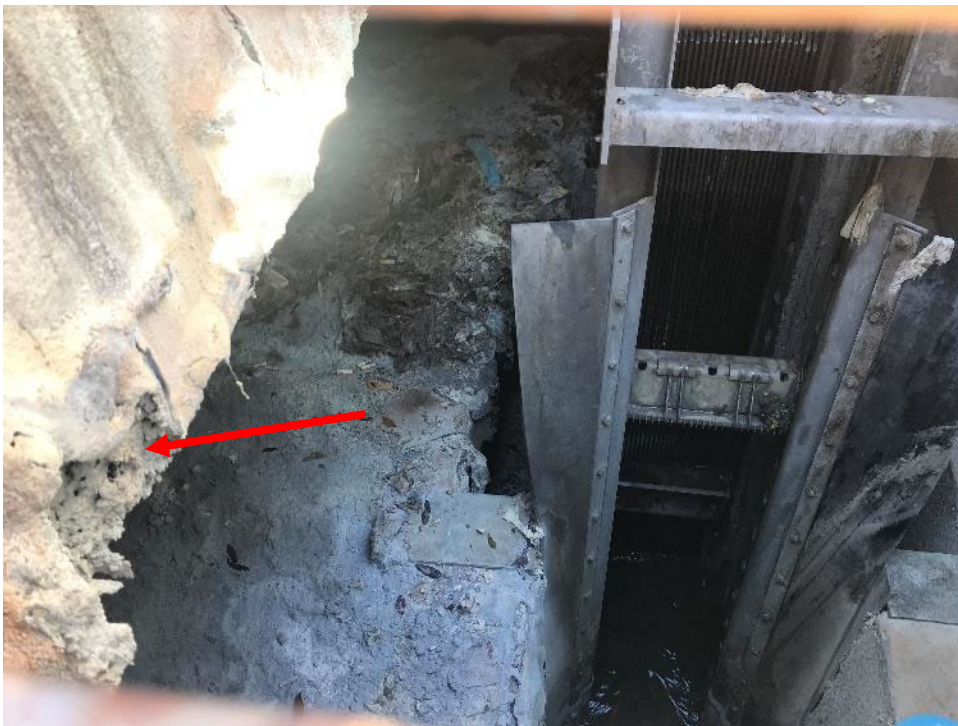
Photograph #4: View within screening channel. Note: Spalled and deteriorated concrete at concrete beam above channel.

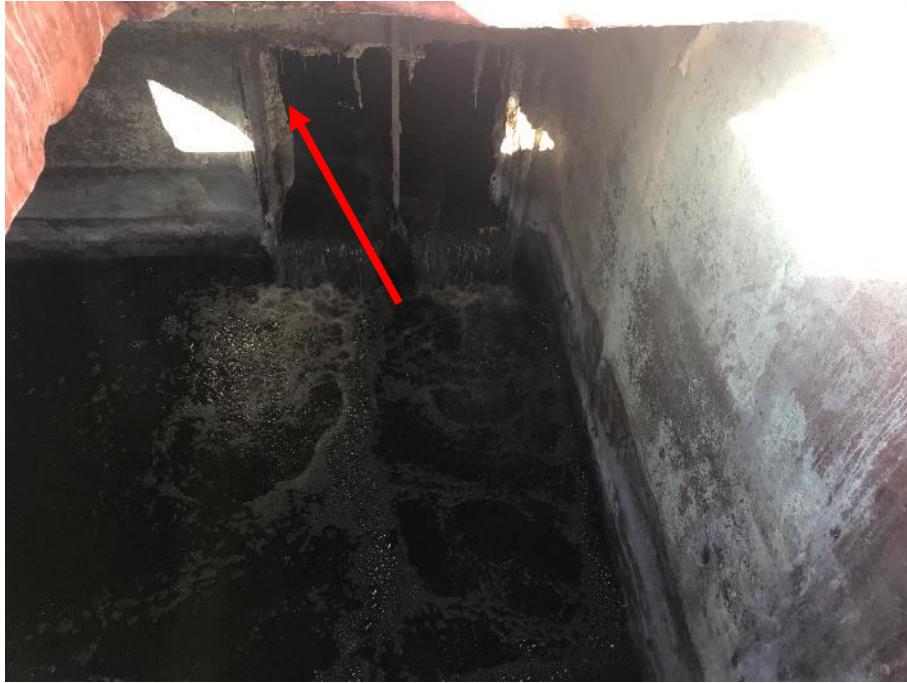
Photograph #5: View within pump station wet well. Note: Spalled and deteriorated concrete in vicinity of gate frames.

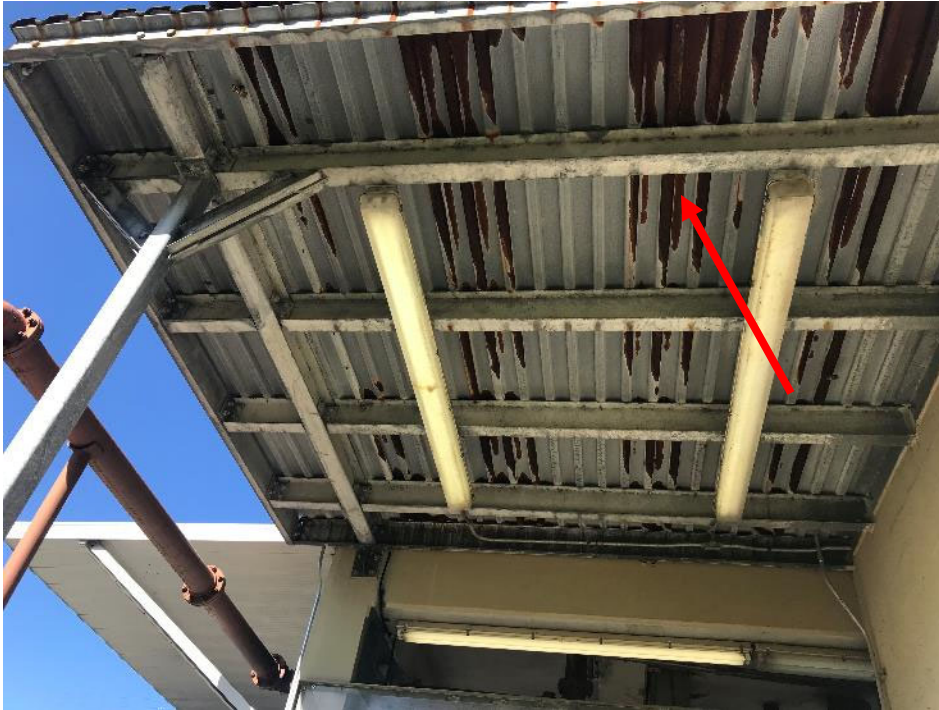
Photograph #7: View of roof framing and roof deck at Centrifuge Facility. Note: Corrosion visible on roof deck.

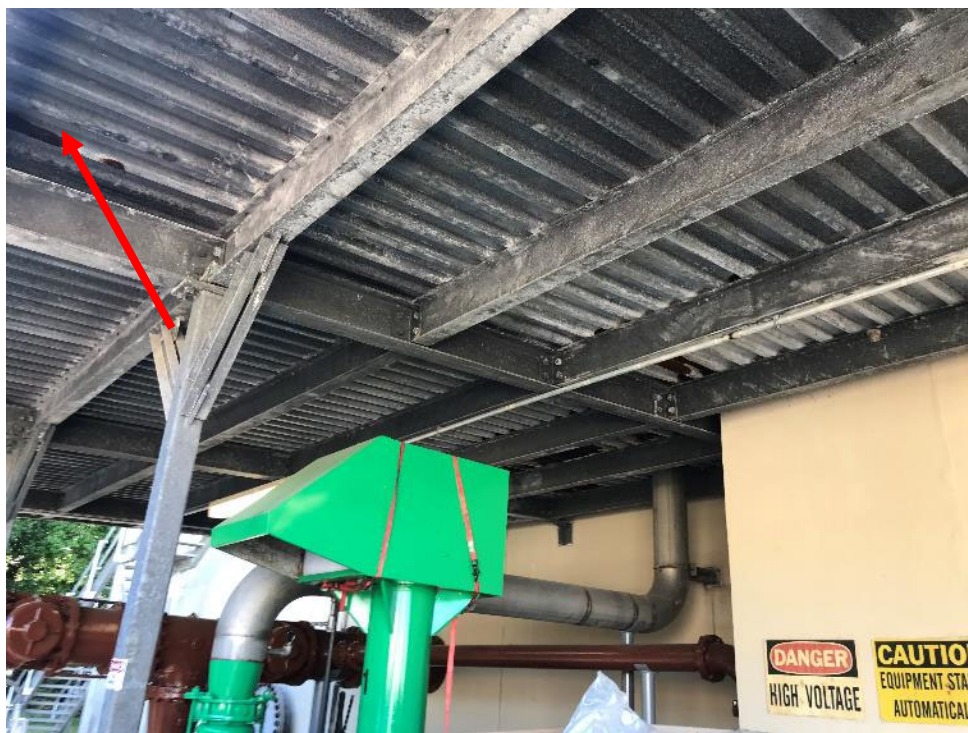
Photograph #12: View of canopy at SBR Basin. Note: Corrosion on underside of roof deck.

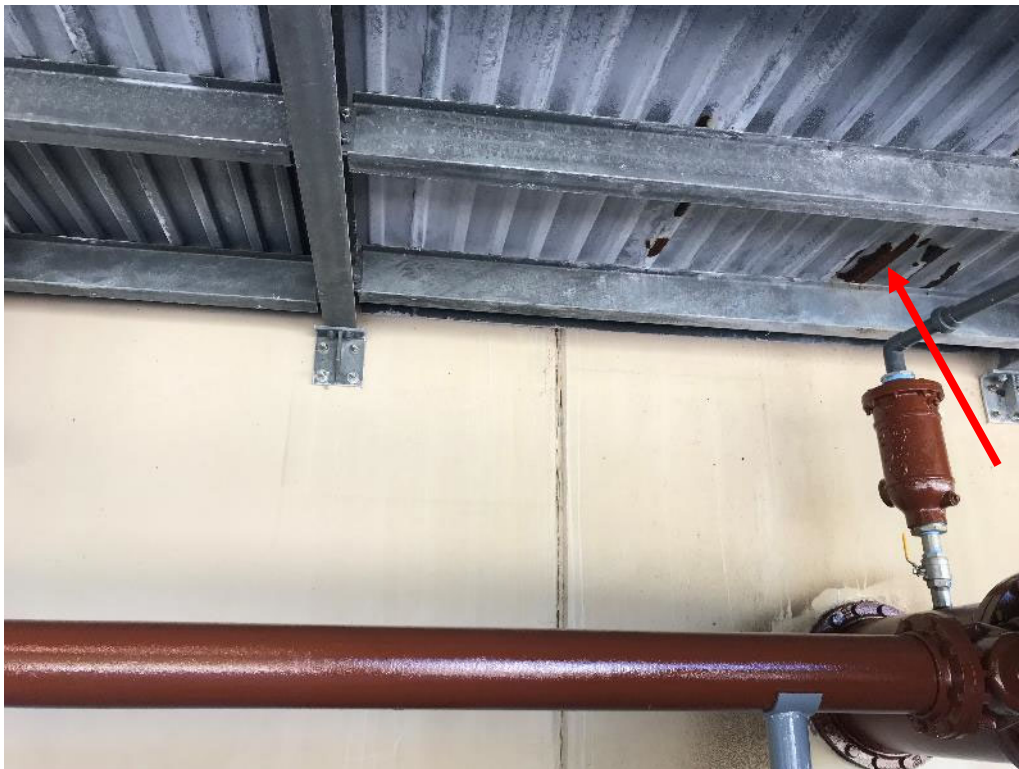
Photograph #13: View of canopy at SBR Basin. Note: Corrosion on underside of roof deck.

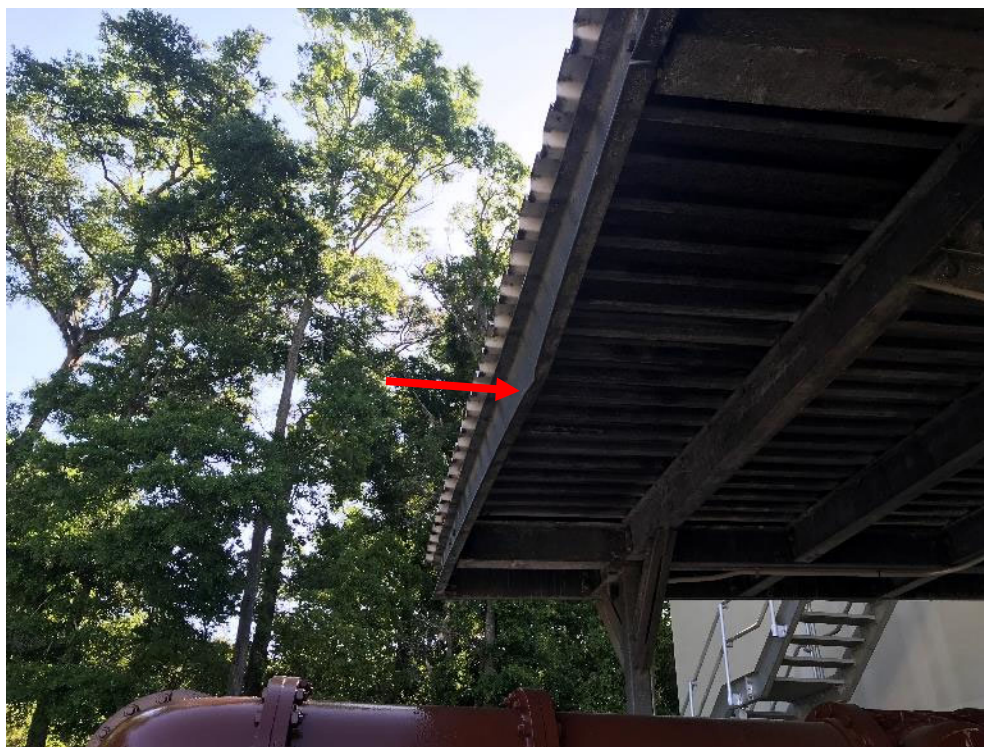
Photograph #14: View of canopy at SBR Basin. Note: Corrosion on underside of roof deck.

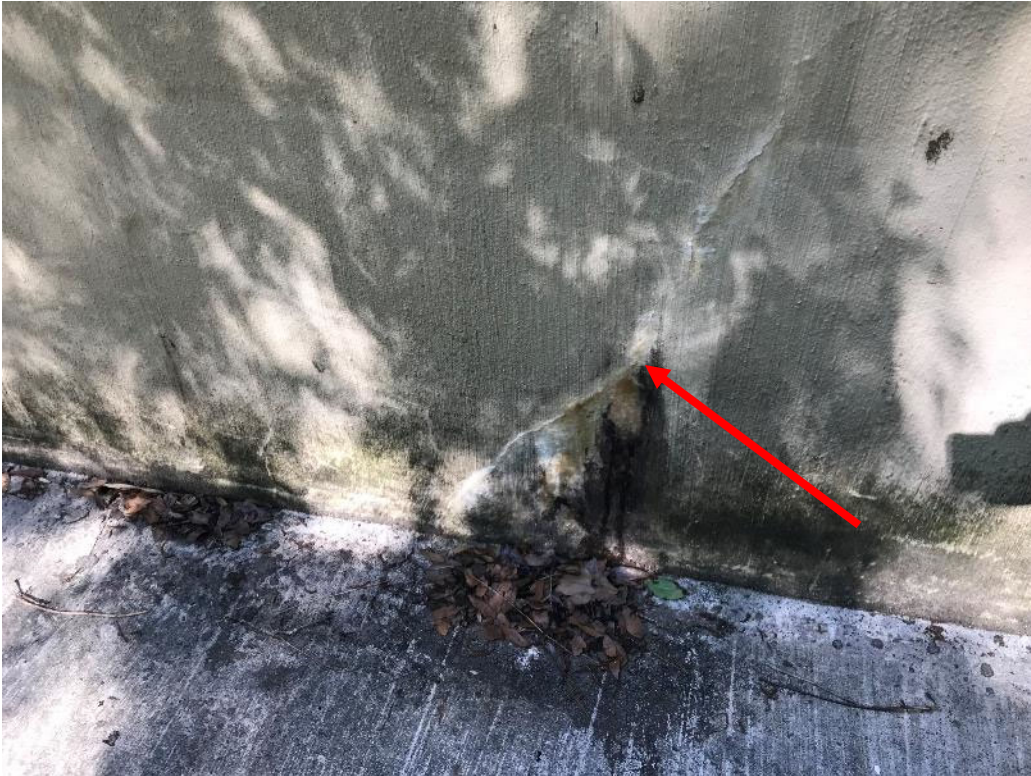
Photograph #15: View of typical cracking on walls at SBR Basin.

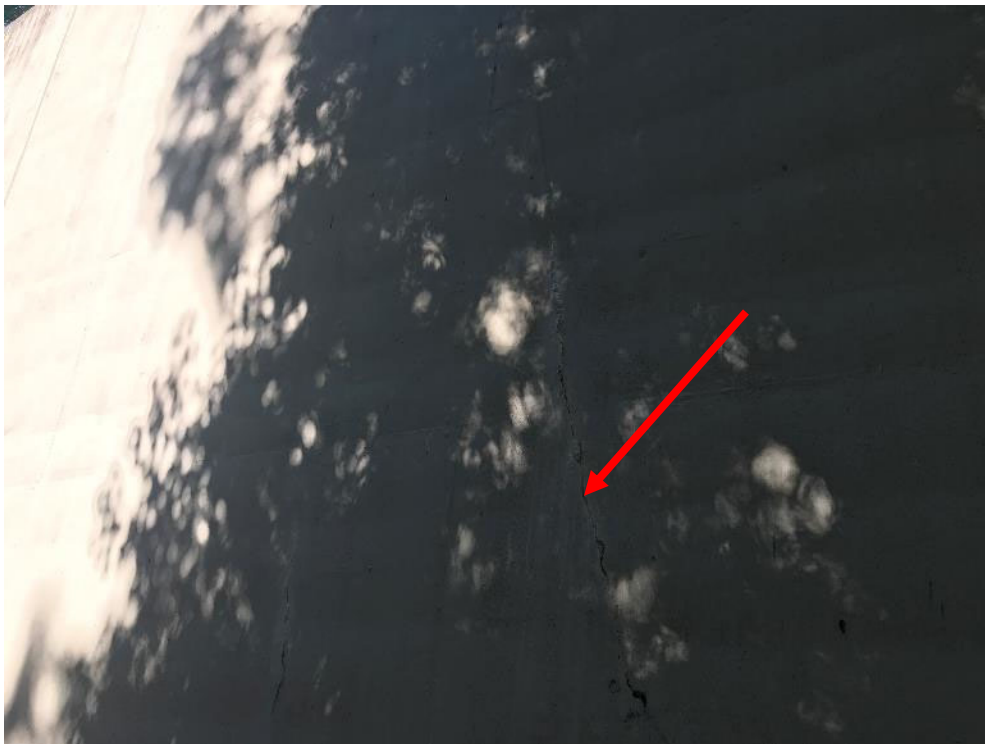
Photograph #16: View of typical cracking on walls at SBR Basin.

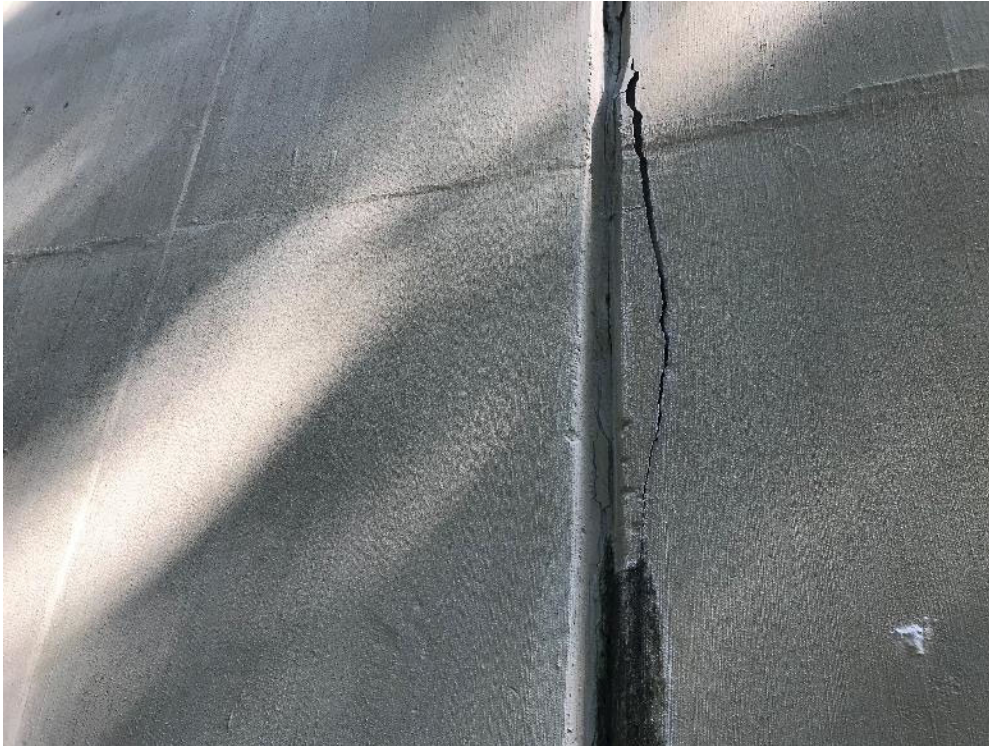
Photograph #17: View of spalling on walls at SBR Basin vertical joints.

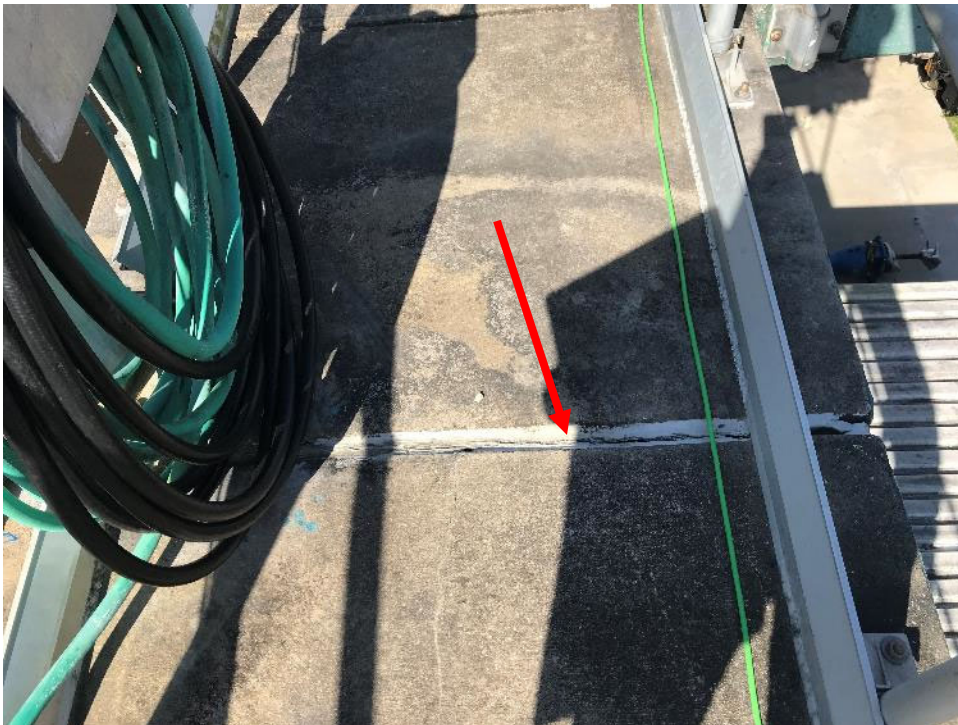
Photograph #18: View of walkway joint at SBR Basin. Note: Cracked and failing sealant.

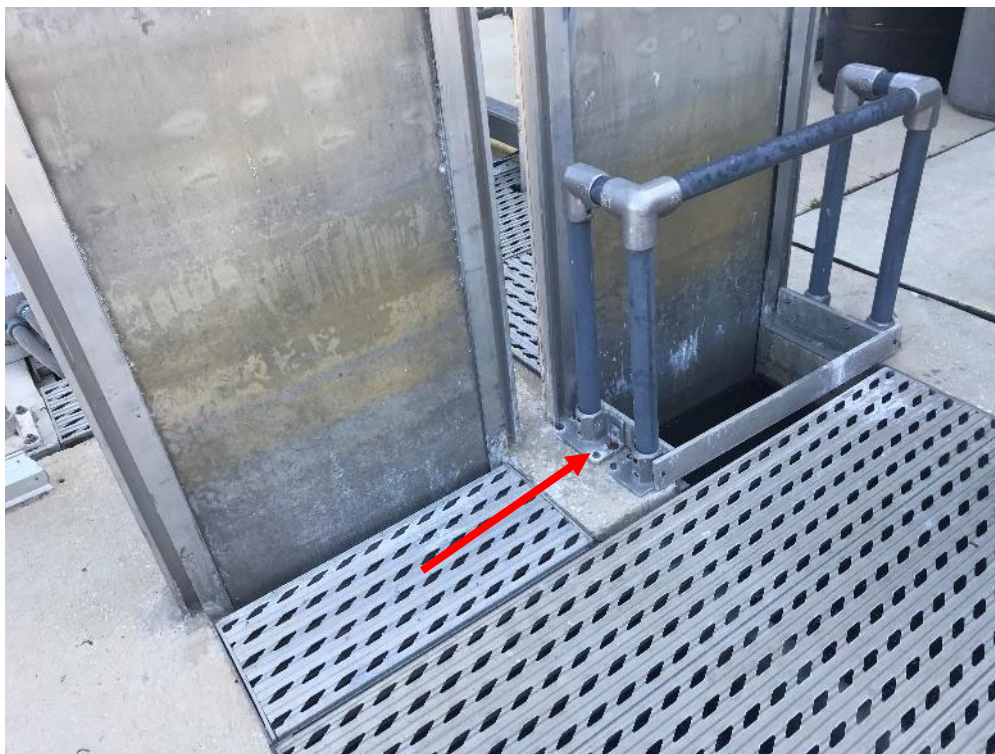
Photograph #19: View of gates and grating at UV Structure. Note: Corroded guardrail anchor bolts.

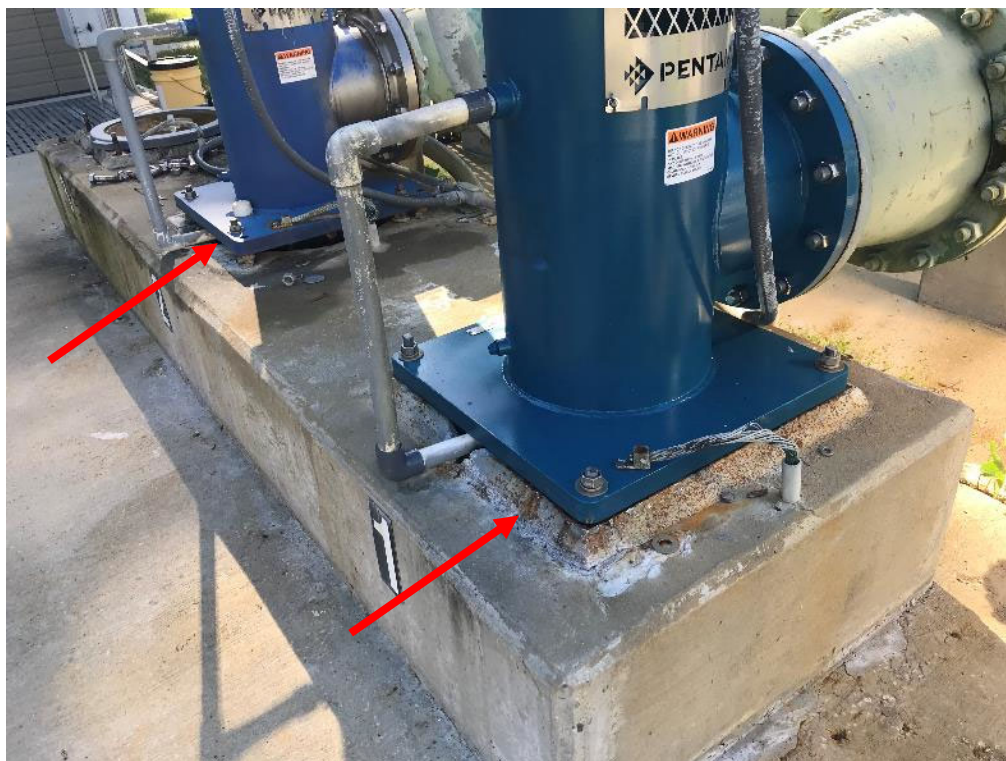
Photograph #20: View of effluent pumps at the UV Structure. Note: Missing grout under base plate, cracked and stained grout.

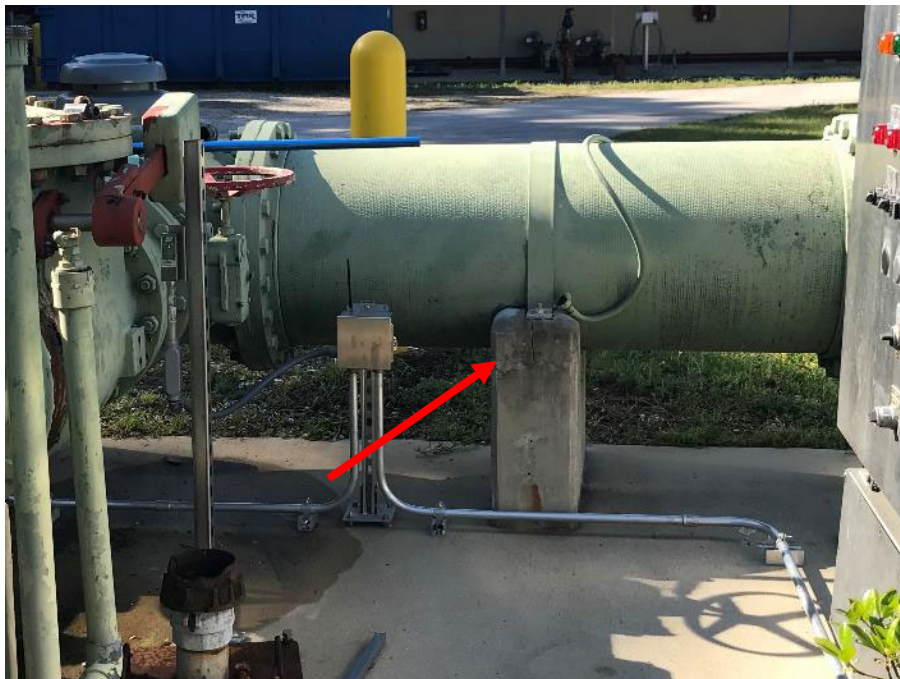
Photograph #21: View of effluent pipes at the UV Structure. Note: Cracked concrete pipe support.

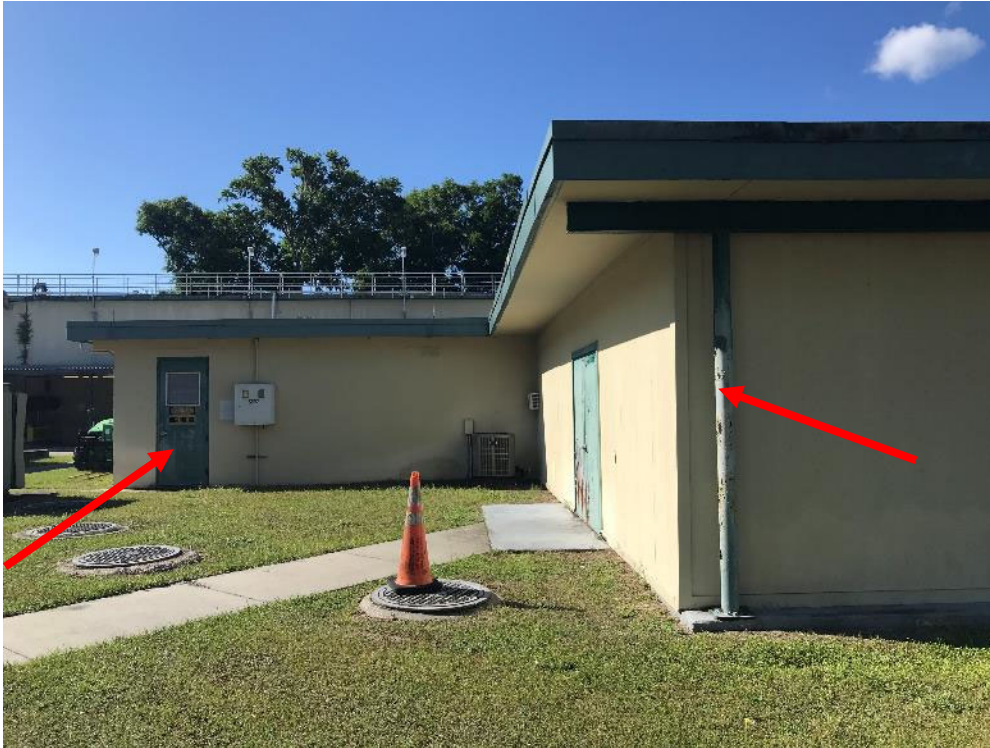
Photograph #25: View of Electrical Building. Note: Paint system failure at all doors and exterior columns and beams supporting the roof system.

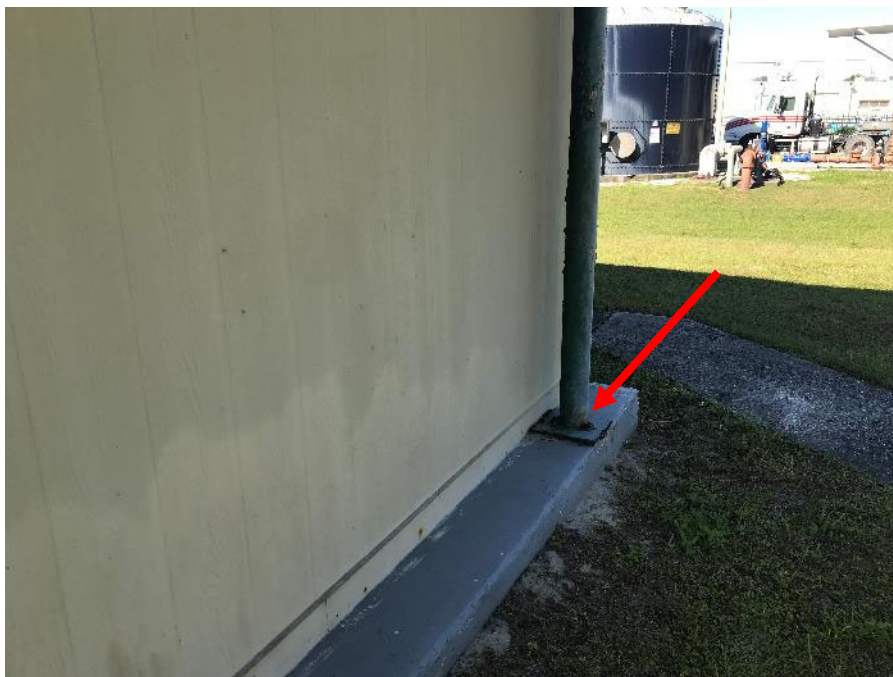
Photograph #26: View of Electrical Building. Note: Paint system failure at all doors and exterior columns and beams supporting the roof system.
