# Subsurface Utility Engineering Test Hole Report

Produced For: J. COLLINS ENGINEERING ASSOCIATES, LLC.

Project Name: JEA - JAMMES RD - WILSON BLVD. TO HARLOW BLVD. - WATER MAIN REPLACEMENT  
 Location: JAMMES RD @ GRAVES ST  
 Road Name: JAMMES RD Utility Owner: TECO  
 WO Number: W104320 Job Number: J062490 Task WO #: N/A City: JACKSONVILLE  
 Client Number: C08867 FPN #: N/A County: DUVAL  
 Station: Offset:  
 Collection Date: 9/30/2019 PM: RWG Ground Cover: ASPHALT Utility Chief: JUBA  
 Weather: CLEAR Soil Type: DIRT Utility Crew: JUBA  
 Time: N/A Soil Condition: HARD-WET Crew Number: 1

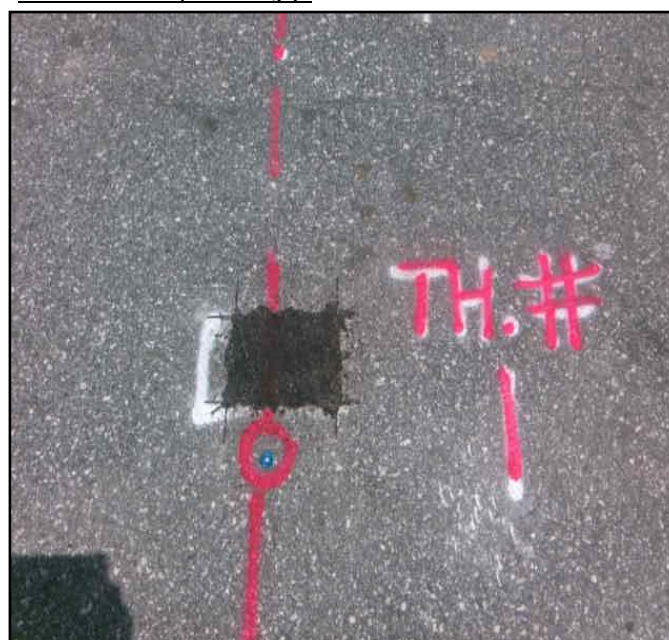
Test Hole: 01

Utility Type: GAS Utility Material: COATED STEEL Size (OD): 6.5 X 6.5  
 Utility Condition: GOOD Testhole Marker: NAIL AND DISK Height (in): 6.5 Width (in): 6.5  
 Top of Pipe: 3.1  
 Utility Note:

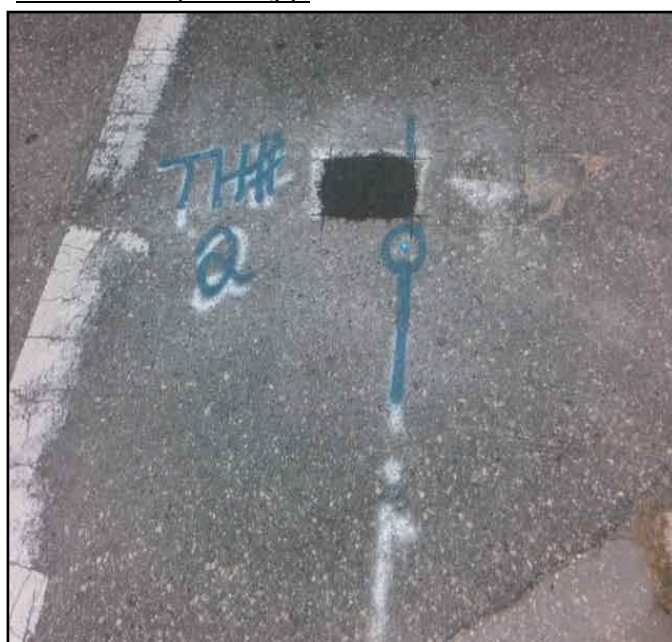
Test Hole: 02

Utility Type: WATER Utility Material: AC-ASBESTOS CONCRETE Size (OD): 8.5 X 8.5  
 Utility Condition: GOOD Testhole Marker: NAIL AND DISK Height (in): 8.5 Width (in): 8.5  
 Top of Pipe: 3.2  
 Utility Note:

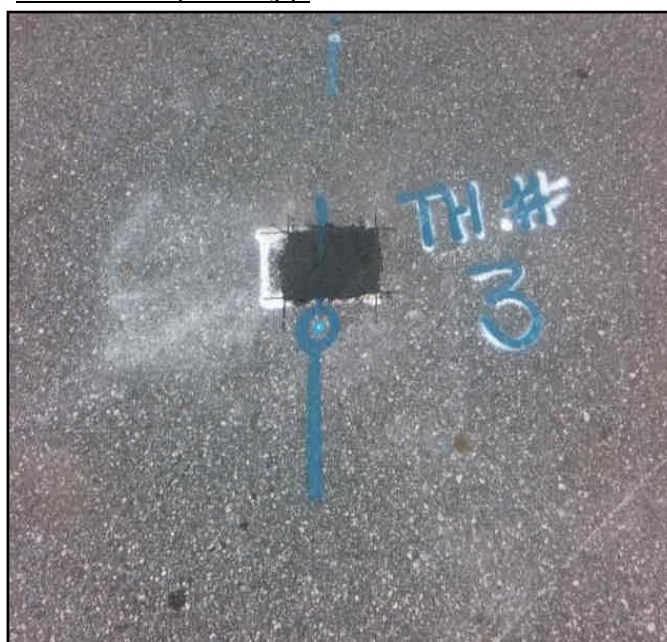
Test Hole: 03

Utility Type: WATER Utility Material: GALVINIZED Size (OD): 2.5 X 2.5  
 Utility Condition: FAIR Testhole Marker: NAIL AND DISK Height (in): 2.5 Width (in): 2.5  
 Top of Pipe: 4.55  
 Utility Note:

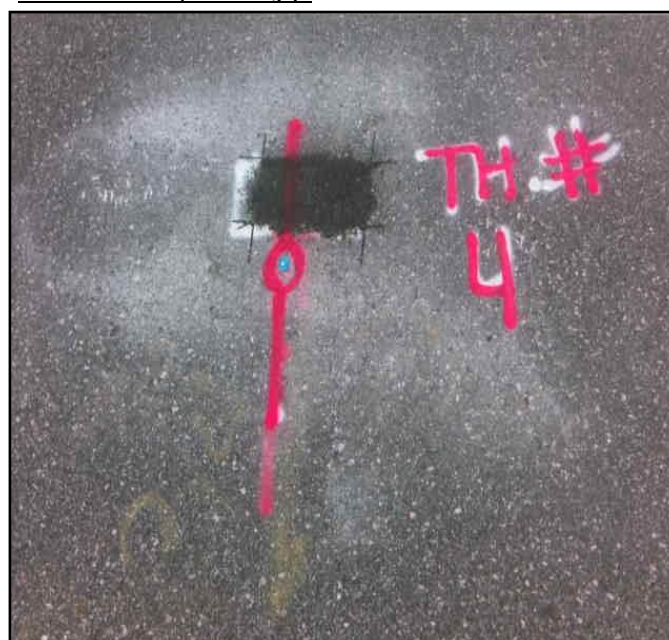
Test Hole: 04

Utility Type: GAS Utility Material: STEEL Size (OD): 1.5 X 1.5  
 Utility Condition: GOOD Testhole Marker: NAIL AND DISK Height (in): 1.5 Width (in): 1.5  
 Top of Pipe: 2.6  
 Utility Note: OWNERS MARKS SHOW 3/4 LINE. MOST LIKELY INTERIOR DIAMETER

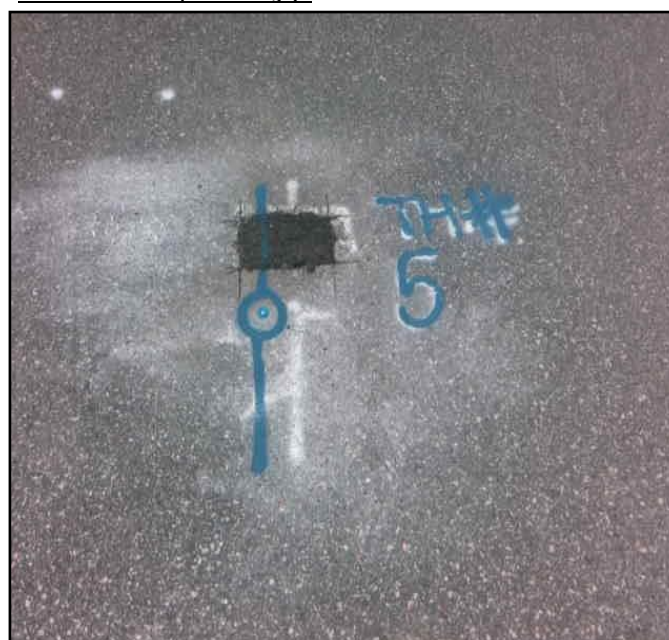
Test Hole: 05

Utility Type: WATER Utility Material: GALVINIZED Size (OD): 2.5 X 2.5  
Utility Condition: FAIR Testhole Marker: NAIL AND DISK Height (in): 2.5 Width (in): 2.5  
Top of Pipe: 4.5  
Utility Note:

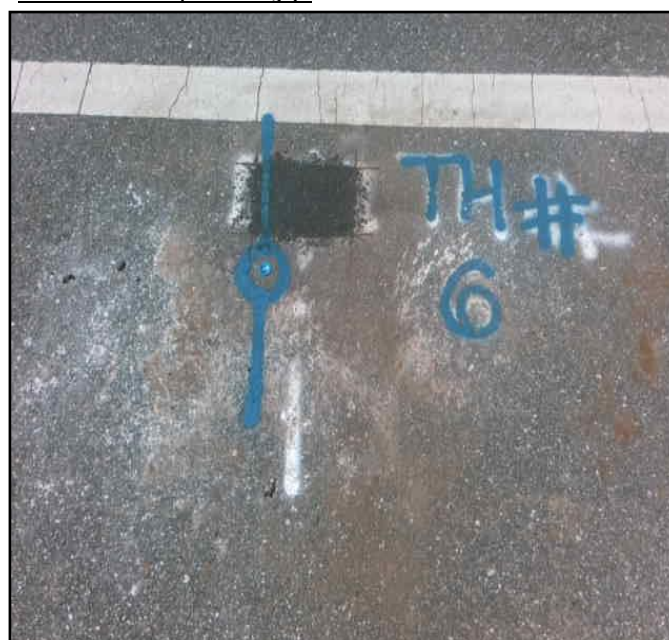
Test Hole: 06

Utility Type: WATER Utility Material: AC-ASBESTOS CONCRETE Size (OD): 4.5 X 4.5  
 Utility Condition: GOOD Testhole Marker: NAIL AND DISK Height (in): 4.5 Width (in): 4.5  
 Top of Pipe: 4.8  
 Utility Note:

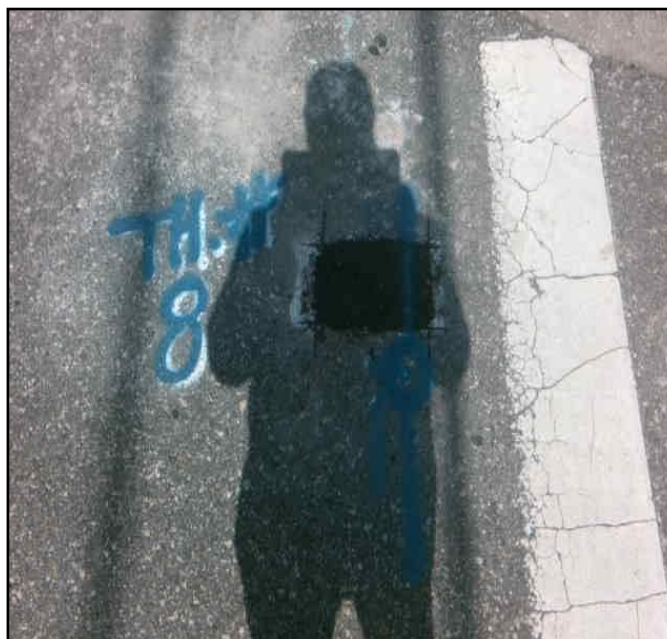
Test Hole: 08

Utility Type: WATER Utility Material: GALVINIZED Size (OD): 2.5 X 2.5  
 Utility Condition: FAIR Testhole Marker: NAIL AND DISK Height (in): 2.5 Width (in): 2.5  
 Top of Pipe: 2.9  
 Utility Note:

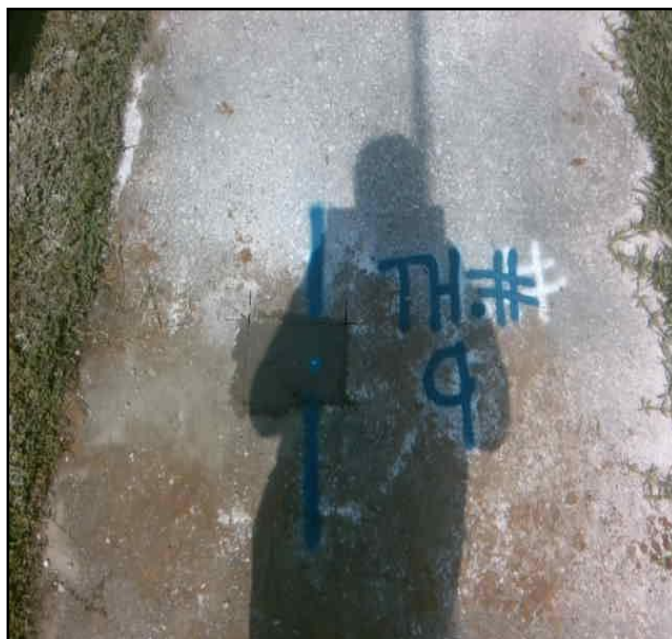
Test Hole: 09

Utility Type: WATER Utility Material: GALVINIZED Size (OD): 2.5 X 2.5

Utility Condition: POOR Testhole Marker: NAIL AND DISK Height (in): 2.5 Width (in): 2.5

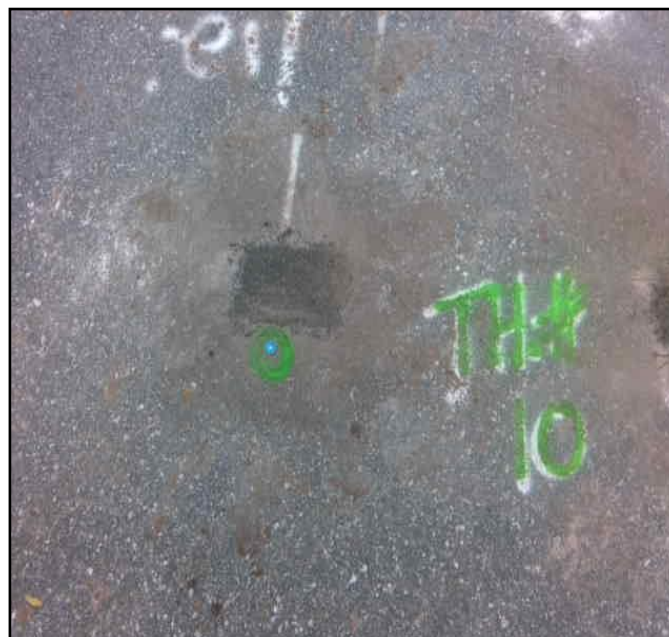
Test Hole: 10

Utility Type: SANITARY FM Utility Material: HDPE-HIGH DENSITY POLYETHYLENE Size (OD): 0 X 0  
 Utility Condition: OTHER Testhole Marker: NAIL AND DISK Height (in): 0 Width (in): 0  
 Top of Pipe: 0  
 Utility Note: COULD NOT MAKE CONTACT WITH UTILITY. TEST HOLE WAS FILLING UP WITH WATER, CAUSING POTENTIAL PATCH ISSUES. LANCED TO 10FT. EQUIPMENT SHOWS LINE IS 12FT+.

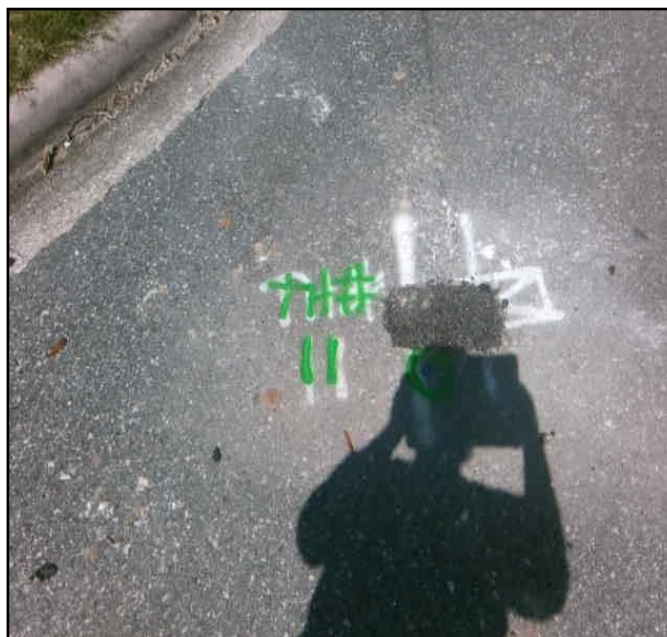
Test Hole: 11

Utility Type: SANITARY FM Utility Material: HDPE-HIGH DENSITY POLYETHYLENE Size (OD): 0 X 0  
 Utility Condition: OTHER Testhole Marker: NAIL AND DISK Height (in): 0 Width (in): 0  
 Top of Pipe: 0  
 Utility Note: COULD NOT LOCATE UTILITY DUE TO HARD PAN BEING INPENETRABLE AT 8FT. EQUIPMENT IS SHOWING PIPE AT 11FT+
