# DEGROVE SURVEYORS, INC.

## VACUUM TEST HOLE REPORT

PROJECT NAME: <u>GATE PARKWAY</u>	TEST HOLE #: <u>1</u>
DATE: <u>08.23.19</u>	DSI PROJECT #: <u>2019.111</u>
CLIENT: <u>JEA</u>	CREW: <u>BS, DK, AN</u>
EXPECTED UTILITY: GAS STORM SAN COMM UNK FM CATV H2O TEL <u>ELEC</u> IRRIGATION REUSE	SURFACE TYPE: <u>ASPHALT</u> CONCRETE ASPHALT OVER CONCRETE BRICKS SIDEWALK DIRT/GRASS N/A
UTILITY FOUND: GAS STORM SAN COMM UNK FM CATV H2O TEL <u>ELEC</u> IRRIGATION RW	PAVEMENT CONDITION: <u>GOOD</u> FAIR POOR N/A
MATERIAL: DIP C/I STEEL CABLE PLASTIC VCP CLAY RCP CMP <u>PVC</u> HDPE PE UNK	SOIL CONDITION: HARD <u>SOFT</u> WET MOIST DRY SAND CLAY <u>ROCK</u> <u>DIRT</u> DEBRIS
OTHER: COLOR: <u>GREY</u>	SURVEY LOCATION BY: <u>DSI</u>

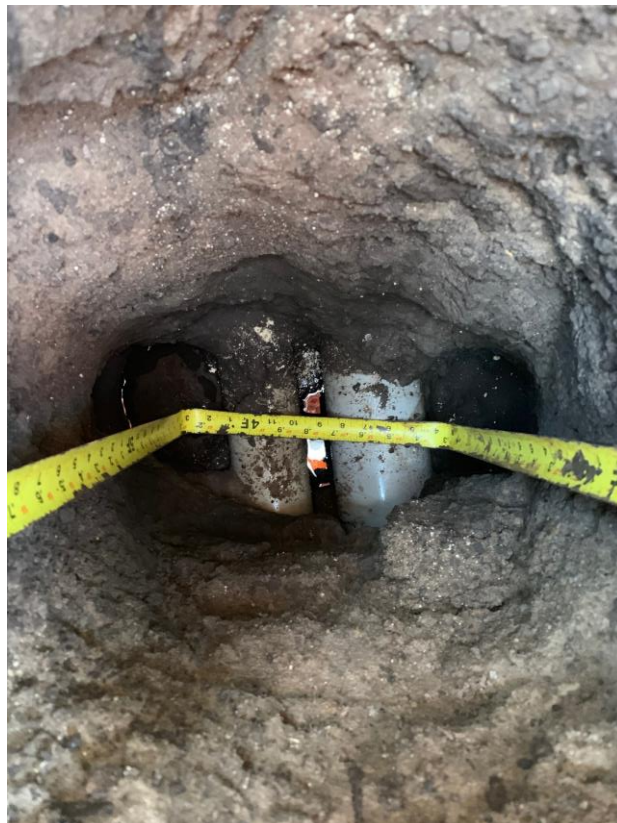
# TEST HOLE #1

Found 2" and  
4" ELEC LINES.

2" & 4" ELECTRIC CONDUITS

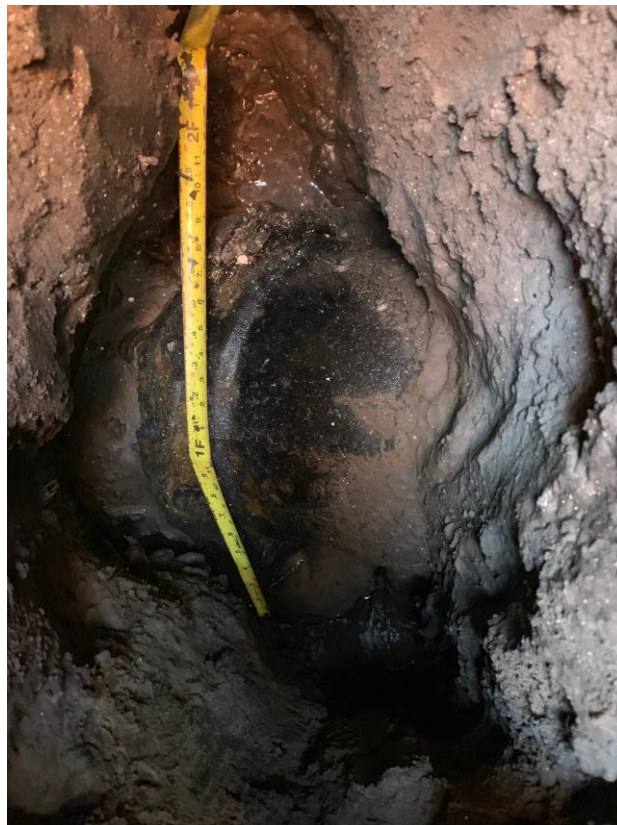
## TEST HOLE #2

FOUND 12" WL.

DUG WL ON 45° BEND DOWN.

12" WATELINE – 45 DEGREE BEND – EAST TO LEFT

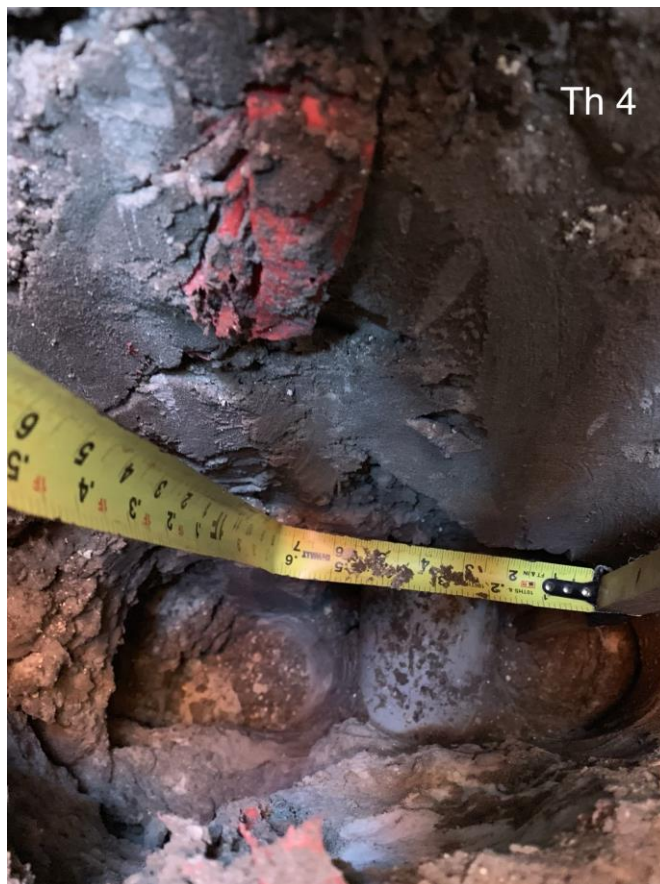
# TEST HOLE #4

3" CONDUIT – COMMUNICATIONS LINE

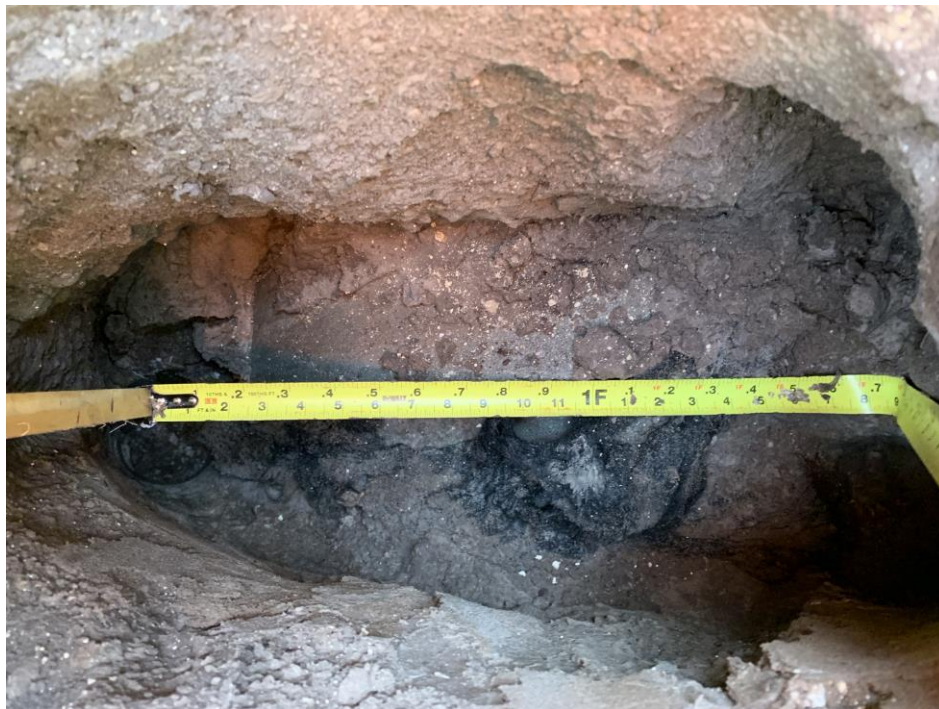
TEST HOLE #5

15" I.D. RCP – STORM SEWER

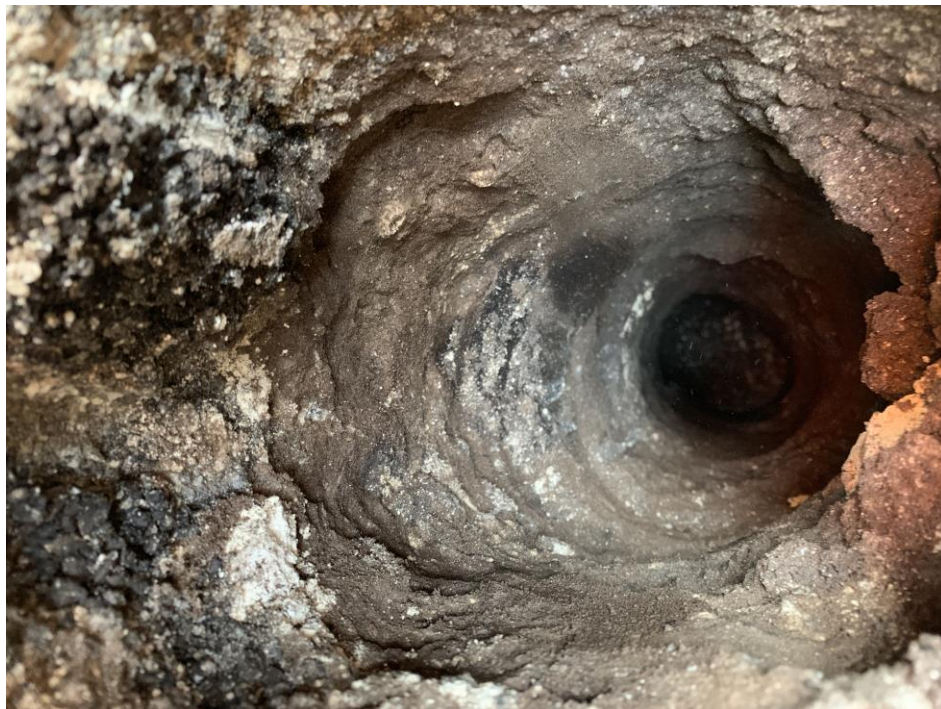
TEST HOLE #6

UNABLE TO LOCATE  
UTILITY DUE TO DEPTH,  
DUG TO A DEPTH OF 8'

NOT FOUNF – TOO DEEP

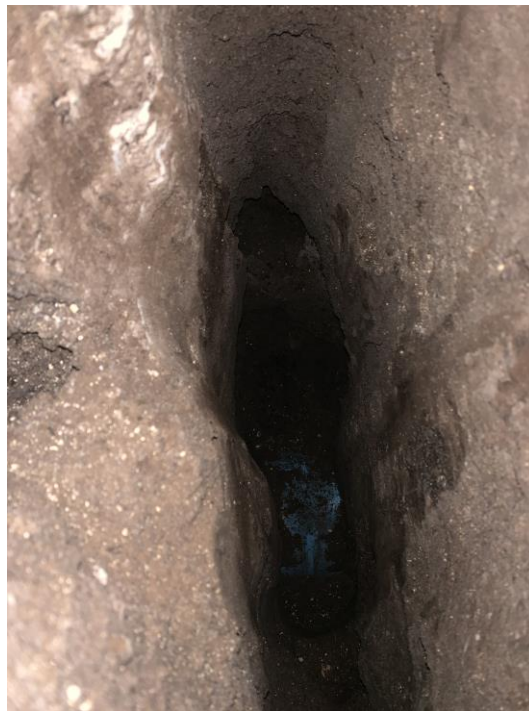
TEST HOLE #7

Found 16" w/  
6.2' down

16" PVC WATERLINE

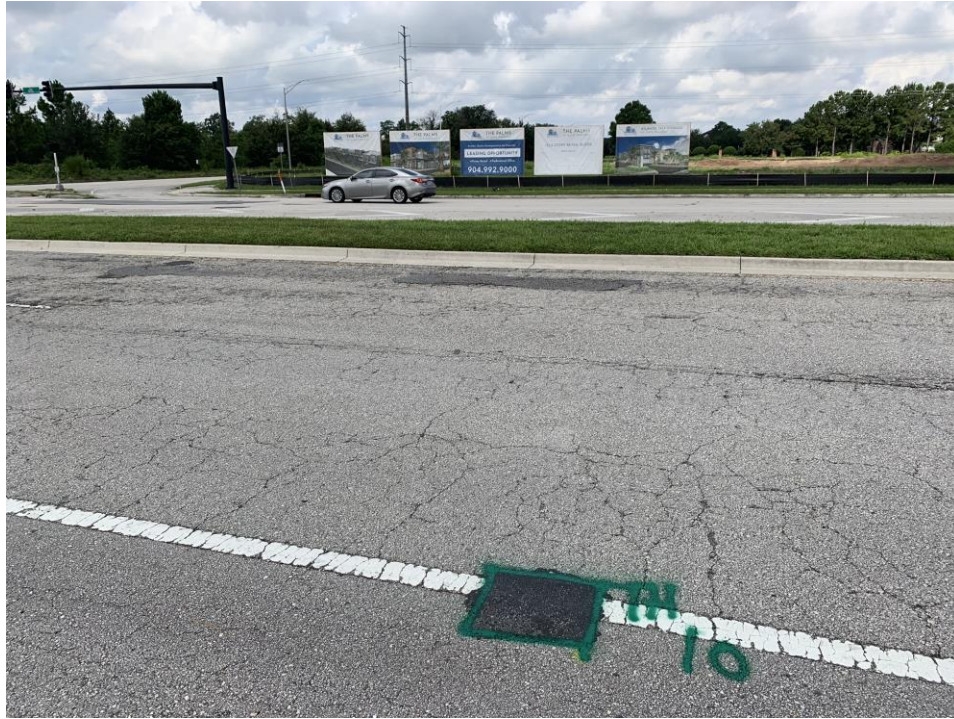
TEST HOLE #10

<p>EA</p> <p>TH10</p> <p>GATE PAVELWAY</p> <p>EA</p>	<p>UNABLE TO LOCATE UTILITY DUE TO DEPTH DUE TO A DEPTH OF 8'</p>
--	---

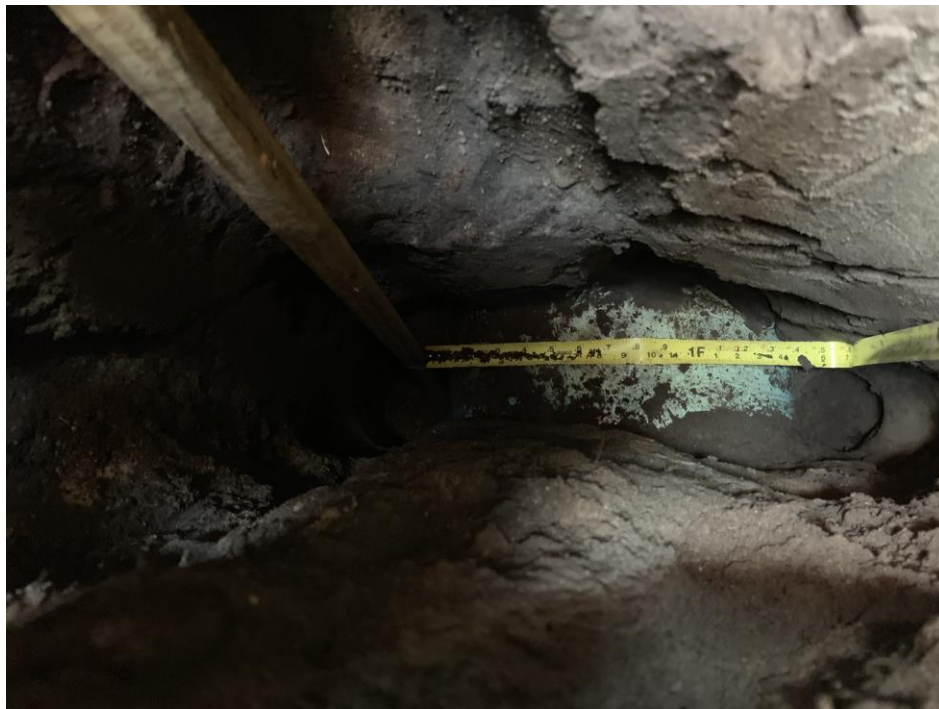
## TEST HOLE #11

FOUND 18" PVC  
WL

18" PVC WATERLINE

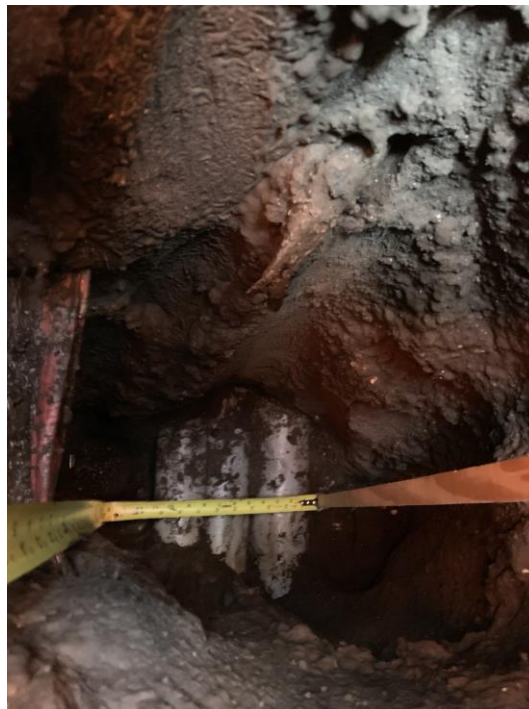
## TEST HOLE #12

FOUND 3-4"  
CONDUIT  
Depth

4-4" PVC ELECTRIC CONDUITS

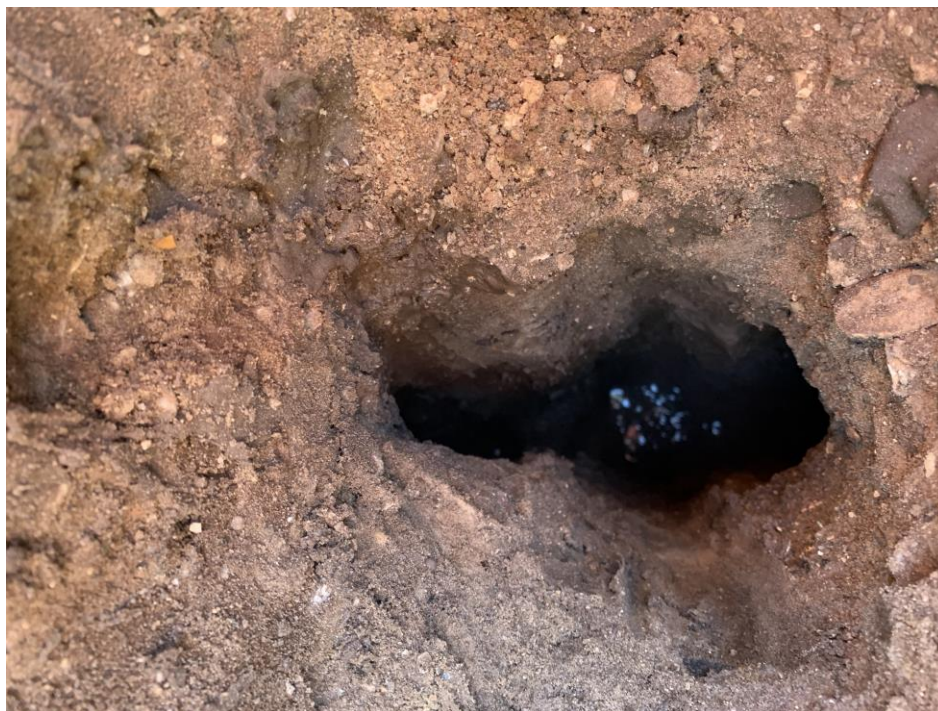
TEST HOLE #13

UNABLE TO  
REACH UTILITY  
DUE TO DEPTH  
DOG AND  
PROBED TO  
A DEPTH  
OF 7'-8'

UNABLE TO LOCATE DUE TO DEPTH

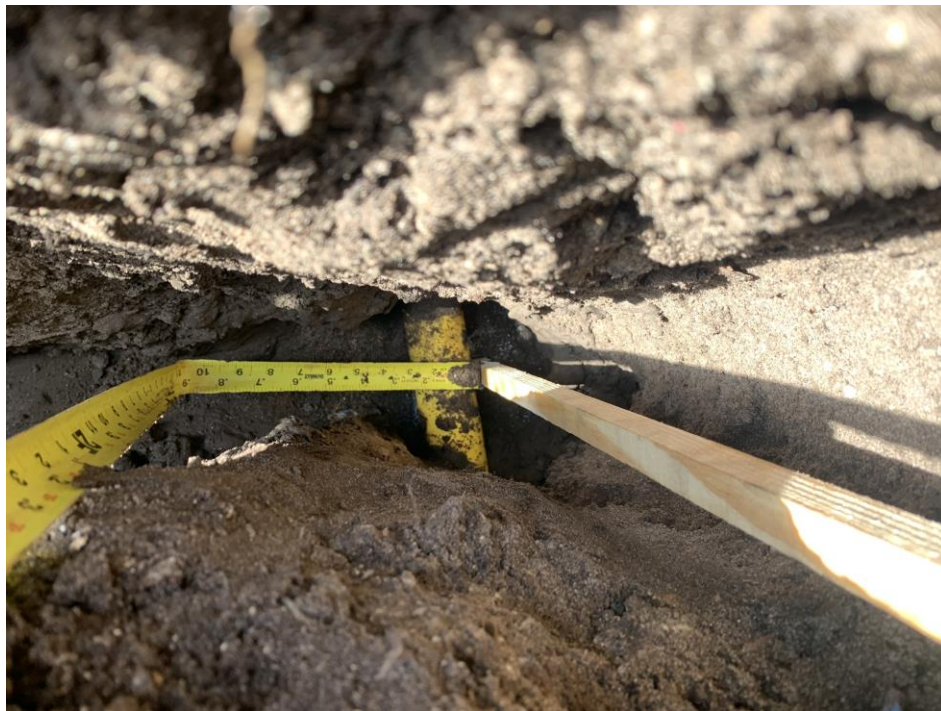
## TEST HOLE #14

3" GAS LINE

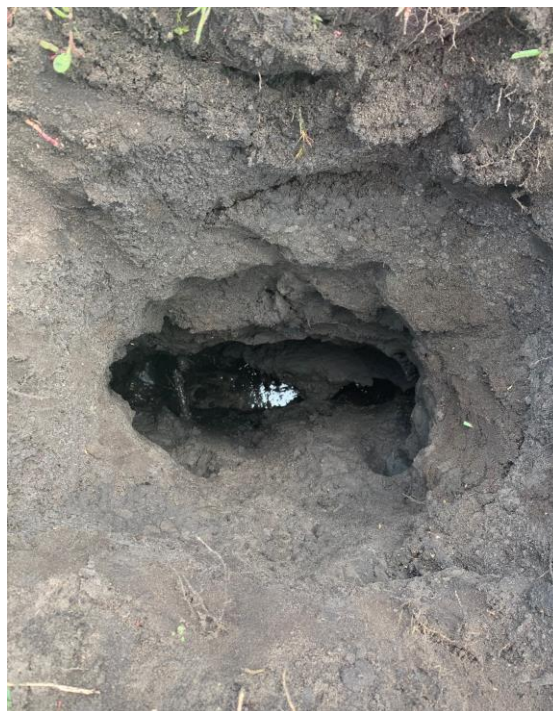
TEST HOLE #15

UNABLE TO LOCATE  
DUE TO DEPTH.  
DUE TO A DEPTH  
OF 7'8".

WATER IN HOLE

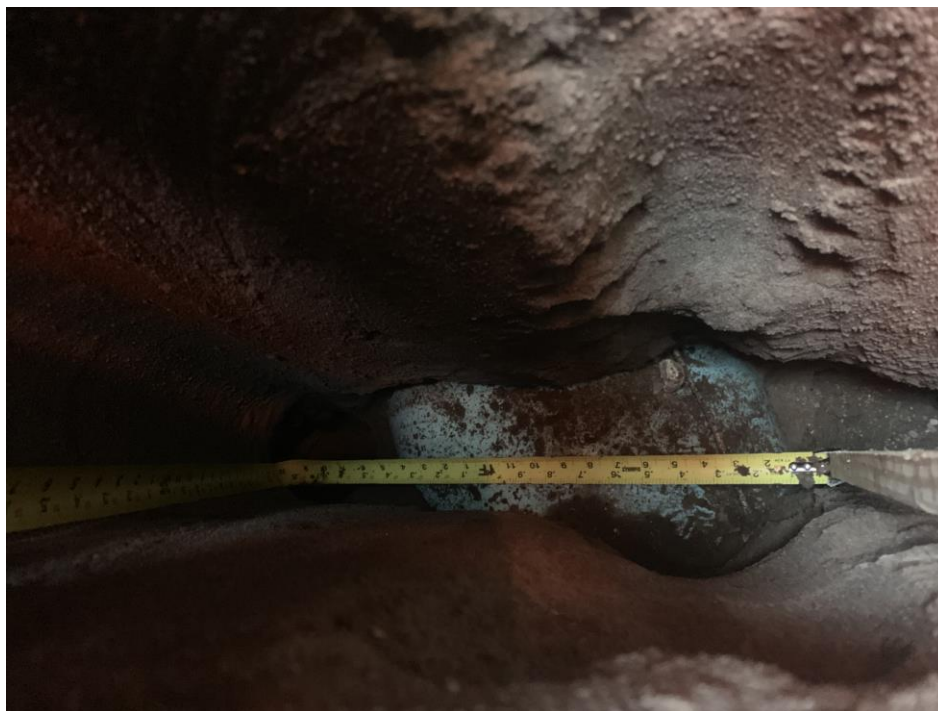
TEST HOLE #16

18" PVC WATER LINE

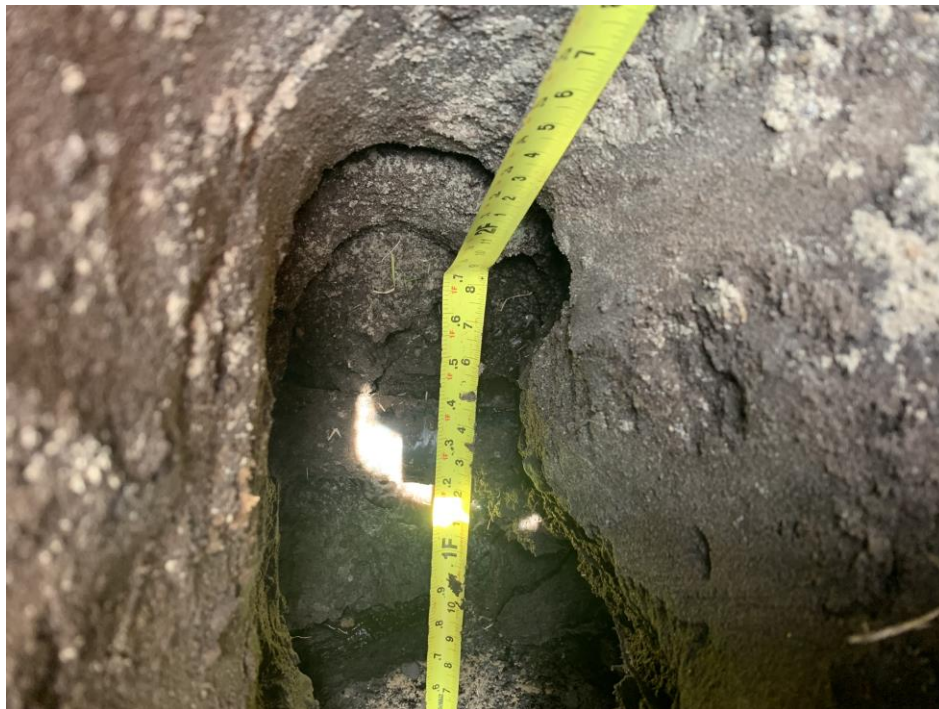
TEST HOLE #17

FOUND 3" COMM  
CABLE 2.36'

3" COMMUNICATIONS CABLE

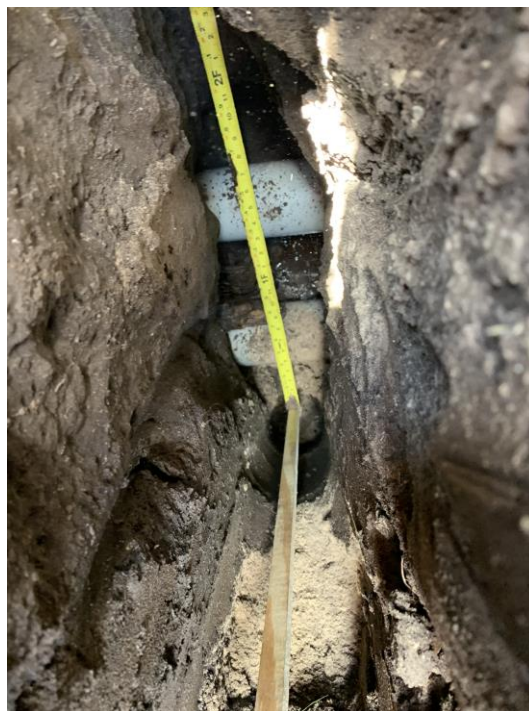
## TEST HOLE #19

2-3" ELECTRIC CONDUITS

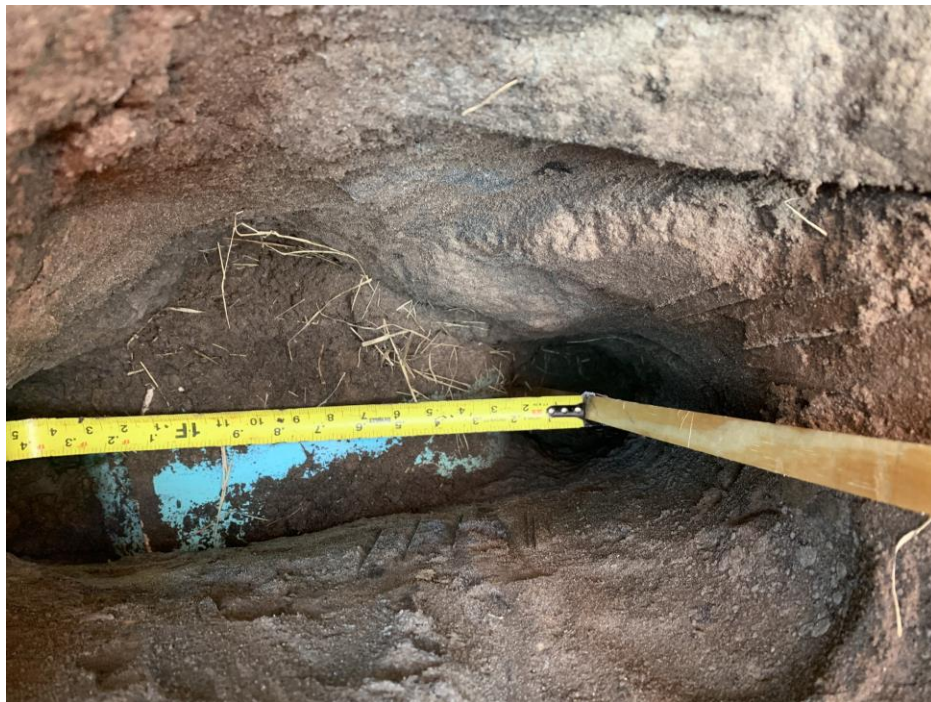
FOUND 12"  
BLUE PVC w

12" PVC WATER LINE

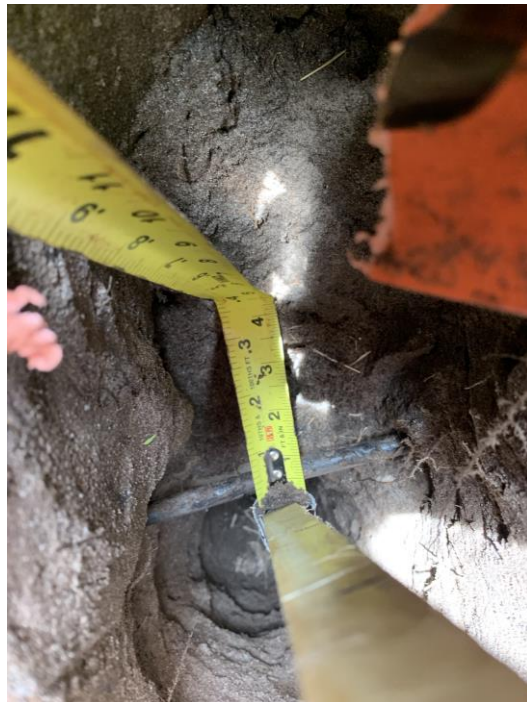
## TEST HOLE #22

FOUND 1" COMM CABLE

1" COMMUNICATIONS CABLE

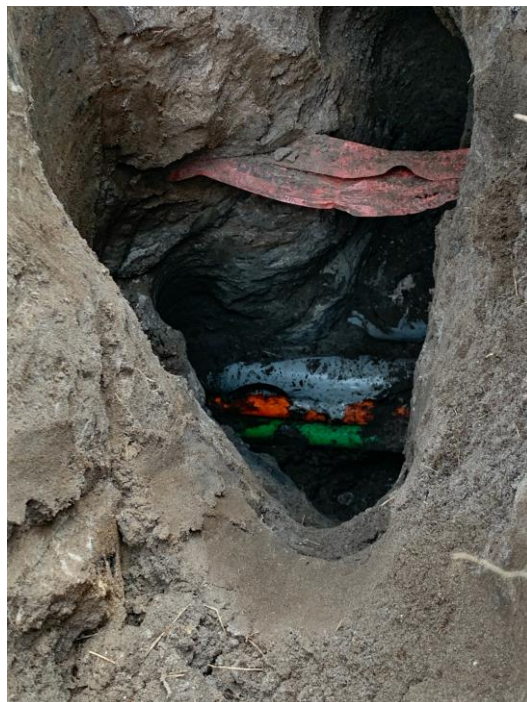
FOUND 2' x 2"  
COMM LINES

2-2" COMMUNICATIONS CABLE

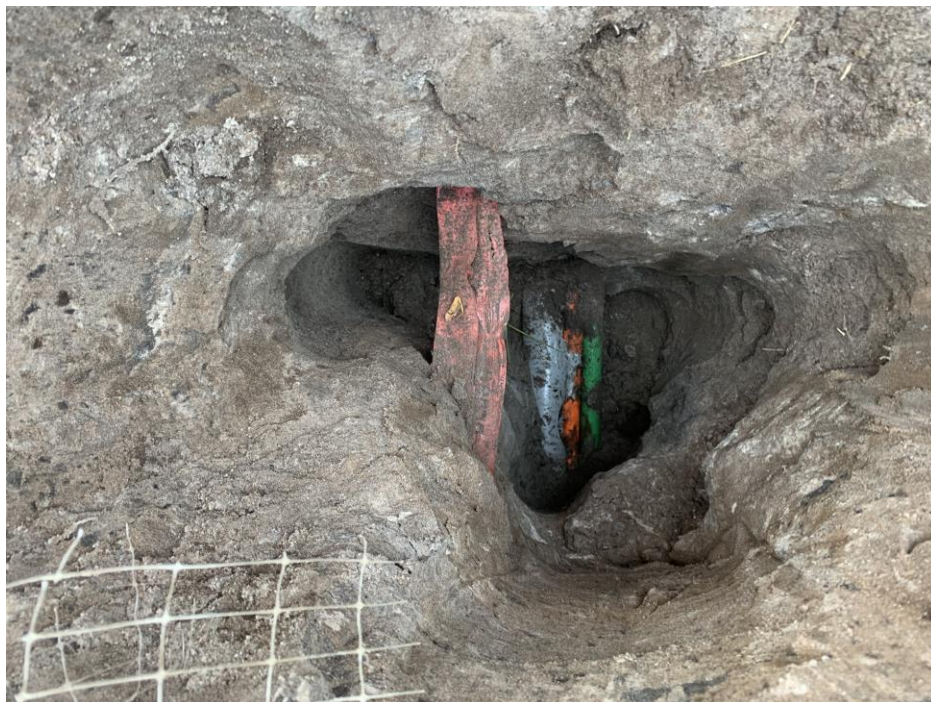
2-4" ELECTRIC CONDUITS

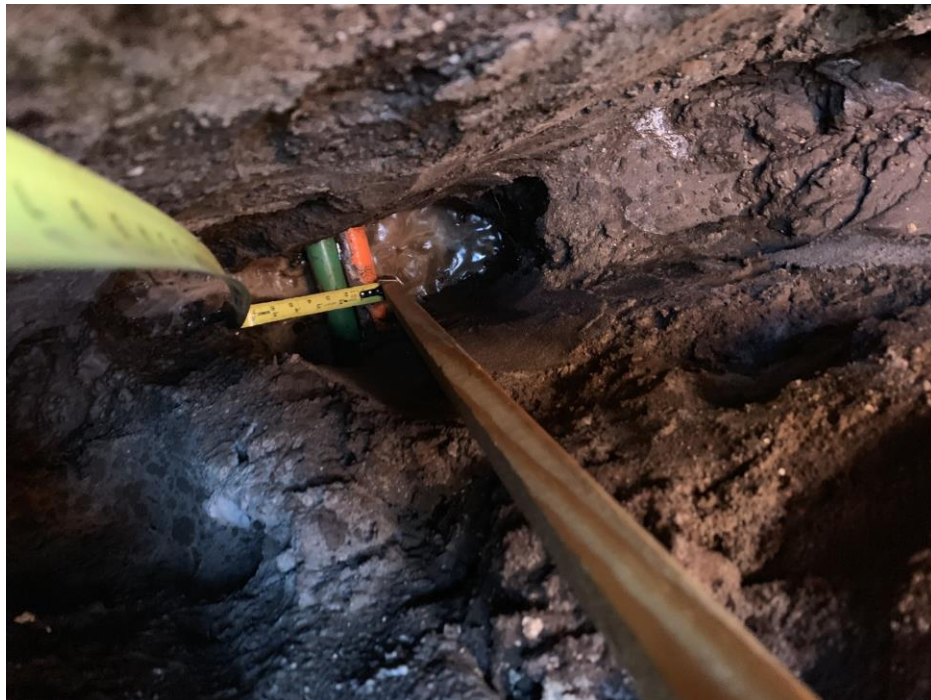
FOUND 2x1"  
CONDUIT COMM  
LINES

2-1" COMMUNICATIONS CONDUITS

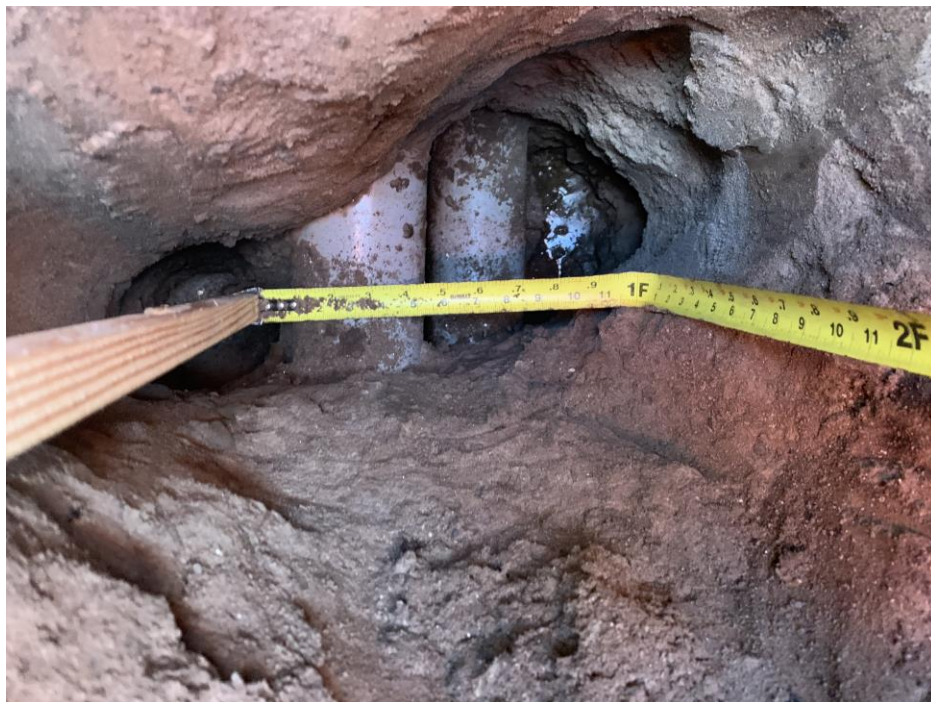
FOUND 2x4"  
GREY CONDUIT

2-4" ELECTRIC CONDUITS

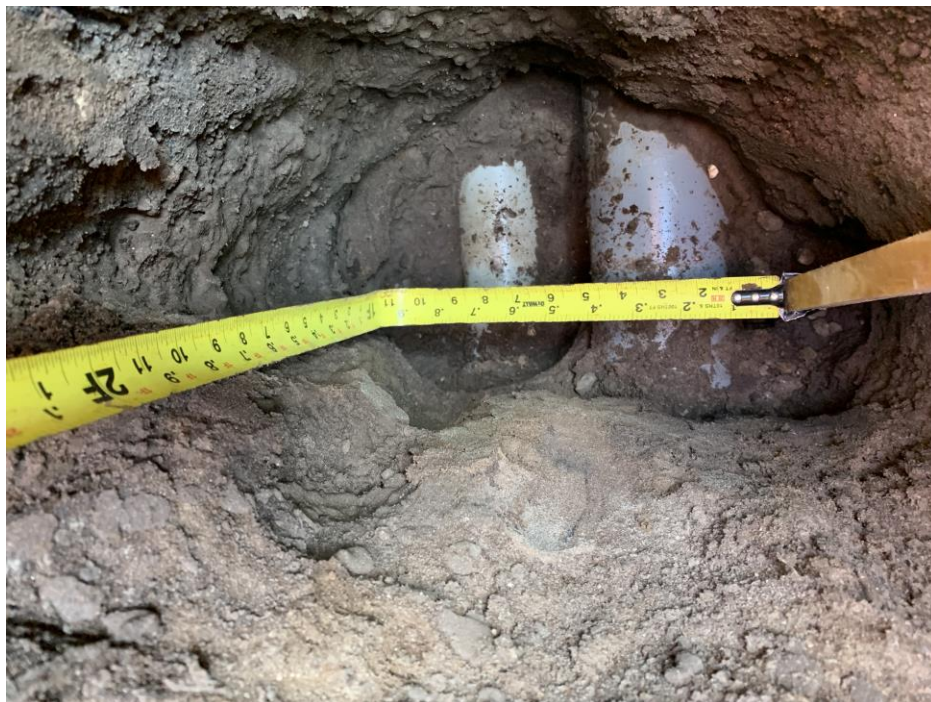
Found 2x4"  
GREY CONDUIT

2-4" ELECTRIC CONDUITS

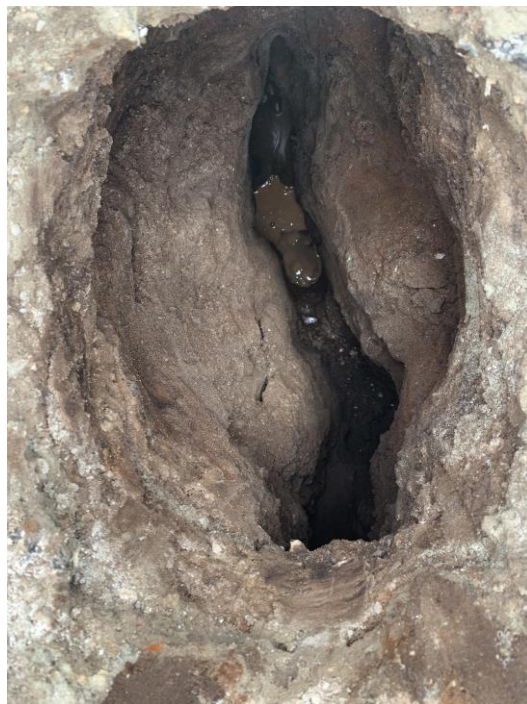
TEST HOLE #29

UNABLE TO  
LOCATE UTILITY  
DUE TO DEPTH  
DUG TO A DEPTH  
OF 7'.

NOT FOUND
