**Bernita Street Forc Main Replacement - Test Hole Locations for Survey**

# VACUUM TEST HOLE REPORT

FRA Job No.: 2984

| PROJECT NAME: <u>Bernita St Force Main Replacement</u> | | Subcontract No.: | WORK ORDER No.: <u>16</u> |

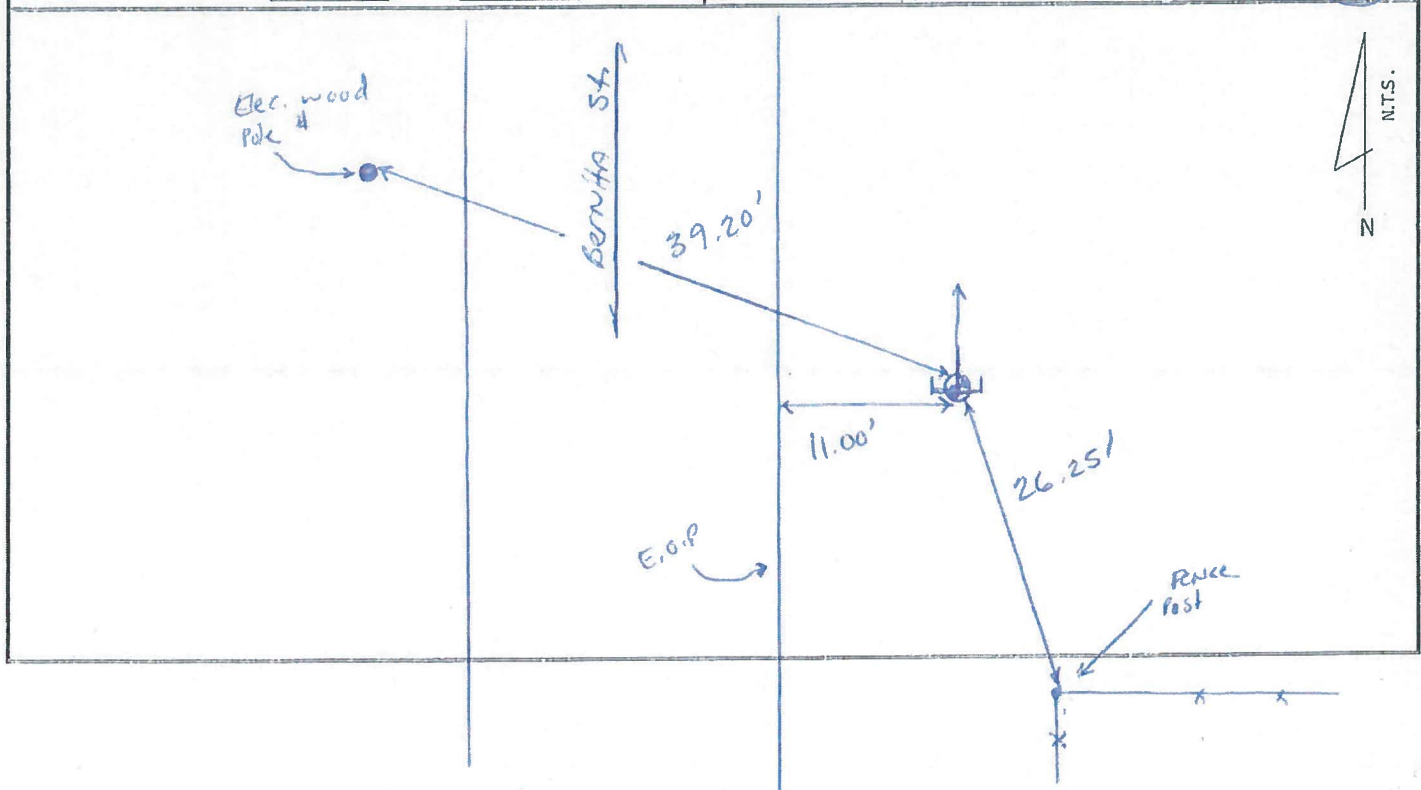
Test Hole No.: 1

| | | NOTES: Excavated to a depth of <u>2.62'</u><br><br><u>Found a 18" C.I. F.M. w/ Plug.</u> | |

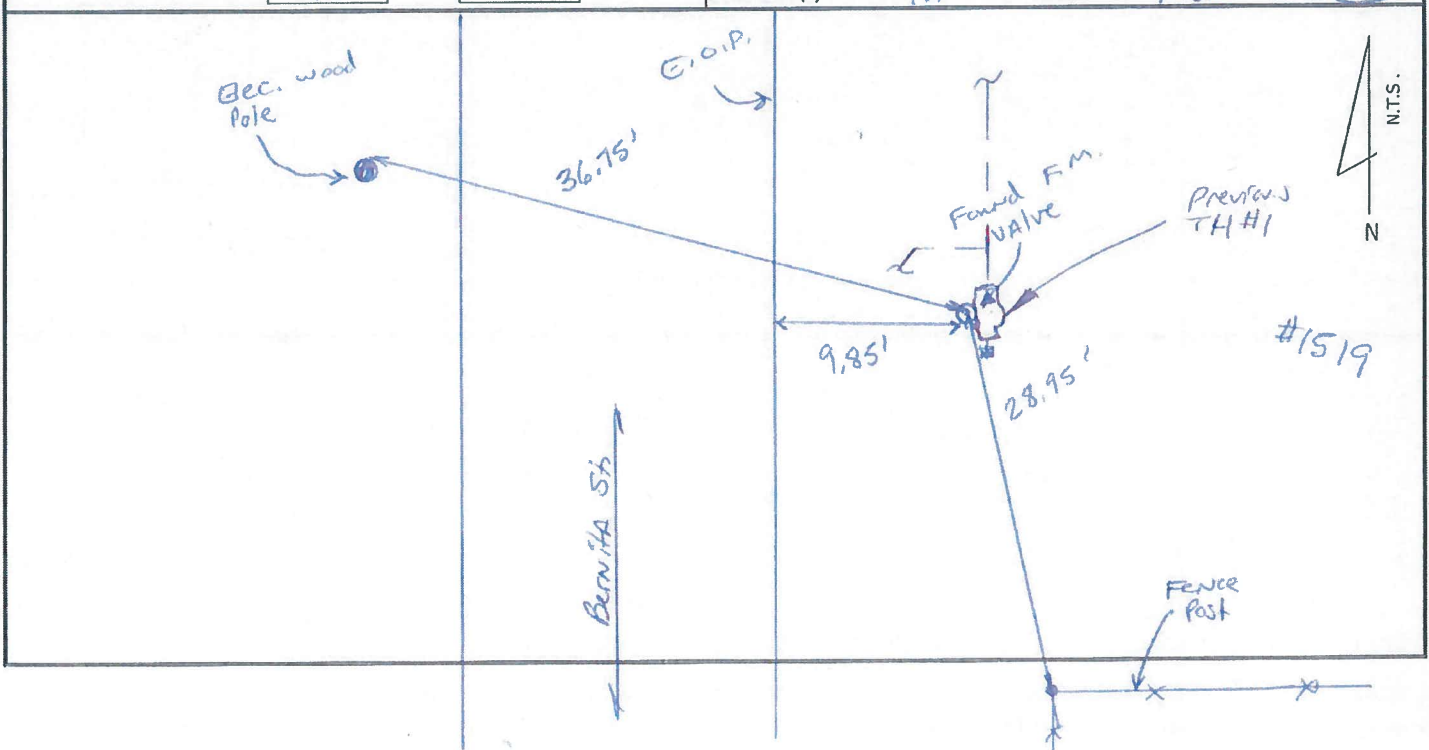
Test Hole No.: 6  
FRA Job No.: 2984

| | | <p><i>Found a F.M. valve w/ NO valve cover.</i></p> | | | |

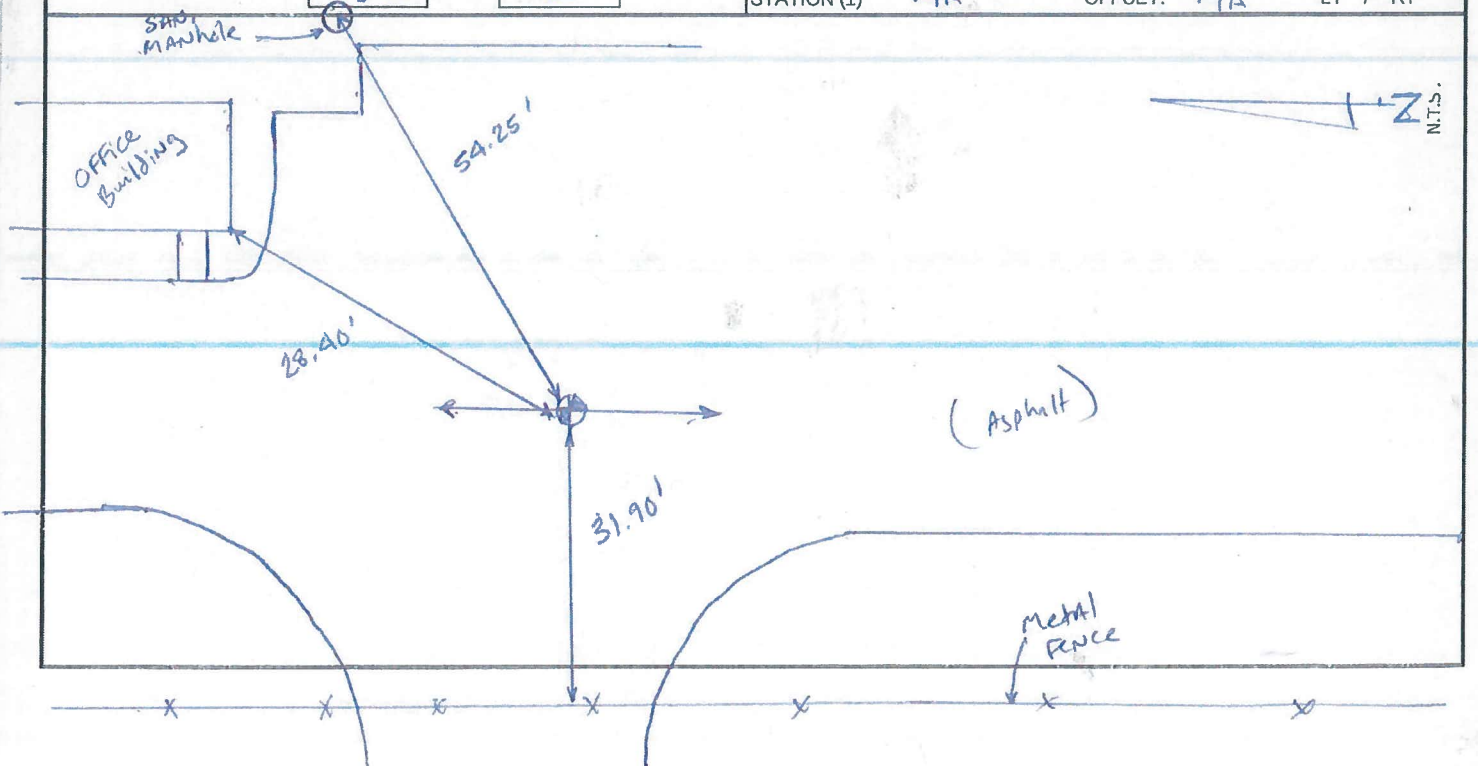
Test Hole No.: 7  
FRA Job No.: 2984

| <div style="display: flex; justify-content: space-between;"> <div> BLEV. SURFACE: N/A<br/> COVER TOP: <u>1.65'</u><br/> N/A<br/> REVISION: _____<br/> COVER BOTTOM: <u>2.40'</u><br/> N/A<br/> BLEV. BOTTOM: _____ </div> <div> PAVEMENT: <u>.15'</u><br/> BLEV. SURFACE: <u>.45'</u><br/> VERTICAL: _____<br/> WIDTH: <u>.75'</u><br/> FACING: <u>N&amp;S</u> </div> </div> | | INSTALLED: <u>PK</u> HUB STEEL PIN CHIS "X" CHIS BOX<br>AT: <u>CROWN</u> EDGE OF UTILITY:<br>SURVEY PIN LOCATED BY: N/A<br>JOB MEASUREMENT TYPE: <u>TENTHS</u> METRIC INCHES<br>NOTES: Excavated to a depth of <u>1.65'</u><br><br><u>Found a 8" pvc w/ m (50A water &amp; sewer)</u> | |

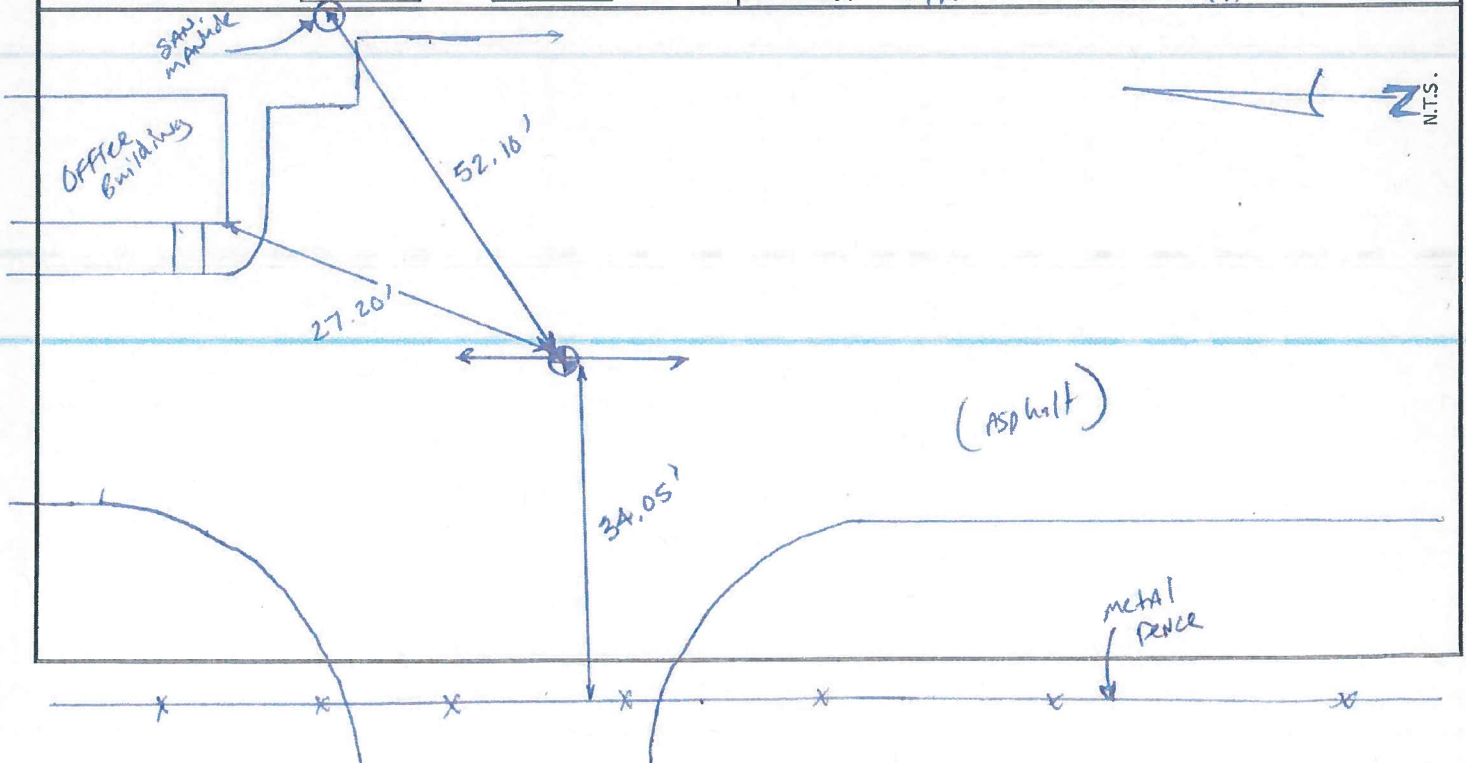
Test Hole No.: 8  
FRA Job No.: 2984

| | | JOB MEASUREMENT TYPE: <u>TENTHS</u> METRIC INCHES<br>NOTES: Excavated to a depth of <u>3.54'</u><br>"Found a 16" PVC F.M. (SDA under & sewer)" | | | |

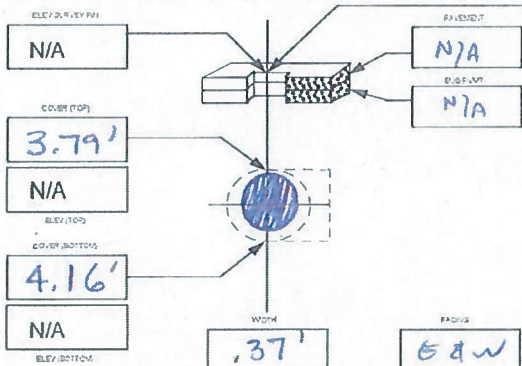
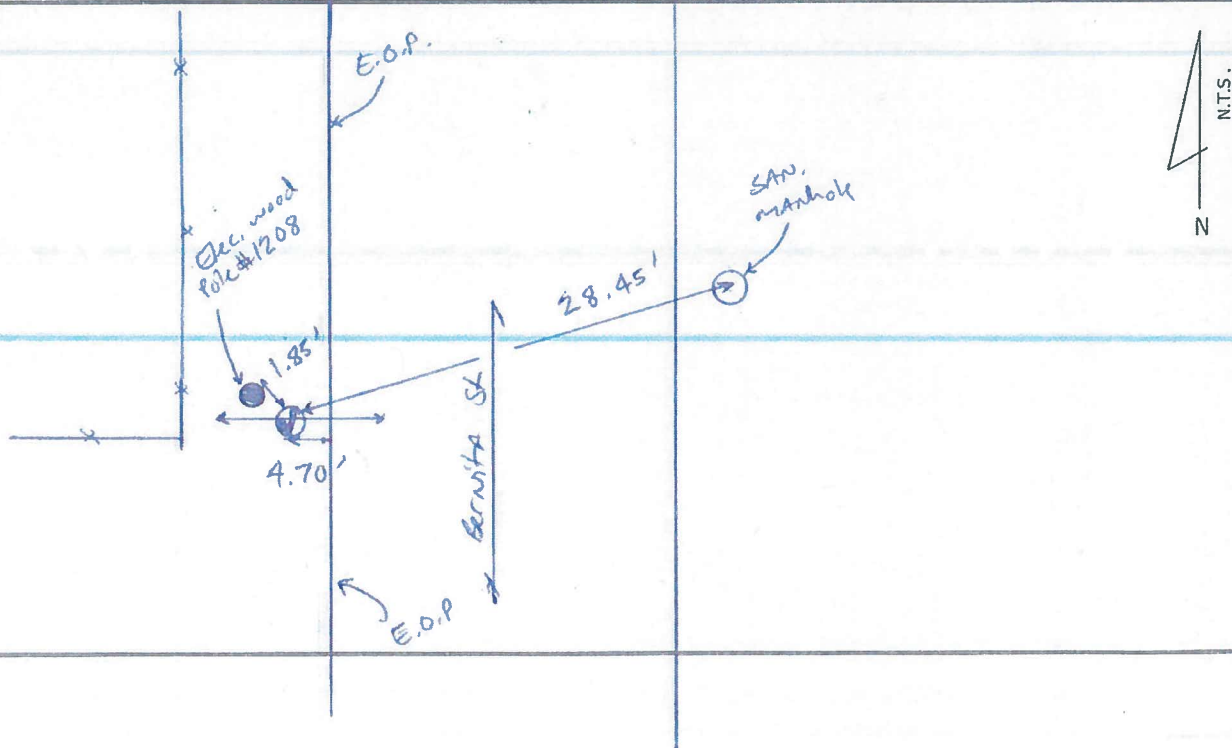
Test Hole No.: 12  
FRA Job No.: 2984

NOTES: Excavated to a depth of 3.79'

*Found a 4" PVC SAN. sewer (JEA water & sewer)*
