# Intracoastal Builders Corporation

## BUILDING INSPECTION REPORT

FOR THE PROPERTY AT  
**10855 New Berlin Rd, Jacksonville, FL 32226**

**April 16, 2020**

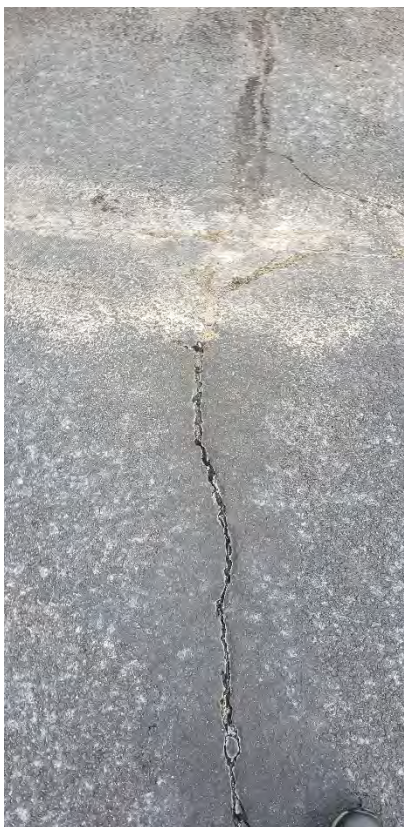
1 A

22.	Exterior	19B	Mitered Endwall Structure is overgrown
23.	Exterior	1A / 1B	Asphalt paving has cracking throughout
24.	Exterior	1C	Debris has accumulated over inlets and drainage areas

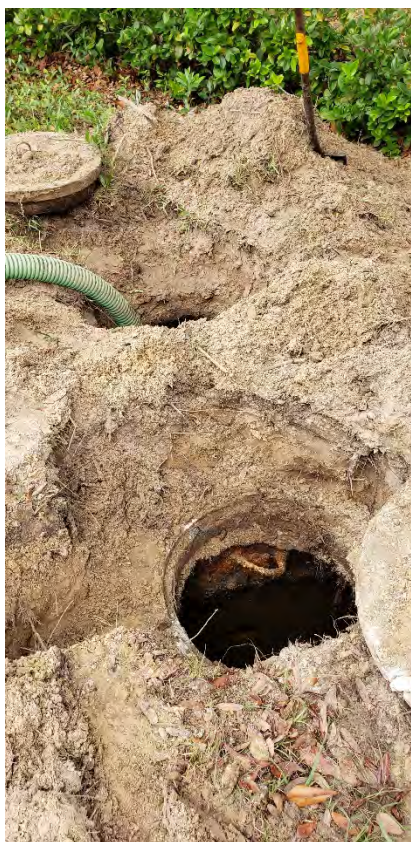
4 B

25.	Exterior	4B / 4C	The lids to the septic tank are covered by several feet of dirt
26.	Exterior	9B / 9C	The east exterior block wall paint is failing which may be a contributory factor to the moisture wicking mentioned in other comments

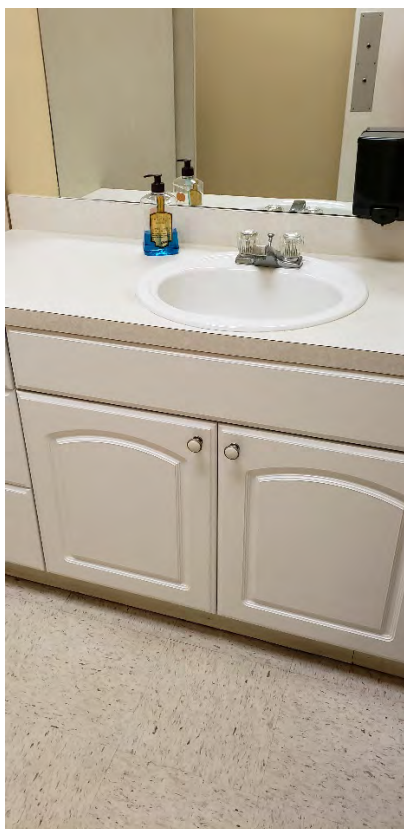
5 A

39.	Office	5A	Bathroom sink and vanity do not meet ADA requirements
40.	Office	5B	Urinal is out of service
41.	Office	5C	Water fountain was not installed or was removed

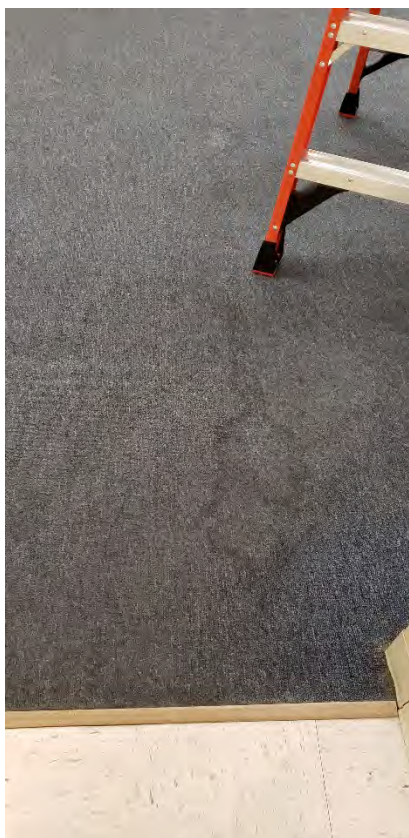
6 A

42.	Office	5D	Exhaust fan is causing ceiling tile to sag in bathroom and a lamp is not working in the adjacent light fixture
43.	Office	6A	Carpet is stained by corridor to the warehouse

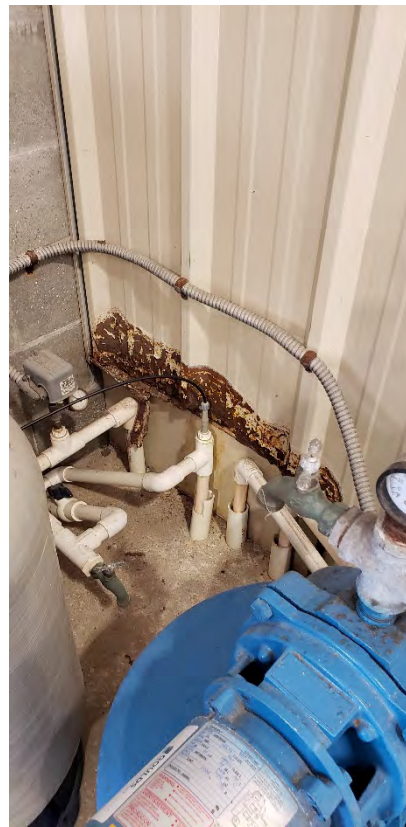
7 B

68.	Warehouse	7B / 7C	Wall panel on the Warehouse side of the Office/Warehouse has a buildup of rust on the east side and along the track extending west

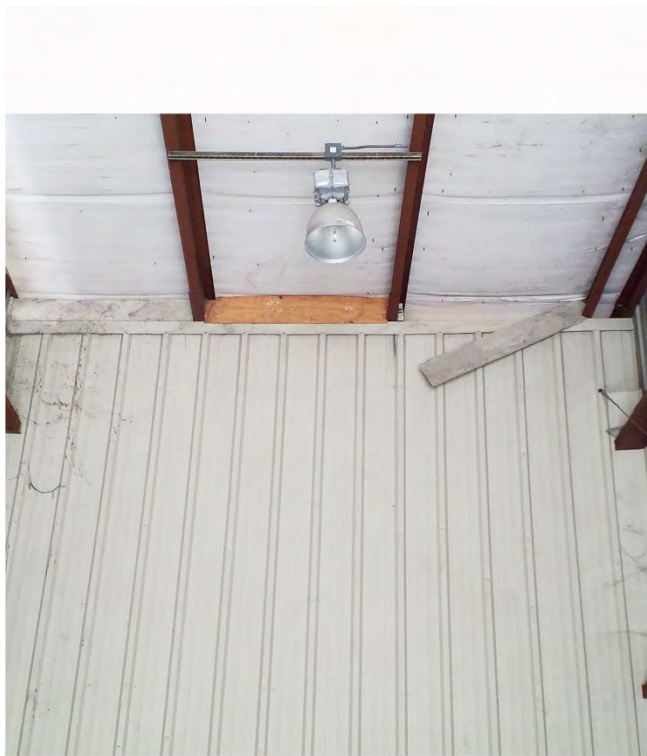
11 A

50.	Open Bays	11A	Blocking has been installed to close the space between the roof purlins. One piece has come loose leaving the enclosed warehouse open to the exterior - <i>See J.C. Harward &amp; Associates report for additional details.</i>

- LINER PANELS AT OPEN AIR CANOPY HAS A COUPLE PANELS THAT HAVE NORMAL DENTS DUE TO USE. REPLACE IF NEEDED. ONE PIECE OF CLOSURE IS MISSING AT THE WASH BAY. THIS SHOULD BE RESECURED TO PROTECT ACCESS OF BIRDS/ANIMALS INTO THE WAREHOUSE.

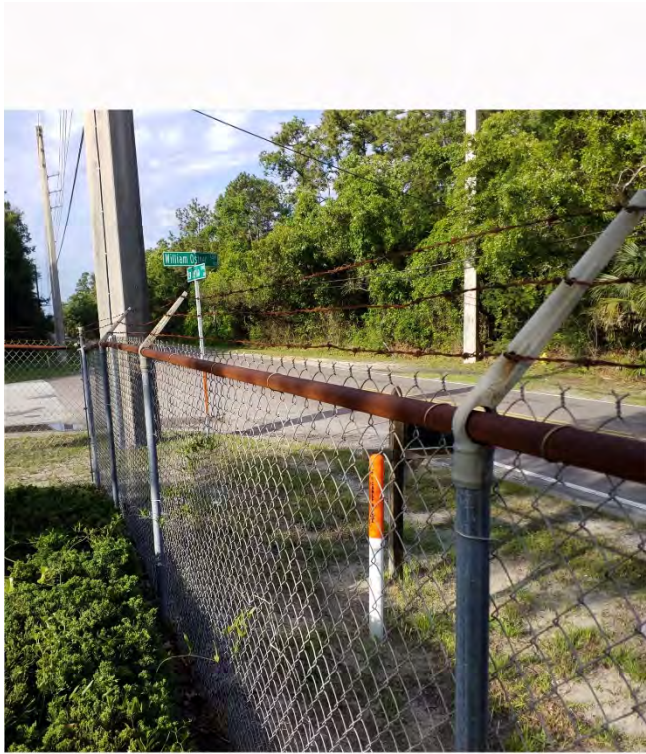
17 A

13.	Exterior	16D	An irrigation control valve box has been damaged
14.	Exterior	17A	Fencing components are rusted
15.	Exterior	17B	Monument sign has minor cracking and vegetation growth

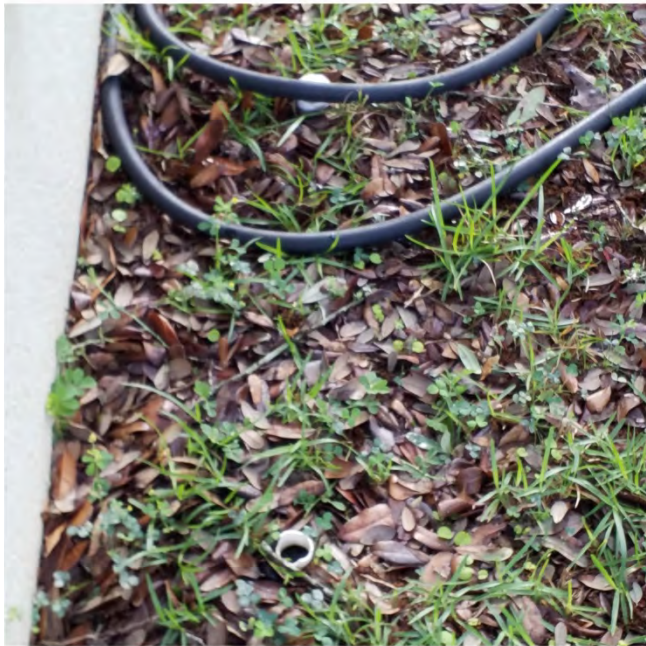
18 A

18.	Exterior	18A	Unknown PVC pipe is broken at grade
19.	Exterior	18B	The concrete apron is cracked at roof drain locations

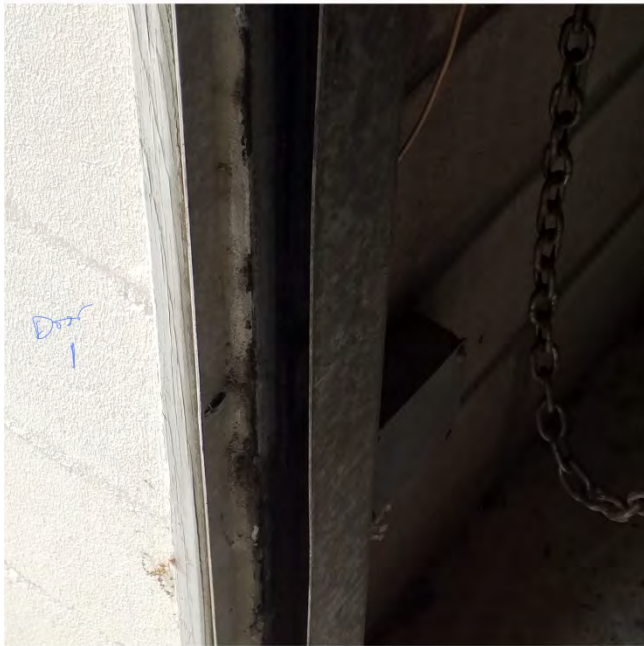
20 A

63.	Warehouse	20B	Roll up door #1 chain lock is pulling building steel loose
64.	Warehouse	20A	Roll up door #1 missing track fasteners on bottom 4'
65.	Warehouse	20C	Roll up door #10 missing fastener on door lock

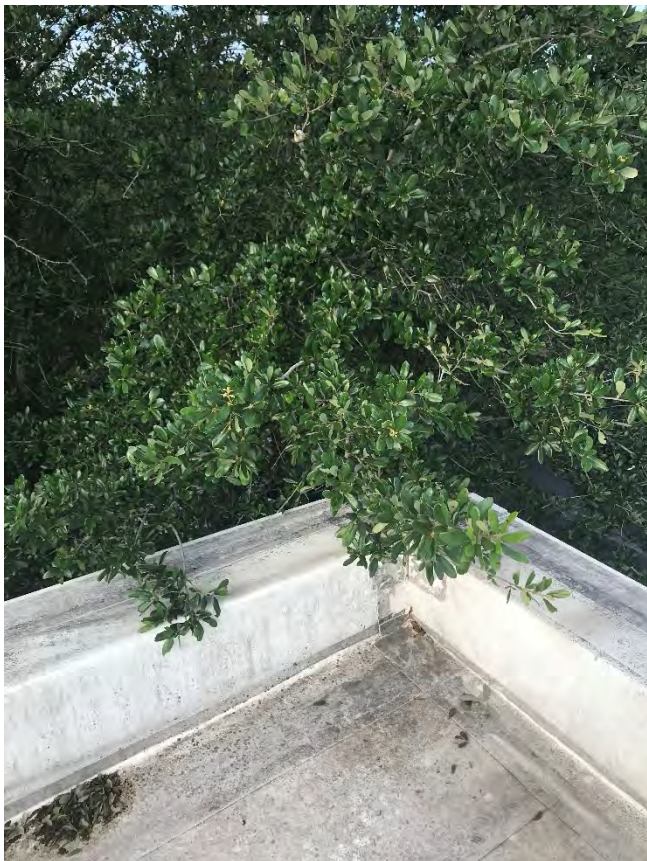
21 A

51.	Roof	20D / 21A 22A	Tree limbs extend over roof footprint – <i>See J.C. Harward &amp; Associates report for additional details.</i>
52.	Roof	21B / 21C	Condensate lines are disconnected - <i>See J.C. Harward &amp; Associates report for additional details.</i>

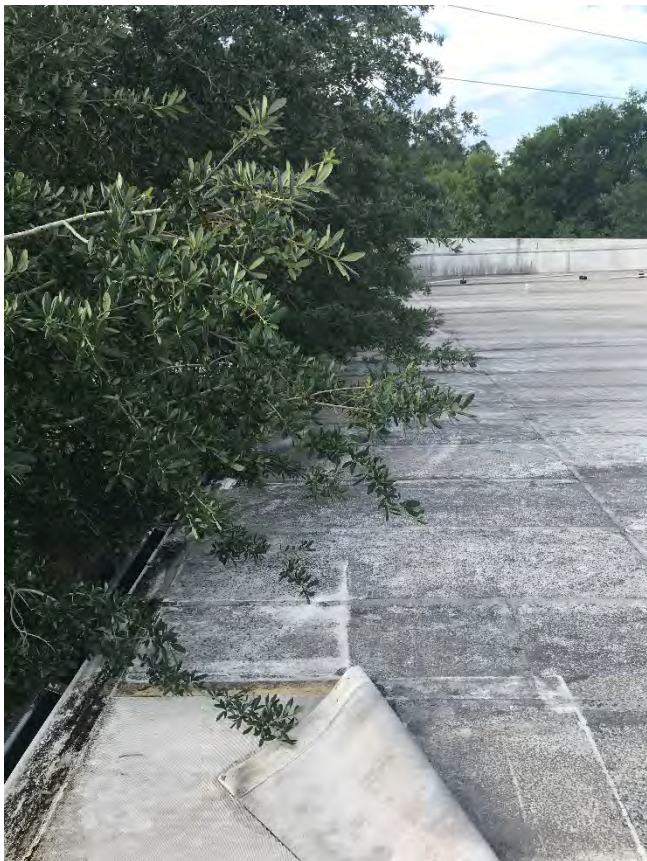
22 A

10.	Exterior	11D / 12B 22A / 22B	The gutters have a buildup of vegetation - <i>See J.C. Harward &amp; Associates report for additional details.</i>
11.	Exterior	12C	The rip rap has washed out at the bottom of the mitered end structure causing minor erosion at the base of the structure

53.	Roof	21D	Walk pad is not attached to the roof at ladder access point - <i>See J.C. Harward &amp; Associates report for additional details.</i>
54.	Roof	22A / 22B 22C	Gutters are filled with debris and vegetation which may be causing water to back up and flow into the building - <i>See J.C. Harward &amp; Associates report for additional details.</i>

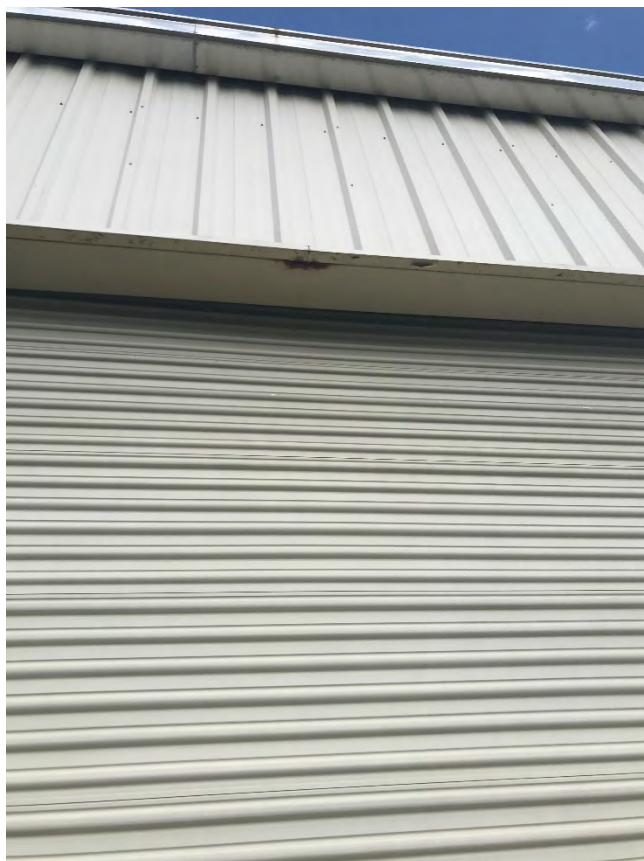
23 B

66.	Warehouse	23B	Door frames are rusting - <i>See J.C. Harward &amp; Associates report for additional details.</i>
67.	Warehouse	24D	Well system was not operating properly. The tank would not fill to an adequate pressure for the supply system.

- RECOMMENDATIONS:
  - PRIME AND PAINT SCREW HEADS. OR REPLACE WITH GALVANIZED / S.S. SCREWS.
  - OVERHEAD DOOR FRAMES THAT HAVE VISUAL RUST SHOULD BE PREP, PRIME AND PAINTED.
