# **Preventive Maintenance Inspection at**

## **SE Jax Sub. EL-20170706-000013**

*7/6/2017*

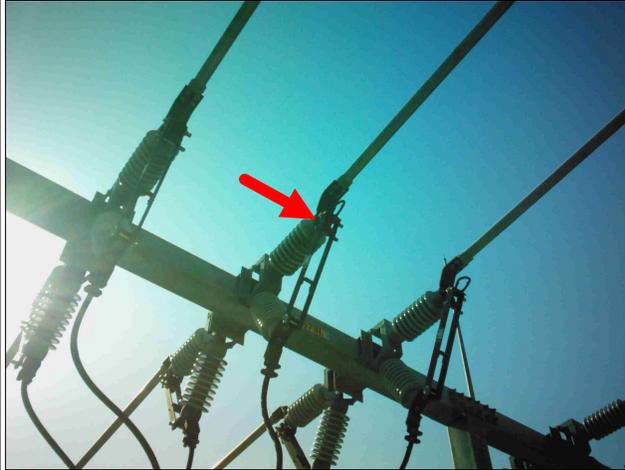
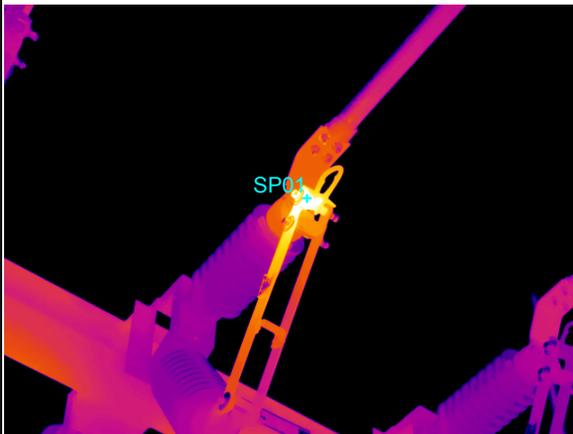
**Sw. 573L**

| Additional information | B phase clip |

**#1**

| Label | Value |
|---|---|
| SP01 | 333°C |

304.6°C

**Immediate repair**
