Subsurface Utility Engineering Reports

JEA Galvanized Pipe Replacement Program

College Street Area – Package G

England-Thims & Miller, Inc.

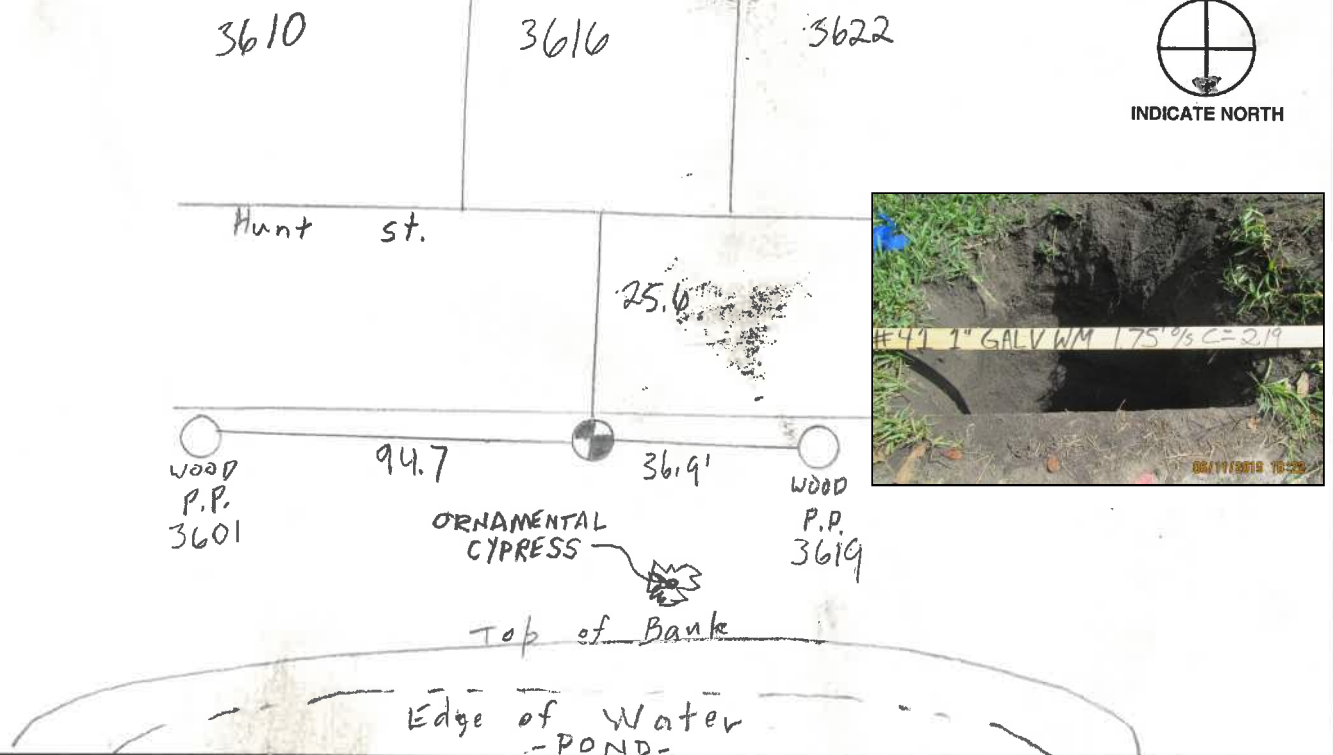
TEST HOLE NO.: VVH #41
PROJECT NO.: _____
WORK ORDER NO.: 19-041.00
CLIENT PROJECT NO.: _____
SUNSHINE-811 TICKET: 137901405

REPORT BY: <u>I. FINLEY</u>		ASSISTED BY: <u>P. HEROLD</u>		PROJECT NAME: JEA Galvanized Pipe Replacement	
CHECKED BY: <u>[Signature]</u>		VVH REQUESTED BY: ETM			
NO. HOLES:	DATE: <u>6/11/19</u>	TIME:	REQUESTED UTILITY: Water main		
UTILITY OWNER: JEA			LOCATED UTILITY: <u>1" GALV PIPE</u>		
PAVEMENT TYPE: <u>soft dig</u>			MATERIAL AS FOUND: <u>GALV</u>	COLOR: <u>-</u>	
PAVEMENT CONDITION: <u>N/A</u>			SIZE AS EXPECTED: <u>1"</u>	SIZE AS FOUND: <u>1"</u>	
SOIL CONDITIONS: SOFT <input type="checkbox"/> DRY <input type="checkbox"/> CLAY <input type="checkbox"/> DIRT <input checked="" type="checkbox"/>			UTILITY CONDITION: <u>RUSTED</u>		
PROPOSED: Determine pipe material			PAINT FLAGGED: <u>BLUE</u>		
INSTALLED: IRON ROD & CAP LB3624 or _____					
AT: CROWN, EDGE, OTHER _____					
JOB MEASUREMENT TYPE: Tenths - Feet					
NOTES: <u>FND 1" GALV PIPE @ 2.19</u>					
Approx. STATION (±)		OFFSET:		PAVEMENT: <u>N/A</u> SUB PAVEMENT: <u>N/A</u> WIDTH: <u>1"</u> UTILITY DIRECTION: <u>E-W</u>

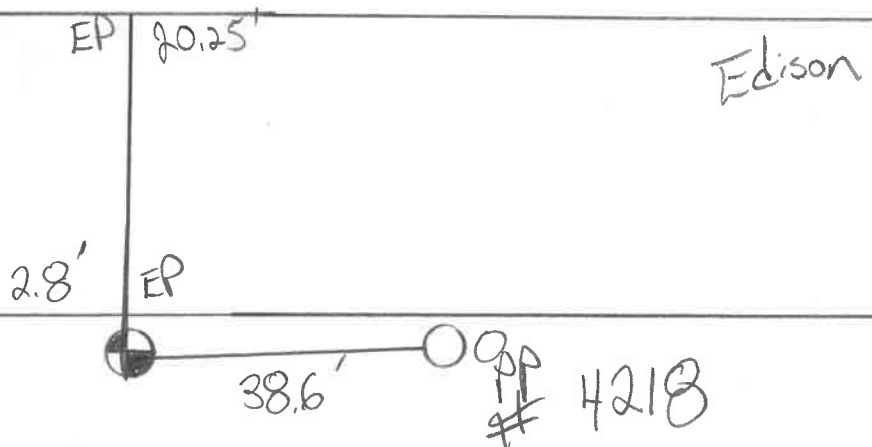
TEST HOLE NO.: 313 G
PROJECT NO.: _____
WORK ORDER NO.: 19-041-00 19-212
CLIENT PROJECT NO.: _____
SUNSHINE-811 TICKET: 21000001

REPORT BY: <u>P. Harold</u>	ASSISTED BY: <u>P. Chesteen</u>	PROJECT NAME: JEA Galvanized Pipe Replacement	
CHECKED BY:		VVH REQUESTED BY: ETM	
NO. HOLES: <u>1</u>	DATE: <u>5/4/20</u>	TIME:	REQUESTED UTILITY: Water main
UTILITY OWNER: JEA		LOCATED UTILITY: <u>WM</u>	
PAVEMENT TYPE: <u>Soft dis</u>	MATERIAL AS FOUND: <u>PVC</u>		COLOR: <u>Blue</u>
PAVEMENT CONDITION: <u>NA</u>	SIZE AS EXPECTED:	SIZE AS FOUND: <u>4"</u>	
SOIL CONDITIONS: SOFT <input type="checkbox"/> DRY <input type="checkbox"/> CLAY <input type="checkbox"/> DIRT <input checked="" type="checkbox"/>		UTILITY CONDITION: <u>Fair</u>	
PROPOSED: Determine pipe material		PAINT FLAGGED: <u>Blue</u>	
INSTALLED: <u>IRON ROD & CAP LB3624</u> or _____			
AT: <u>CROWN</u> , EDGE, OTHER _____			
JOB MEASUREMENT TYPE: Tenths - Feet			
NOTES: <u>FIND 4" Blue pvc wm @ 2.76'</u>			
Approx. STATION (±): _____		OFFSET: _____

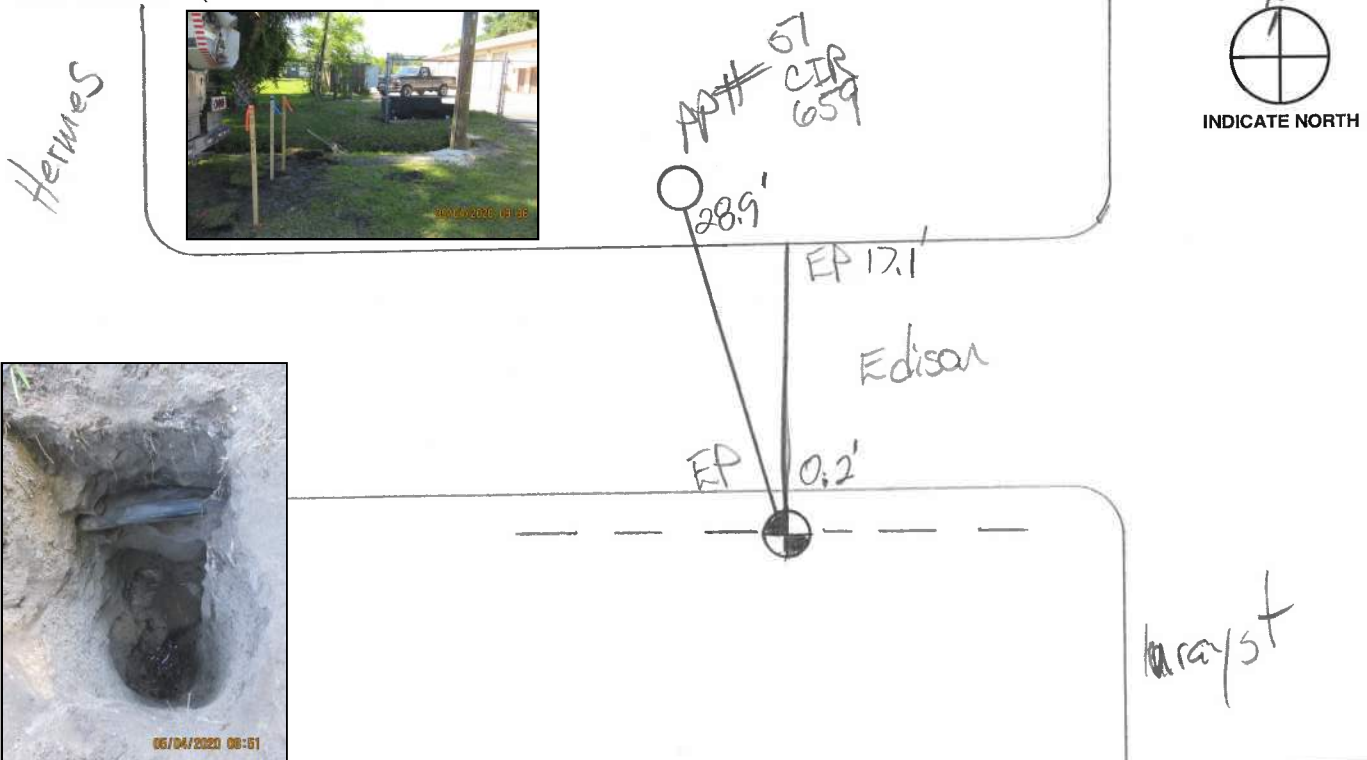
TEST HOLE NO.: HR INV 6
PROJECT NO.: _____
WORK ORDER NO.: 19-04180 A-212
CLIENT PROJECT NO.: _____
SUNSHINE-811 TICKET: 121000001

REPORT BY: <u>A Herold</u>	ASSISTED BY: <u>P Chester</u>	PROJECT NAME: JEA Galvanized Pipe Replacement	
CHECKED BY:		VVH REQUESTED BY: ETM	
NO. HOLES: <u>1</u>	DATE: <u>5/4/20</u>	TIME:	REQUESTED UTILITY: <u>Water main Com</u>
UTILITY OWNER: <u>JEA</u>		LOCATED UTILITY: <u>Com</u>	
PAVEMENT TYPE:		MATERIAL AS FOUND: <u>DB cable</u>	COLOR: <u>Black</u>
PAVEMENT CONDITION:		SIZE AS EXPECTED:	SIZE AS FOUND: <u>1"</u>
SOIL CONDITIONS: <input checked="" type="checkbox"/> SOFT <input type="checkbox"/> DRY <input type="checkbox"/> CLAY <input type="checkbox"/> DIRT <input checked="" type="checkbox"/>		UTILITY CONDITION: <u>fair</u>	
PROPOSED: Determine pipe material		PAINT FLAGGED: <u>Orange</u>	
INSTALLED: IRON ROD & CAP LB3624 or <u>Hub & Tack</u>			
AT: <u>CROWN</u> , EDGE, OTHER _____			
JOB MEASUREMENT TYPE: <u>Tenths - Feet</u>			
NOTES: <u>FIND 1" Black DB cable @ 1.03</u> <u>see pics 136-3845 / 136-3848</u>

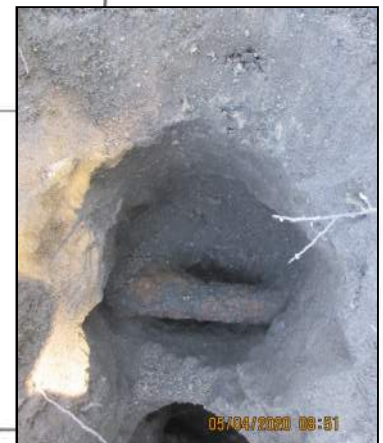
TEST HOLE NO.: HR INV 6
PROJECT NO.: _____
WORK ORDER NO.: 19-044.00 15-212
CLIENT PROJECT NO.: _____
SUNSHINE-811 TICKET: 121 000001

REPORT BY: <u>P. Harold</u>		ASSISTED BY: <u>P. Chasteen</u>		PROJECT NAME: JEA Galvanized Pipe Replacement	
CHECKED BY:				VVH REQUESTED BY: ETM	
NO. HOLES: <u>1</u>	DATE: <u>5/4/20</u>	TIME:	REQUESTED UTILITY: Water main		
UTILITY OWNER: JEA			LOCATED UTILITY:		
PAVEMENT TYPE: <u>Soft dig</u>			MATERIAL AS FOUND: <u>Galv</u>		COLOR: <u>Rust</u>
PAVEMENT CONDITION: <u>NA</u>			SIZE AS EXPECTED:		SIZE AS FOUND: <u>2.5'</u>
SOIL CONDITIONS: SOFT <input type="checkbox"/> DRY <input type="checkbox"/> CLAY <input type="checkbox"/> DIRT <input checked="" type="checkbox"/>			UTILITY CONDITION: <u>poor</u>		
PROPOSED: Determine pipe material			PAINT FLAGGED: <u>Blue</u>		
INSTALLED: IRON ROD & CAP LB3624 or <u>Hub tack</u>					
AT: <u>CROWN</u> , EDGE, OTHER _____					
JOB MEASUREMENT TYPE: Tenths - Feet					
NOTES: <u>FIND 2" Galv. WM @ 1.44'</u> <u>see pics 136-3846 / 136-3848</u>					
Approx. STATION (±)		OFFSET:

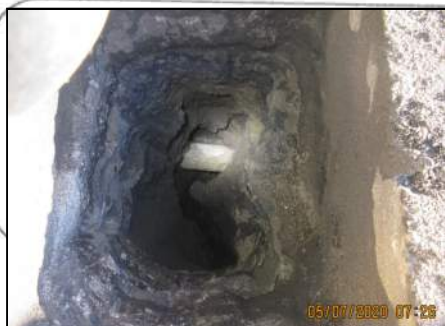
TEST HOLE NO.: 324 G
PROJECT NO.: _____
WORK ORDER NO.: 10104100 210
CLIENT PROJECT NO.: _____
SUNSHINE-811 TICKET: 1260000024

REPORT BY: <u>P Herold</u>	ASSISTED BY: <u>P Cheston</u>	PROJECT NAME: JEA Galvanized Pipe Replacement	
CHECKED BY:		VVH REQUESTED BY: ETM	
NO. HOLES: <u>1</u>	DATE: <u>5/7/20</u>	TIME:	REQUESTED UTILITY: Water main
UTILITY OWNER: JEA		LOCATED UTILITY: <u>WM</u>	
PAVEMENT TYPE: <u>Asphalt</u>	MATERIAL AS FOUND: <u>Galv</u>		COLOR: <u>Brown/silver</u>
PAVEMENT CONDITION: <u>fair</u>	SIZE AS EXPECTED:		SIZE AS FOUND: <u>2"</u>
SOIL CONDITIONS: SOFT <input type="checkbox"/> DRY <input type="checkbox"/> CLAY <input type="checkbox"/> DIRT <input checked="" type="checkbox"/>	UTILITY CONDITION: <u>fair</u>		
PROPOSED: Determine pipe material	PAINT FLAGGED: <u>Blue</u>		
INSTALLED: IRON ROD & CAP LB3624 or <u>Nail & disk</u>			
AT: <u>CROWN</u> , EDGE, OTHER _____			
JOB MEASUREMENT TYPE: Tenths - Feet			
NOTES: <u>FND 2" Galv WM @ 1.34'</u> <u>see pirs 136-3872 / 136-3873</u>			
Approx. STATION (±)	OFFSET:

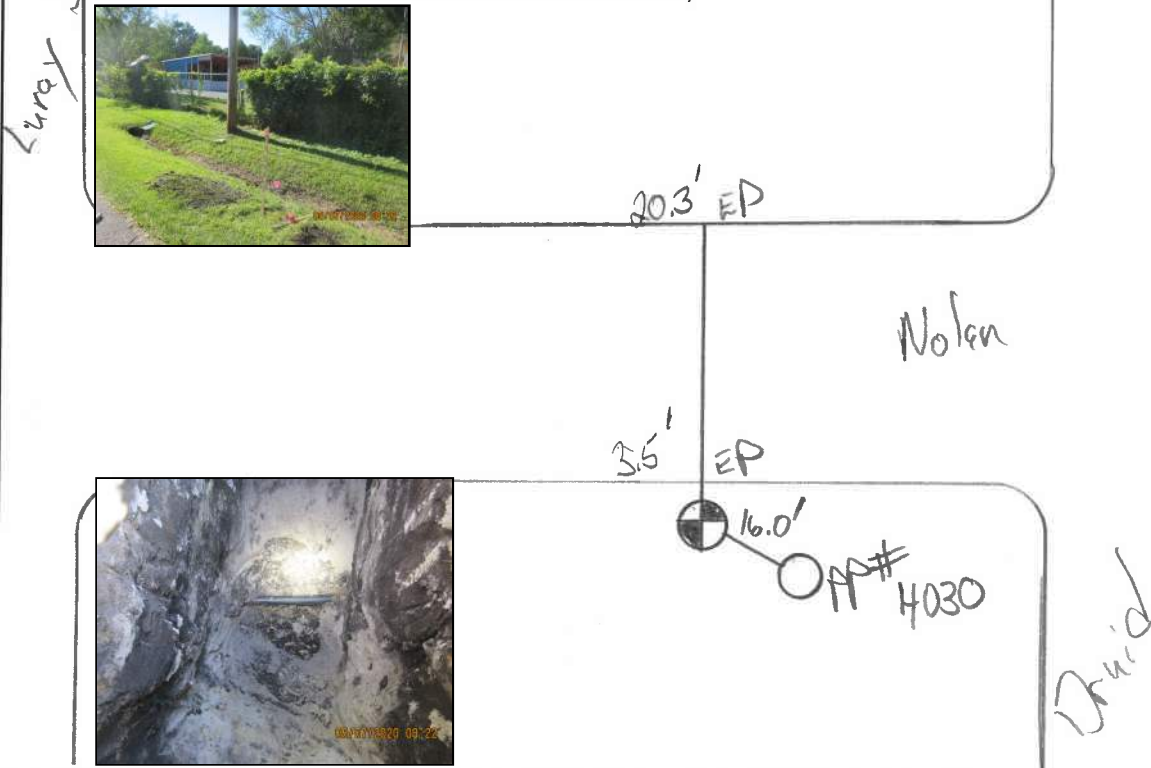
REPORT BY: <u>P Herold</u>	ASSISTED BY: <u>P Chasteen</u>	PROJECT NAME: JEA Galvanized Pipe Replacement	
CHECKED BY:		VVH REQUESTED BY: ETM	
NO. HOLES: <u>1</u>	DATE: <u>5/7/00</u>	TIME:	REQUESTED UTILITY: <u>Water main</u> <u>WKN</u>
UTILITY OWNER: <u>JEA</u> <u>AT&T?</u>		LOCATED UTILITY: <u>DB cable</u>	
PAVEMENT TYPE: <u>Soft dig</u>		MATERIAL AS FOUND: <u>DB cable</u>	COLOR: <u>Black</u>
PAVEMENT CONDITION: <u>NA</u>		SIZE AS EXPECTED:	SIZE AS FOUND: <u>0.75</u>
SOIL CONDITIONS: <u>SOFT</u> <input type="checkbox"/> <u>DRY</u> <input type="checkbox"/> <u>CLAY</u> <input type="checkbox"/> <u>DIRT</u> <input checked="" type="checkbox"/>		UTILITY CONDITION: <u>Good</u>	
PROPOSED: Determine pipe material		PAINT FLAGGED: <u>Orange</u>	
INSTALLED: <u>IRON ROD & CAP LB3624</u> or _____			
AT: <u>CROWN</u> , EDGE, OTHER _____			
JOB MEASUREMENT TYPE: <u>Tenths - Feet</u>			
NOTES: <u>FND 0.75" Black DB cable @ 2.54'</u> <u>see pics 136-3874 / 136-3875</u>

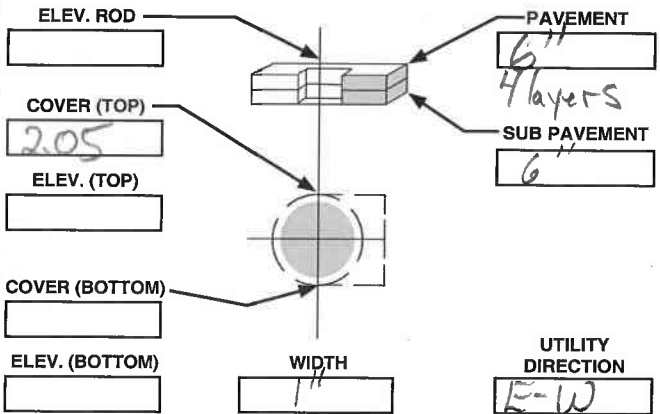
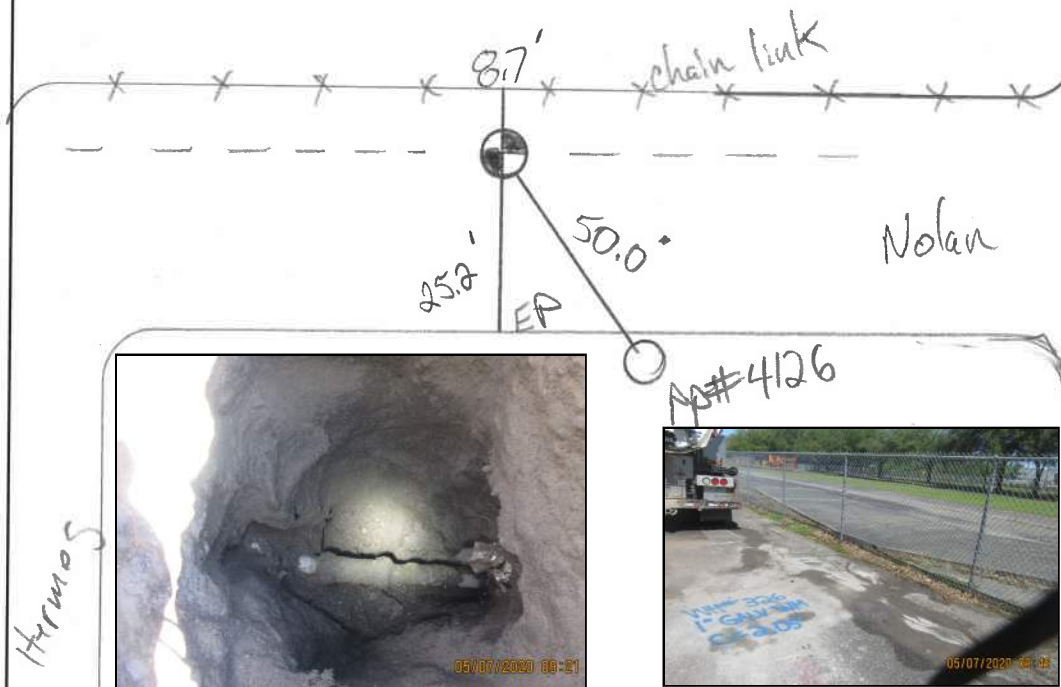
TEST HOLE NO.: 326 G
PROJECT NO.: _____
WORK ORDER NO.: 19-041-00 012
CLIENT PROJECT NO.: _____
SUNSHINE-811 TICKET: 126000004

REPORT BY: <u>P. Herold</u>		ASSISTED BY: <u>P. Chasteen</u>		PROJECT NAME: JEA Galvanized Pipe Replacement	
CHECKED BY:				VVH REQUESTED BY: ETM	
NO. HOLES: <u>1</u>	DATE: <u>5/7/20</u>	TIME:		REQUESTED UTILITY: Water main	
UTILITY OWNER: JEA				LOCATED UTILITY: <u>WM</u>	
PAVEMENT TYPE: <u>Asphalt</u>				MATERIAL AS FOUND: <u>Galv</u>	COLOR: <u>Rust</u>
PAVEMENT CONDITION: <u>fair</u>				SIZE AS EXPECTED:	SIZE AS FOUND: <u>1"</u>
SOIL CONDITIONS: SOFT <input type="checkbox"/> DRY <input type="checkbox"/> CLAY <input type="checkbox"/> DIRT <input checked="" type="checkbox"/>				UTILITY CONDITION: <u>fair</u>	
PROPOSED: Determine pipe material				PAINT FLAGGED: <u>Blue</u>	
INSTALLED: IRON ROD & CAP LB3624 or <u>Nail & disk</u>					
AT: <u>CROWN</u> , EDGE, OTHER _____					
JOB MEASUREMENT TYPE: Tenths - Feet					
NOTES: <u>FND 1" Galv WM / pipe @ 2.05</u> <u>see pics 136-387 / 136-387</u>					
Approx. STATION (±)		OFFSET:

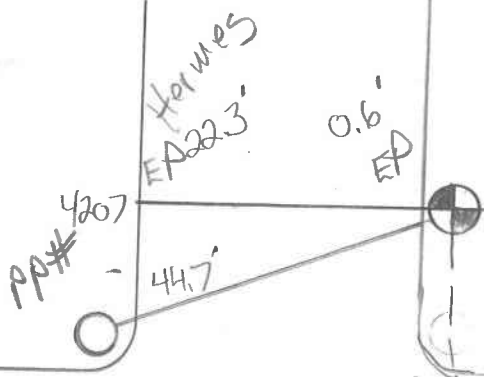
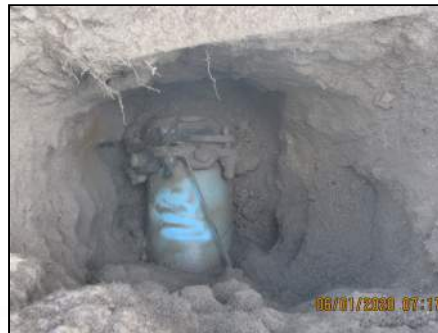
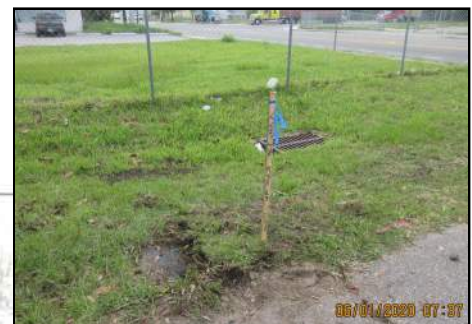
TEST HOLE NO.: 376 B
PROJECT NO.: _____
WORK ORDER NO.: 19-041-00 212
CLIENT PROJECT NO.: _____
SUNSHINE-811 TICKET: 136-005862

REPORT BY: <u>PH</u>		ASSISTED BY: <u>RZamora</u>		PROJECT NAME: JEA Galvanized Pipe Replacement	
CHECKED BY:				VVH REQUESTED BY: ETM	
NO. HOLES: <u>1</u>	DATE: <u>6/120</u>	TIME:	REQUESTED UTILITY: Water main		
UTILITY OWNER: JEA			LOCATED UTILITY: <u>WMM stub out</u>		
PAVEMENT TYPE: <u>Soft dis</u>			MATERIAL AS FOUND: <u>PVC</u>	COLOR: <u>Blue</u>	
PAVEMENT CONDITION: <u>NA</u>			SIZE AS EXPECTED:	SIZE AS FOUND: <u>8"</u>	
SOIL CONDITIONS: SOFT <input type="checkbox"/> DRY <input type="checkbox"/> CLAY <input type="checkbox"/> DIRT <input checked="" type="checkbox"/>			UTILITY CONDITION: <u>Good</u>		
PROPOSED: Determine pipe material			PAINT FLAGGED: <u>Blue</u>		
INSTALLED: IRON ROD & CAP LB3624 or _____					
AT: CROWN, EDGE, OTHER <u>offset iron 2.15' south of stub out</u>					
JOB MEASUREMENT TYPE: Tenths - Feet					
NOTES: <u>FIND 8" Blue pvc wmm stub out @ 2.74'</u>					
Approx. STATION (±)			OFFSET:

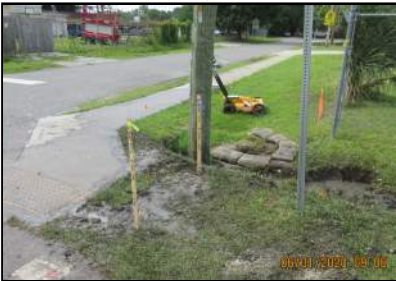
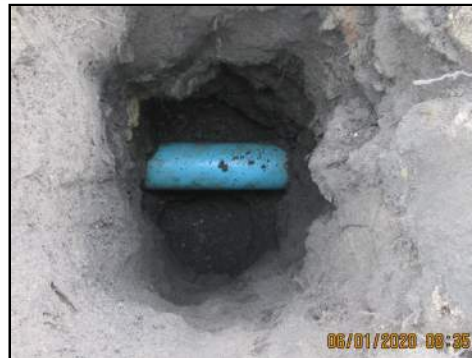
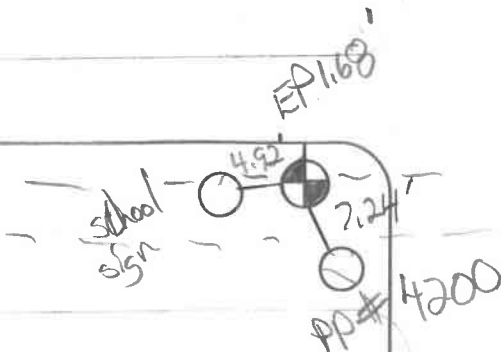
TEST HOLE NO.: 377 A/B G
PROJECT NO.: _____
WORK ORDER NO.: 19-041.00 212
CLIENT PROJECT NO.: _____
SUNSHINE-811 TICKET: 136005862

REPORT BY: <u>P. Hood</u>		ASSISTED BY: <u>R. Zamora</u>		PROJECT NAME: JEA Galvanized Pipe Replacement	
CHECKED BY: _____				VVH REQUESTED BY: ETM	
NO. HOLES: <u>1</u>	DATE: <u>6/1/20</u>	TIME: _____	REQUESTED UTILITY: <u>Water main FM</u>		
UTILITY OWNER: JEA			LOCATED UTILITY: <u>FM / WM</u>		
PAVEMENT TYPE: <u>Soft dis</u>			MATERIAL AS FOUND: <u>pvc/galv</u>		COLOR: <u>Brown/rust/silver</u>
PAVEMENT CONDITION: <u>NA</u>			SIZE AS EXPECTED: _____		SIZE AS FOUND: <u>4 1/2"</u>
SOIL CONDITIONS: SOFT <input type="checkbox"/> DRY <input type="checkbox"/> CLAY <input type="checkbox"/> DIRT <input checked="" type="checkbox"/>			UTILITY CONDITION: <u>Good fair</u>		
PROPOSED: Determine pipe material			PAINT FLAGGED: <u>Green / Blue</u>		
INSTALLED: IRON ROD & CAP LB3624 or _____ AT: <u>CROWN</u> , EDGE, OTHER _____					
JOB MEASUREMENT TYPE: Tenths - Feet					
NOTES: <u>FND 4" Green pvc F.M @ 3.06'</u> <u>FND 2" Galv. WM @ 2.92'</u> <u>3.91' of of FM is WM</u> <u>see pics 1364050/51/136-4052</u>

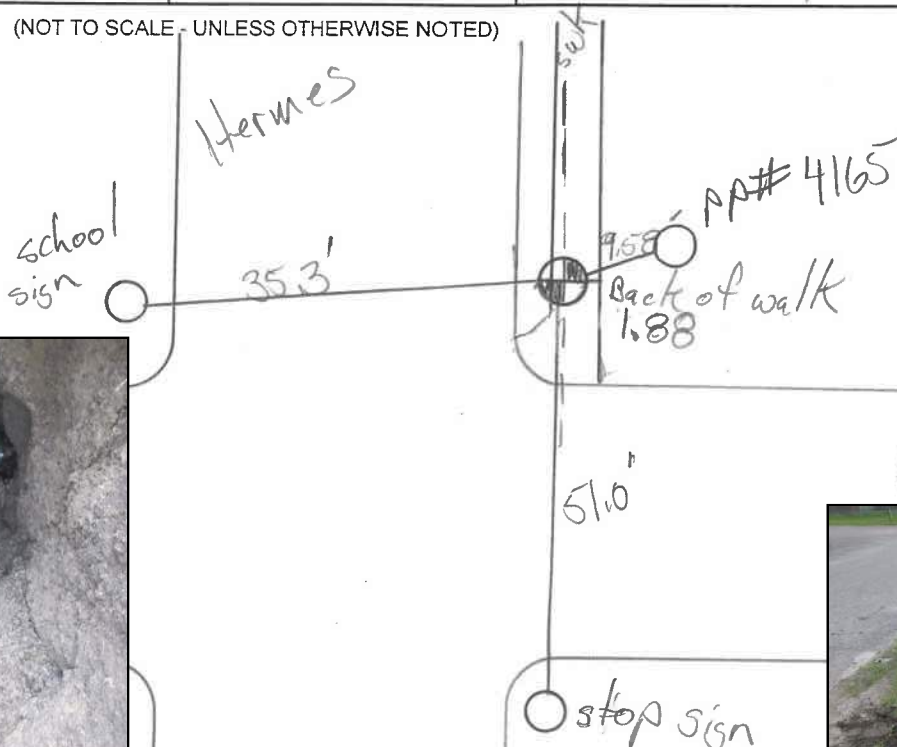
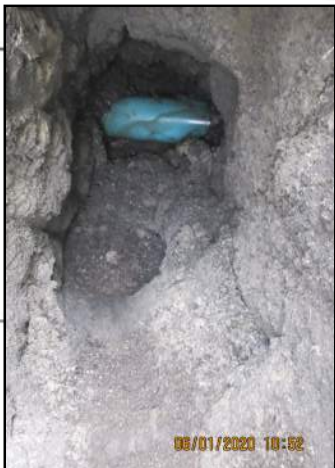
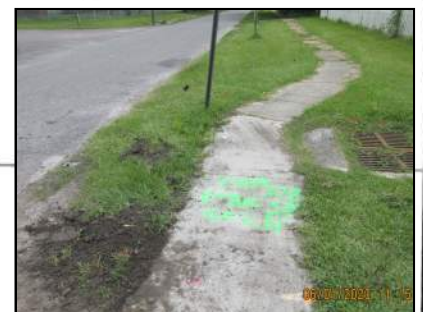
TEST HOLE NO.: 378 G
PROJECT NO.: _____
WORK ORDER NO.: 19-041-00-212
CLIENT PROJECT NO.: _____
SUNSHINE-811 TICKET: 136005862

REPORT BY: <u>PHerod</u>	ASSISTED BY: <u>RZamora</u>	PROJECT NAME: JEA Galvanized Pipe Replacement	
CHECKED BY:		VVH REQUESTED BY: ETM	
NO. HOLES: <u>1</u>	DATE: <u>6/1/20</u>	TIME:	REQUESTED UTILITY: <u>Water main FM</u>
UTILITY OWNER: JEA		LOCATED UTILITY: <u>FM</u>	
PAVEMENT TYPE: <u>Soft dig under sidewalk</u>		MATERIAL AS FOUND:	COLOR: <u>Green</u>
PAVEMENT CONDITION: <u>NA</u>		SIZE AS EXPECTED:	SIZE AS FOUND: <u>4"</u>
SOIL CONDITIONS: SOFT <input type="checkbox"/> DRY <input type="checkbox"/> CLAY <input type="checkbox"/> DIRT <input checked="" type="checkbox"/>		UTILITY CONDITION: <u>Good</u>	
PROPOSED: Determine pipe material		PAINT FLAGGED: <u>Green</u>	
INSTALLED: IRON ROD & CAP LB3624 or <u>Nail & disk</u>			
AT: <u>CROWN</u> , EDGE, OTHER _____			
JOB MEASUREMENT TYPE: Tenths - Feet			
NOTES: <u>FND 4" Green PVC FM @ 2.81</u> <u>see pics 136-4055/136-4056</u>			
Approx. STATION (±)	OFFSET:

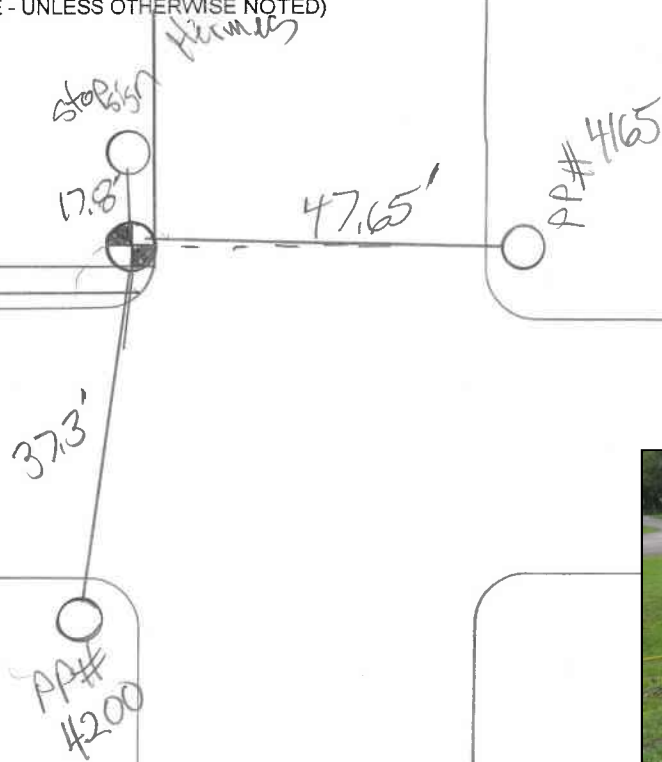
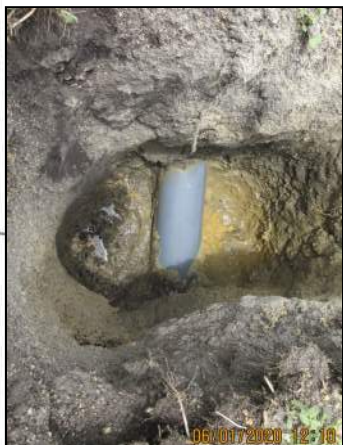
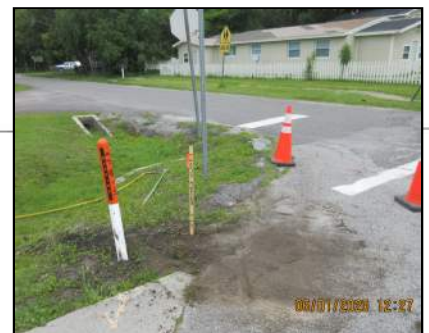
TEST HOLE NO.: 379 6
PROJECT NO.: _____
WORK ORDER NO.: 19-041.00 212
CLIENT PROJECT NO.: _____
SUNSHINE-811 TICKET: 136005862

REPORT BY: <u>P. Hurold</u>		ASSISTED BY: <u>R. Zamora</u>		PROJECT NAME: JEA Galvanized Pipe Replacement	
CHECKED BY:				VVH REQUESTED BY: ETM	
NO. HOLES: <u>1</u>	DATE: <u>6/1/20</u>	TIME:	REQUESTED UTILITY: <u>Water main Com</u>		
UTILITY OWNER: <u>JEA AT&T</u>			LOCATED UTILITY: <u>Com</u>		
PAVEMENT TYPE: <u>Soft dig</u>			MATERIAL AS FOUND: <u>PE</u>		COLOR: <u>Gray</u>
PAVEMENT CONDITION: <u>NA</u>			SIZE AS EXPECTED:		SIZE AS FOUND: <u>4"</u>
SOIL CONDITIONS: SOFT <input type="checkbox"/> DRY <input type="checkbox"/> CLAY <input type="checkbox"/> DIRT <input checked="" type="checkbox"/>			UTILITY CONDITION: <u>Good</u>		
PROPOSED: Determine pipe material			PAINT FLAGGED: <u>Orange</u>		
INSTALLED: IRON ROD & CAP LB3624 or _____			ELEV. ROD _____		
AT: CROWN, EDGE, OTHER _____			COVER (TOP) <u>2.07</u>		
JOB MEASUREMENT TYPE: Tenths - Feet			ELEV. (TOP) _____		
NOTES: <u>FIND 4" PE gray com conduit @ 207</u> <u>see pics 136-4057 / 136-4058</u>			COVER (BOTTOM) _____

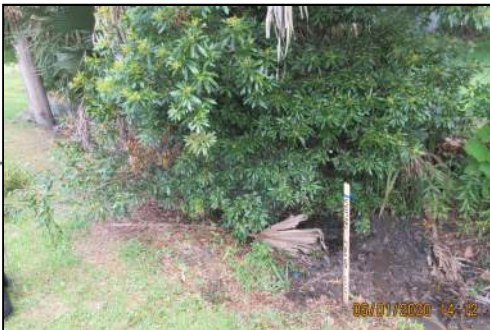
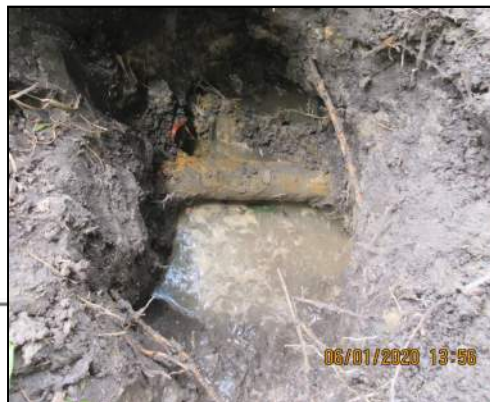
TEST HOLE NO.: 380 G
PROJECT NO.: _____
WORK ORDER NO.: 49-041.00 212
CLIENT PROJECT NO.: _____
SUNSHINE-811 TICKET: 136005862

REPORT BY: <u>P. Herold</u>		ASSISTED BY: <u>R. Zamora</u>		PROJECT NAME: JEA Galvanized Pipe Replacement	
CHECKED BY:				VVH REQUESTED BY: ETM	
NO. HOLES: <u>1</u>	DATE: <u>6/1/20</u>	TIME:		REQUESTED UTILITY: Water main	
UTILITY OWNER: JEA				LOCATED UTILITY: <u>WM</u>	
PAVEMENT TYPE: <u>Soft dig</u>				MATERIAL AS FOUND: <u>Galv</u>	COLOR: <u>Rust</u>
PAVEMENT CONDITION: <u>NA</u>				SIZE AS EXPECTED:	SIZE AS FOUND: <u>2"</u>
SOIL CONDITIONS: <u>SOFT</u> <input type="checkbox"/> <u>DRY</u> <input type="checkbox"/> <u>CLAY</u> <input type="checkbox"/> <u>DIRT</u> <input checked="" type="checkbox"/>				UTILITY CONDITION: <u>poor</u>	
PROPOSED: Determine pipe material				PAINT FLAGGED: <u>blue</u>	
INSTALLED: IRON ROD & CAP LB3624 or <u>Huck & tack</u>					
AT: <u>CROWN</u> , EDGE, OTHER _____					
JOB MEASUREMENT TYPE: Tenths - Feet					
NOTES: <u>FND 2" Galv WM @ 1.03'</u> <u>see pics 136-4059/136-4066</u>

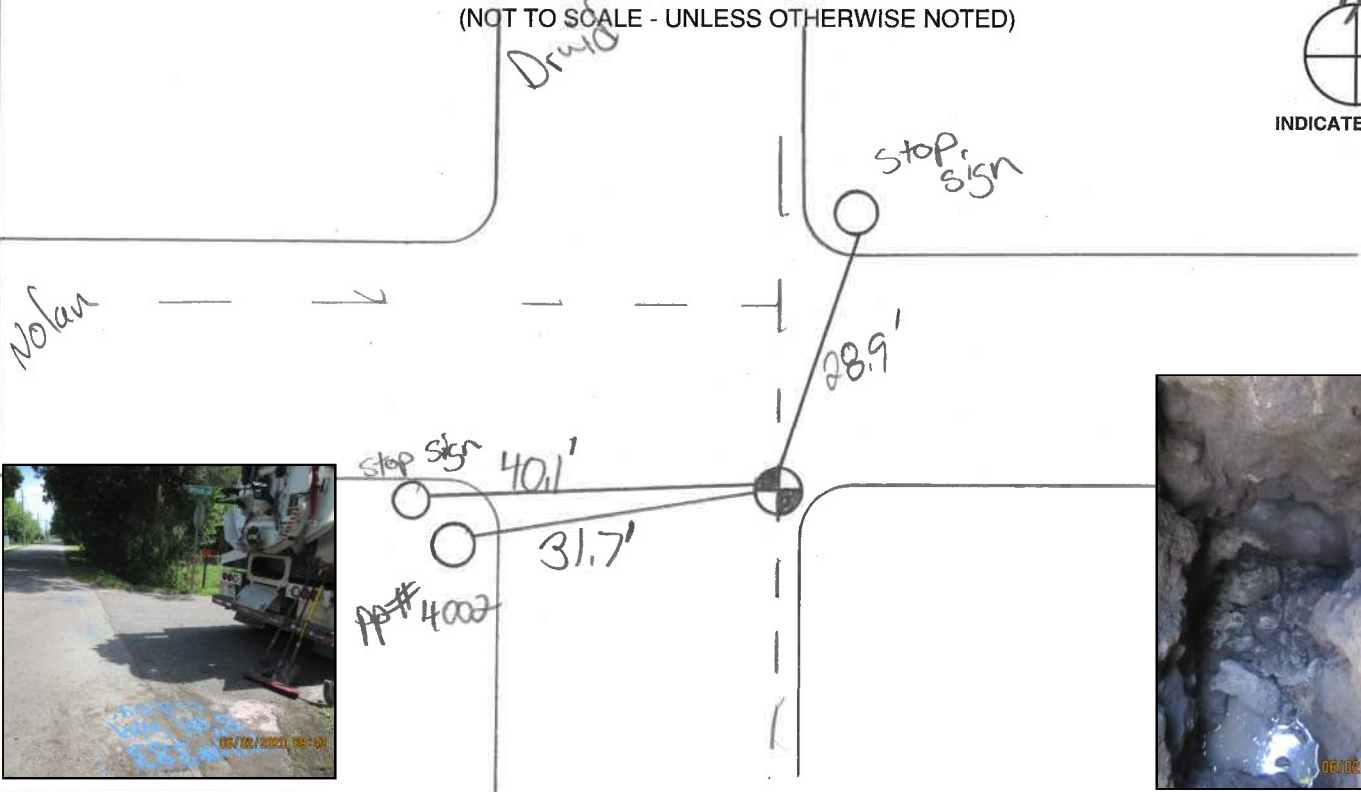
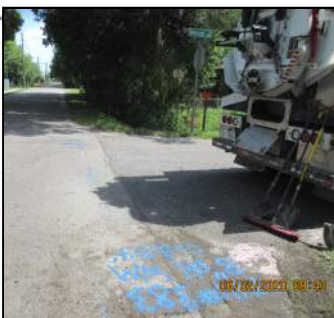
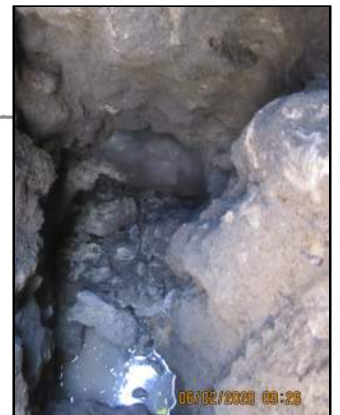
REPORT BY: P HEROLD		ASSISTED BY: R ZAMORA		PROJECT NAME: JEA Galvanized Pipe Replacement	
CHECKED BY:				VVH REQUESTED BY: ETM	
NO. HOLES: <u>1</u>	DATE: <u>6/2/20</u>	TIME:		REQUESTED UTILITY: Water main	
UTILITY OWNER: JEA				LOCATED UTILITY: <u>WM</u>	
PAVEMENT TYPE: <u>Asphalt</u>				MATERIAL AS FOUND: <u>steel</u>	COLOR: <u>rust</u>
PAVEMENT CONDITION: <u>poor</u>				SIZE AS EXPECTED: <u>8"</u>	SIZE AS FOUND: <u>8"</u>
SOIL CONDITIONS: <input checked="" type="checkbox"/> SOFT <input type="checkbox"/> DRY <input type="checkbox"/> CLAY <input type="checkbox"/> DIRT <input checked="" type="checkbox"/>				UTILITY CONDITION: <u>fair</u>	
PROPOSED: Locate Utility				PAINT FLAGGED: <u>Blue</u>	
INSTALLED: IRON ROD & CAP LB3624 or <u>Nail disk</u>					
AT: CROWN, EDGE, OTHER _____					
JOB MEASUREMENT TYPE: Tenths - Feet					
NOTES: <u>FIND 8" steel rusty wm @ 3.54'</u> <u>see pics 136-4065 / 136-4066</u>

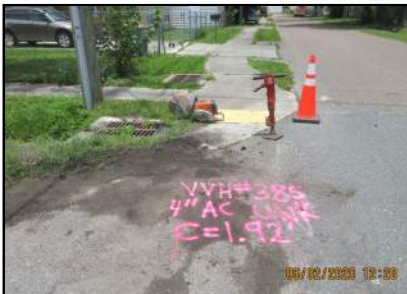
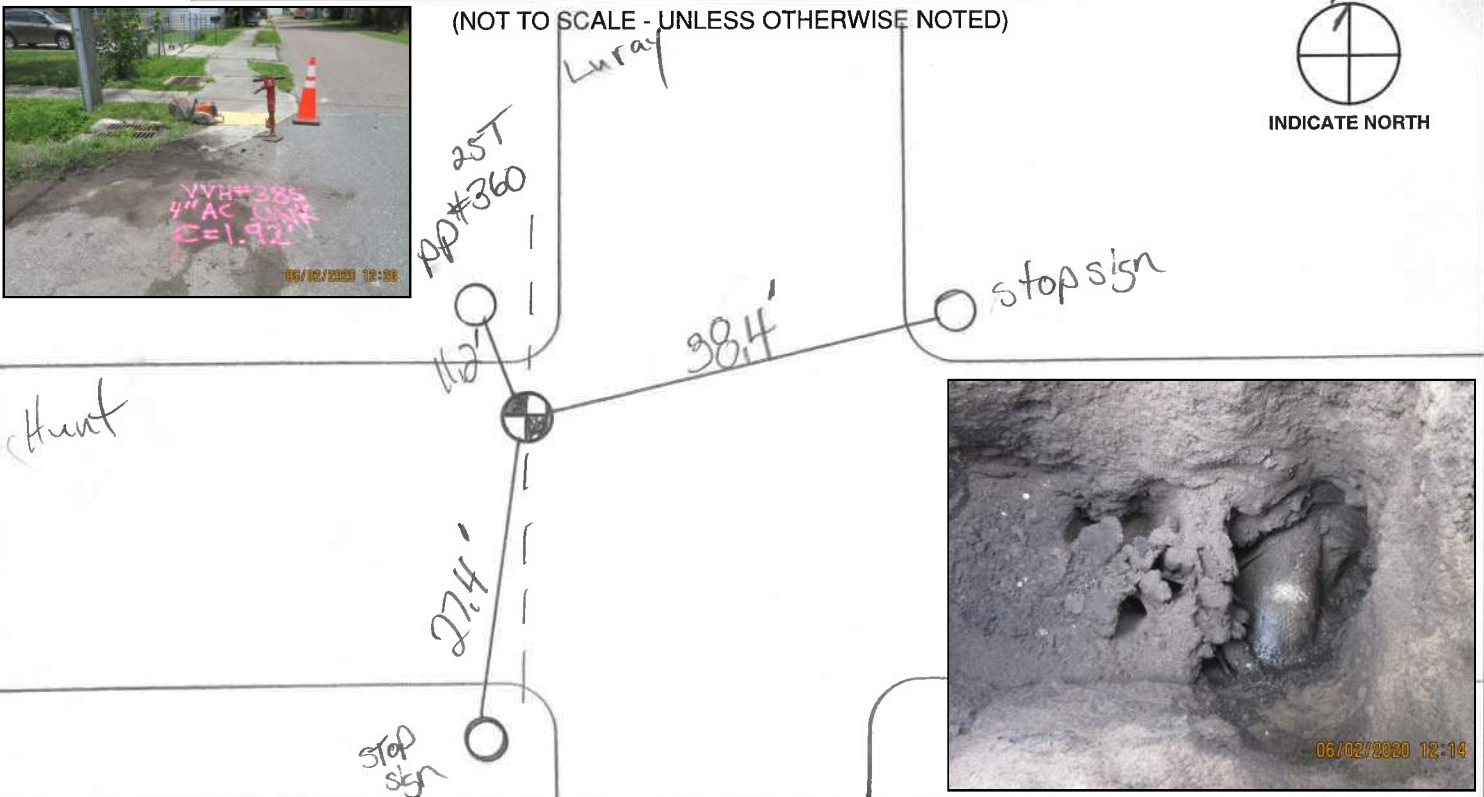
TEST HOLE NO.: 385
JEA PACKAGE: 0-00
WORK ORDER NO.: 19-212
CLIENT PROJECT NO.:
SUNSHINE-811 TICKET: 136005859

REPORT BY: P HEROLD		ASSISTED BY: R ZAMORA		PROJECT NAME: JEA Galvanized Pipe Replacement	
CHECKED BY:				VVH REQUESTED BY: ETM	
NO. HOLES:	DATE:	TIME:	REQUESTED UTILITY: <u>Water main UNK</u>		
UTILITY OWNER: <u>JEA UNK</u>			LOCATED UTILITY: <u>UNK</u>		
PAVEMENT TYPE: <u>Asphalt</u>			MATERIAL AS FOUND: <u>Concrete</u>		COLOR: <u>Gray</u>
PAVEMENT CONDITION: <u>fair</u>			SIZE AS EXPECTED:		SIZE AS FOUND: <u>4"</u>
SOIL CONDITIONS: <u>SOFT</u> <input type="checkbox"/> <u>DRY</u> <input type="checkbox"/> <u>CLAY</u> <input type="checkbox"/> <u>DIRT</u> <input checked="" type="checkbox"/>			UTILITY CONDITION: <u>fair</u>		
PROPOSED: <u>Locate Utility</u>			PAINT FLAGGED: <u>pink</u>		
INSTALLED: IRON ROD & CAP LB3624 or <u>Nail & disk</u>					
AT: CROWN, EDGE, OTHER _____					
JOB MEASUREMENT TYPE: <u>Tenths - Feet</u>					
NOTES: <u>FIND 4" concrete pipe @ 1.92'</u> <u>see pics 136-4069/136-4070</u>

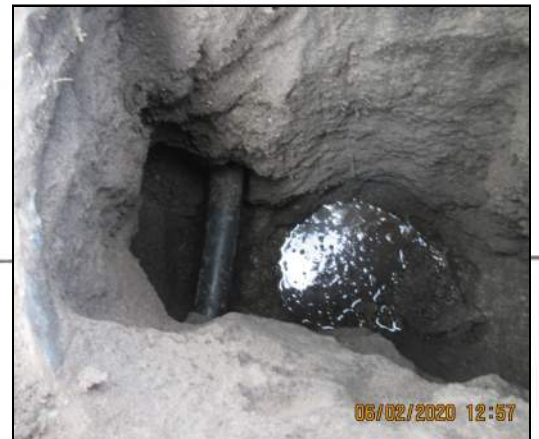
REPORT BY: P HEROLD		ASSISTED BY: R ZAMORA		PROJECT NAME: JEA Galvanized Pipe Replacement	
CHECKED BY:				VVH REQUESTED BY: ETM	
NO. HOLES: <u>1</u>	DATE: <u>6/2/20</u>	TIME:		REQUESTED UTILITY: <u>Water main UNK</u>	
UTILITY OWNER: <u>JEA UNK</u>				LOCATED UTILITY: <u>UNK</u>	
PAVEMENT TYPE: <u>Soft dig</u>				MATERIAL AS FOUND: <u>PE</u>	COLOR: <u>Black</u>
PAVEMENT CONDITION: <u>NA</u>				SIZE AS EXPECTED:	SIZE AS FOUND: <u>2"</u>
SOIL CONDITIONS: <u>SOFT</u> <input type="checkbox"/> <u>DRY</u> <input type="checkbox"/> <u>CLAY</u> <input type="checkbox"/> <u>DIRT</u> <input checked="" type="checkbox"/>				UTILITY CONDITION: <u>Good</u>	
PROPOSED: <u>Locate Utility</u>				PAINT FLAGGED: <u>pink</u>	
INSTALLED: <u>IRON ROD & CAP LB3624</u> or _____					
AT: <u>CROWN</u> , EDGE, OTHER _____					
JOB MEASUREMENT TYPE: <u>Tenths - Feet</u>					
NOTES: <u>FIND 2" Black PE conduit @ 2.47'</u> <u>see pics 136-4071/136-4072</u>

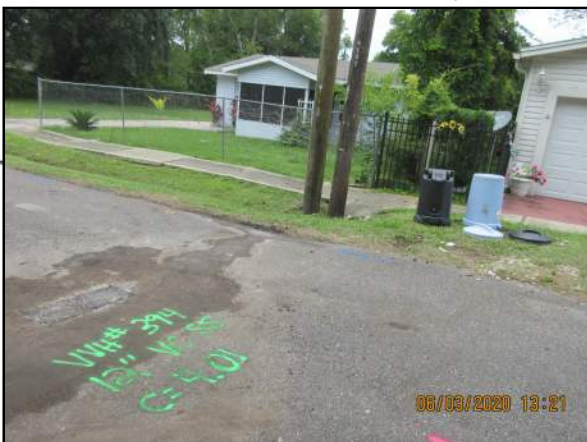
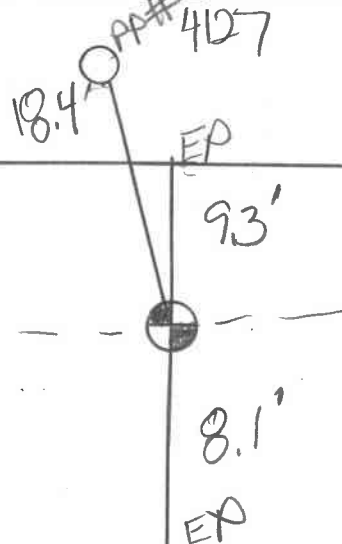
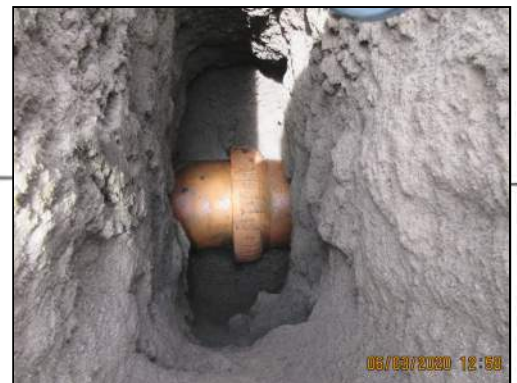
TEST HOLE NO.: 394
JEA PACKAGE: G-08
WORK ORDER NO.: 19-212
CLIENT PROJECT NO.:
SUNSHINE-811 TICKET: 136005859

REPORT BY: P HEROLD		ASSISTED BY: R ZAMORA		PROJECT NAME: JEA Galvanized Pipe Replacement	
CHECKED BY:				VVH REQUESTED BY: ETM	
NO. HOLES: <u>1</u>	DATE: <u>6/3/20</u>	TIME:		REQUESTED UTILITY: <u>Water main SS gravity</u>	
UTILITY OWNER: JEA				LOCATED UTILITY: <u>SS</u>	
PAVEMENT TYPE: <u>Asphalt</u>				MATERIAL AS FOUND: <u>VC terracotta</u> COLOR: <u>Orange</u>	
PAVEMENT CONDITION: <u>fair</u>				SIZE AS EXPECTED:	SIZE AS FOUND: <u>12"</u>
SOIL CONDITIONS: SOFT <input type="checkbox"/> DRY <input type="checkbox"/> CLAY <input type="checkbox"/> DIRT <input checked="" type="checkbox"/>				UTILITY CONDITION: <u>Good</u>	
PROPOSED: Locate Utility				PAINT FLAGGED: <u>Green</u>	
INSTALLED: IRON ROD & CAP LB3624 or <u>nail & disk</u>					
AT: CROWN, EDGE, OTHER _____					
JOB MEASUREMENT TYPE: Tenths - Feet					
NOTES: <u>FIND 12" orange VC sewer main @ 4.01</u> <u>see pics 136-4086 / 136-4087/88</u>

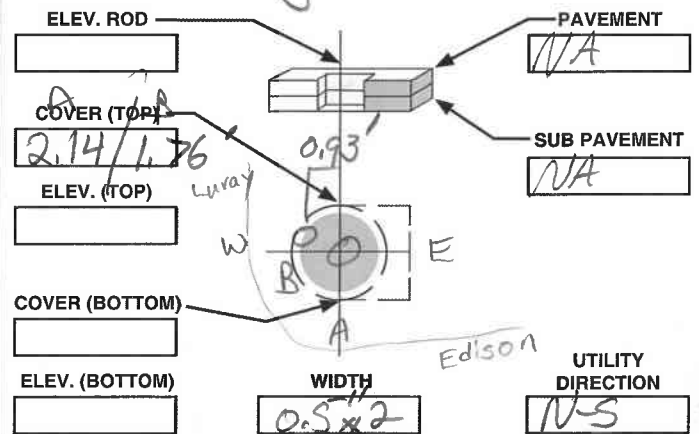
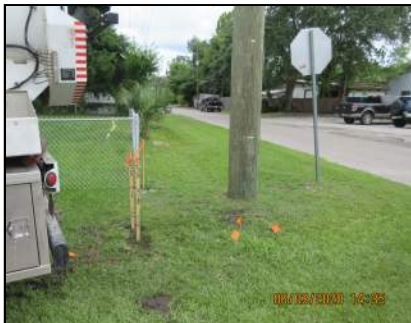
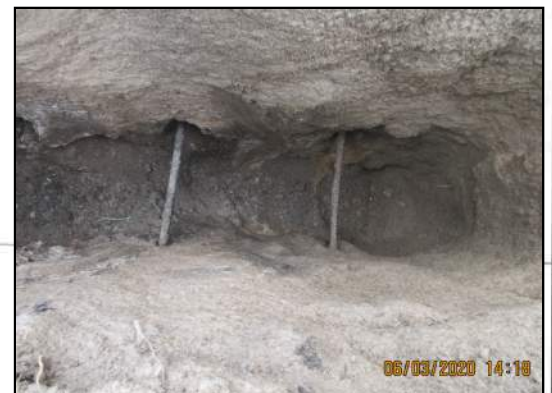
REPORT BY: P HEROLD		ASSISTED BY: R ZAMORA		PROJECT NAME: JEA Galvanized Pipe Replacement	
CHECKED BY:				VVH REQUESTED BY: ETM	
NO. HOLES: <u>1</u>	DATE: <u>6/3/20</u>	TIME:		REQUESTED UTILITY: <u>Water main Com</u>	
UTILITY OWNER: <u>JEA AT&T</u>				LOCATED UTILITY: <u>Com x2</u>	
PAVEMENT TYPE: <u>Soft dis</u>				MATERIAL AS FOUND: <u>DB cables</u>	COLOR: <u>Black</u>
PAVEMENT CONDITION: <u>NA</u>				SIZE AS EXPECTED:	SIZE AS FOUND: <u>0.5' x 2</u>
SOIL CONDITIONS: SOFT <input type="checkbox"/> DRY <input type="checkbox"/> CLAY <input type="checkbox"/> DIRT <input checked="" type="checkbox"/>				UTILITY CONDITION: <u>Good</u>	
PROPOSED: <u>Locate Utility</u>				PAINT FLAGGED: <u>Orange</u>	
INSTALLED: <u>IRON ROD & CAP LB3624</u> or _____					
AT CROWN, EDGE, OTHER _____					
JOB MEASUREMENT TYPE: <u>Tenths - Feet</u>					
NOTES: <u>A FND 0.5" AT&T DB cables @ 2.14</u> <u>FND 0.5" B DB cable @ 1.76 closest to road</u> <u>see pics 136-4089/136-4090</u>

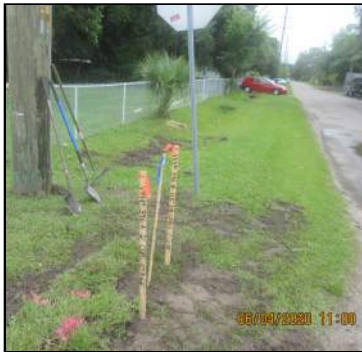
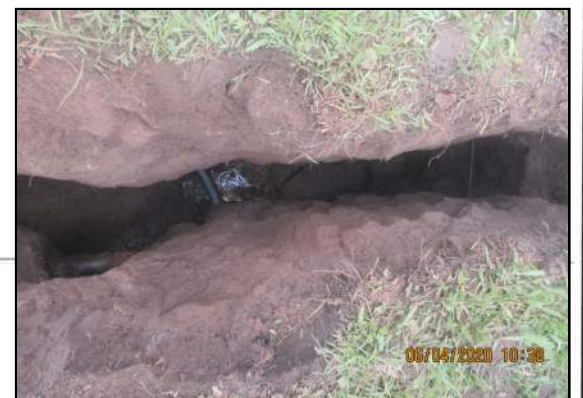
TEST HOLE NO.: 396
JEA PACKAGE: 6-08
WORK ORDER NO.: 19-212
CLIENT PROJECT NO.:
SUNSHINE-811 TICKET: 154000390

REPORT BY: P HEROLD		ASSISTED BY: R ZAMORA		PROJECT NAME: JEA Galvanized Pipe Replacement	
CHECKED BY:				VVH REQUESTED BY: ETM	
NO. HOLES: <u>1</u>	DATE: <u>6/4/20</u>	TIME:		REQUESTED UTILITY: <u>Water main</u> <u>Can</u>	
UTILITY OWNER: JEA				LOCATED UTILITY: <u>Can</u>	
PAVEMENT TYPE: <u>Soft dis</u>				MATERIAL AS FOUND: <u>PE/DB cable</u>	COLOR: <u>Black</u>
PAVEMENT CONDITION: <u>NA</u>				SIZE AS EXPECTED:	SIZE AS FOUND: <u>2"/0.5"</u>
SOIL CONDITIONS: SOFT <input type="checkbox"/> DRY <input type="checkbox"/> CLAY <input type="checkbox"/> DIRT <input checked="" type="checkbox"/>				UTILITY CONDITION: <u>Good</u>	
PROPOSED: <u>Locate Utility</u>				PAINT FLAGGED: <u>Orange</u>	
INSTALLED: <u>IRON ROD & CAP LB3624</u> or					
AT: <u>CROWN</u> , EDGE, OTHER					
JOB MEASUREMENT TYPE: <u>Tenths - Feet</u>					
NOTES: <u>A</u> <u>FND 2" Black PE conduit @ 3.62</u> <u>FND 0.5" Black DB cable @ 2.03</u> <u>measured to the 2"</u> <u>see NCS 127-4094/95/137-4096</u>

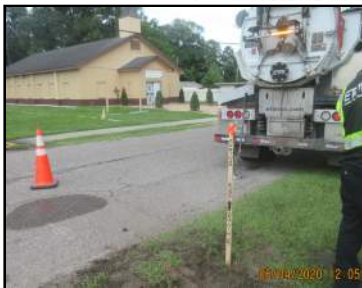
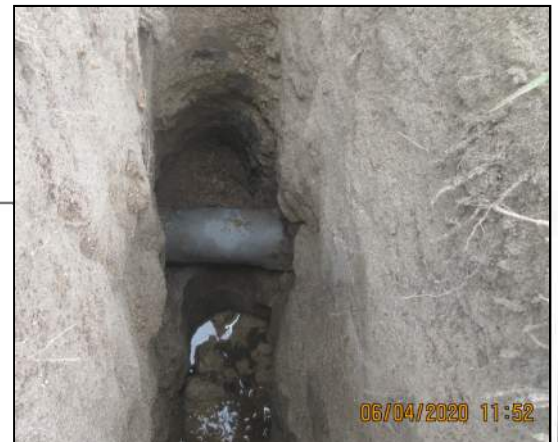
REPORT BY: P HEROLD		ASSISTED BY: R ZAMORA		PROJECT NAME: JEA Galvanized Pipe Replacement	
CHECKED BY:				VVH REQUESTED BY: ETM	
NO. HOLES: <u>1</u>	DATE: <u>6/4/20</u>	TIME:		REQUESTED UTILITY: <u>Water main Com</u>	
UTILITY OWNER: <u>JEA Com</u>				LOCATED UTILITY: <u>Com</u>	
PAVEMENT TYPE: <u>Soft dig</u>				MATERIAL AS FOUND:	COLOR: <u>Gray</u>
PAVEMENT CONDITION: <u>NA</u>				SIZE AS EXPECTED:	SIZE AS FOUND: <u>6"</u>
SOIL CONDITIONS: SOFT <input type="checkbox"/> DRY <input type="checkbox"/> CLAY <input type="checkbox"/> DIRT <input checked="" type="checkbox"/>				UTILITY CONDITION: <u>Good</u>	
PROPOSED: <u>Locate Utility</u>				PAINT FLAGGED: <u>Orange</u>	
INSTALLED: <u>IRON ROD & CAP LB3624</u> or					
AT: <u>CROWN</u> , EDGE, OTHER					
JOB MEASUREMENT TYPE: <u>Tenths - Feet</u>					
NOTES: <u>FIND 8" PVC Gray Conduit @ 2.78'</u> <u>see pics 137-4097/137-4098</u>					
Approx. STATION (±)		OFFSET:		PAVEMENT <u>NA</u>

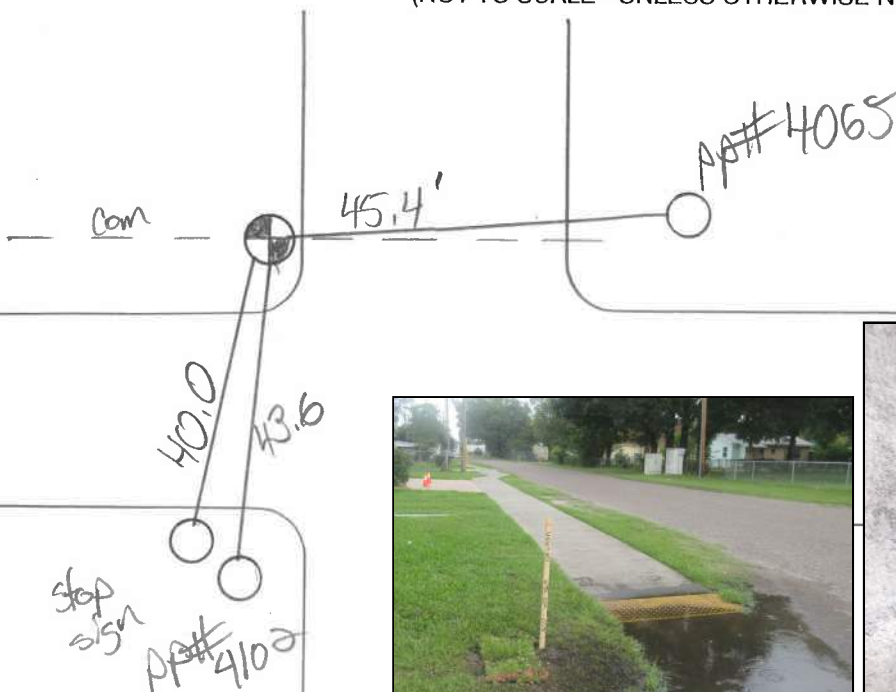
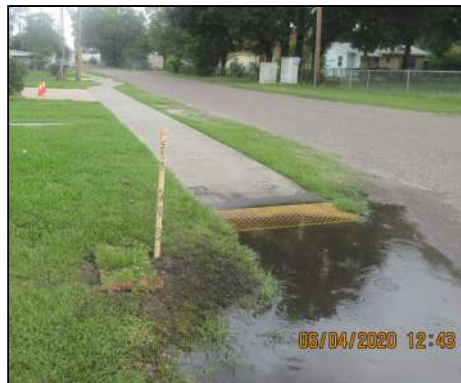
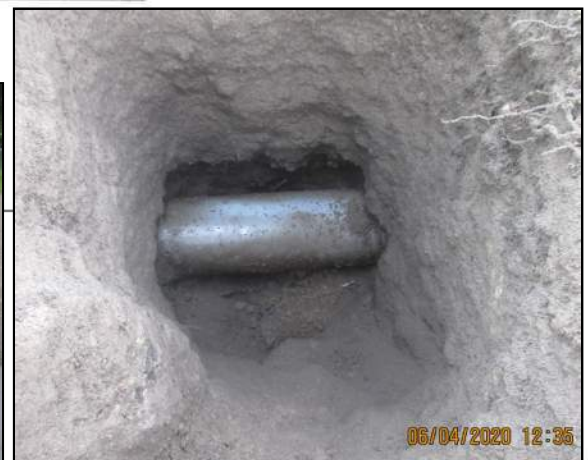
TEST HOLE NO.: 401
JEA PACKAGE: G-08
WORK ORDER NO.: 19-212
CLIENT PROJECT NO.:
SUNSHINE-811 TICKET: 154001300

REPORT BY: P HEROLD		ASSISTED BY: R ZAMORA		PROJECT NAME: JEA Galvanized Pipe Replacement	
CHECKED BY:				VVH REQUESTED BY: ETM	
NO. HOLES: <u>1</u>	DATE: <u>6/4/20</u>	TIME:		REQUESTED UTILITY: <u>Water main</u> <u>Com</u>	
UTILITY OWNER: JEA				LOCATED UTILITY: <u>Com</u>	
PAVEMENT TYPE: <u>Soft dig</u>				MATERIAL AS FOUND: <u>pvc</u>	COLOR: <u>Gray</u>
PAVEMENT CONDITION: <u>NA</u>				SIZE AS EXPECTED:	SIZE AS FOUND: <u>6"</u>
SOIL CONDITIONS: SOFT <input type="checkbox"/> DRY <input type="checkbox"/> CLAY <input type="checkbox"/> DIRT <input checked="" type="checkbox"/>				UTILITY CONDITION: <u>Good</u>	
PROPOSED: Locate Utility				PAINT FLAGGED: <u>Orange</u>	
INSTALLED: IRON ROD & CAP LB3624 or				ELEV. ROD	
AT: CROWN, EDGE, OTHER				COVER (TOP)	
JOB MEASUREMENT TYPE: Tenths - Feet				ELEV. (TOP)	
NOTES: <u>FIND 6" Gray Conduit @ 1.75</u> <u>see pics 137-4103/137-4104</u>				COVER (BOTTOM)	
				ELEV. (BOTTOM)

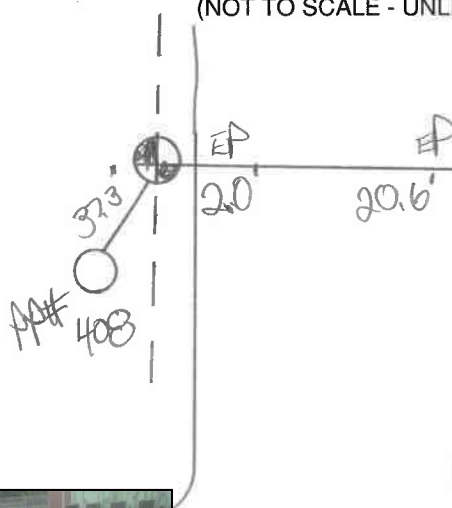
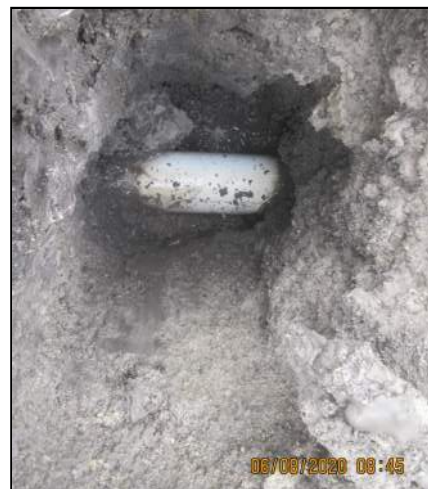
REPORT BY: P HEROLD		ASSISTED BY: R ZAMORA		PROJECT NAME: JEA Galvanized Pipe Replacement	
CHECKED BY:				VVH REQUESTED BY: ETM	
NO. HOLES: <u>1</u>	DATE: <u>6/8/20</u>	TIME:		REQUESTED UTILITY: <u>Water main</u> <u>UNK</u>	
UTILITY OWNER: <u>JEA</u> <u>UNK</u>				LOCATED UTILITY: <u>UNK</u>	
PAVEMENT TYPE: <u>Soft dig</u>				MATERIAL AS FOUND: <u>PVC</u>	COLOR: <u>white</u>
PAVEMENT CONDITION: <u>NA</u>				SIZE AS EXPECTED:	SIZE AS FOUND: <u>4"</u>
SOIL CONDITIONS: SOFT <input type="checkbox"/> DRY <input type="checkbox"/> CLAY <input type="checkbox"/> DIRT <input checked="" type="checkbox"/>				UTILITY CONDITION: <u>fair</u>	
PROPOSED: <u>Locate Utility</u>				PAINT FLAGGED: <u>pink</u>	
INSTALLED: <u>IRON ROD & CAP LB3624</u> or _____					
AT: CROWN, EDGE, OTHER _____					
JOB MEASUREMENT TYPE: <u>Tenths - Feet</u>					
NOTES: <u>FND 4" white pvc pipe @ 2.50'</u> <u>See NCS 137-4115 / 137-4116</u>
