Subject: Final Report of the Nondestructive Evaluation (NDE) and Engineering Analysis  
of Jacksonville Electric Authority (JEA) Northside Generating Station  
Combustion Turbine Unit 5 (NSCT5) Generator Rotor.

**FINAL REPORT**  
**BORESIDE NONDESTRUCTIVE EXAMINATIONS &**  
**ENGINEERING ANALYSIS**  
**JACKSONVILLE ELECTRIC AUTHORITY**  
**NORTH SIDE COMBUSTION TURBINE U-5**  
**GENERATOR ROTOR**

**NORTH AMERICAN ENERGY SERVICES**  
**PO# 07-1786 / R&A C-7293**  
**November 5, 2007**

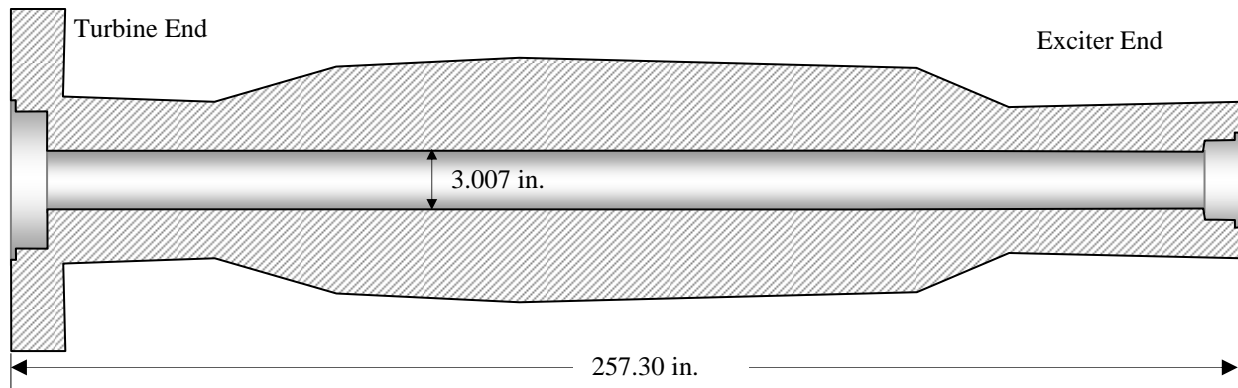
Prior to boreside nondestructive examinations of the JEA NSCT5 generator rotor the governor or turbine end (TE) bore plug was removed and power honing was performed to provide a bore surface suitable for nondestructive examinations. The exciter end bore plug and copper bar were removed by others. Bore diameter measurements were taken before and after power honing. An average of 0.006 in. of material was removed during the honing process resulting in a nominal bore diameter of 3.007 inches. Bore dimensions after honing are shown in Figure 3. A replacement plug was fabricated and installed after all the NDE examinations were completed. The TE plug bore dimensions were measured as ID = 3.501 inches and length = 3.070 inches. The new plug has OD = 3.505 inches and length = 3.000 inches.

Figure 3. Sketch of JEA NSCT5 generator rotor bore configuration and dimensions (not to scale).

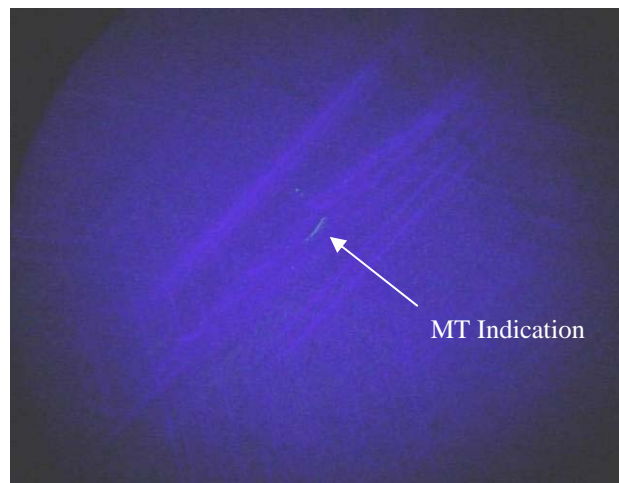
The 2007 boreside WFMT examination performed by R&A personnel revealed 14 areas of linear indication ranging in size of 0.030 inches to 0.125 inches in length. The reason the number of recordable indications changed from 2002 to 2007 is because power honing removes a few thousands of an inch off the boreside surface changing the map and number of surface connected indications (these indications are only a few thousands of an inch in radial depth).

The boreside wet fluorescent magnetic particle examination (WFMT) of the JEA NSCT5 generator rotor was accomplished in two separate passes. The WFMT examination utilized a central conductor to produce a circumferential magnetic field in order to detect primarily axially oriented surface or slightly sub-surface discontinuities. The boreside WFMT examination revealed 14 areas of linear indication ranging in size of 0.030 inches to 0.125 inches in length as listed in Table II. The largest area of these indications was measured as 0.600 inches. Figure 4 shows a photo of one of the indications noted during the MT examination.

Figure 4. Photo of one of the WFMT indications observed on the JEA NSCT5 generator boreside.

Ind. No.	Axial Location (in)	Angular Location (deg)	Axial Extent* (in)
1	20.75	5	0.100
2	32.25	100	0.500
3	47 to 50	225	0.250
4	56.50	45	0.500
5	57.325	230	0.100
6	59.625	130	0.100
7	63.00	45	0.125
8	71.625	5	0.600
9	73.75	245	0.250
10	141.75	100	0.100
11	146.00	180	0.100
12	152.75	180	0.100
13	171.25	135	0.125
14	173.25	180	0.600

\* Extent of groups of intermittent broken indications ranging in linear lengths of 0.030 to 0.125 inches.

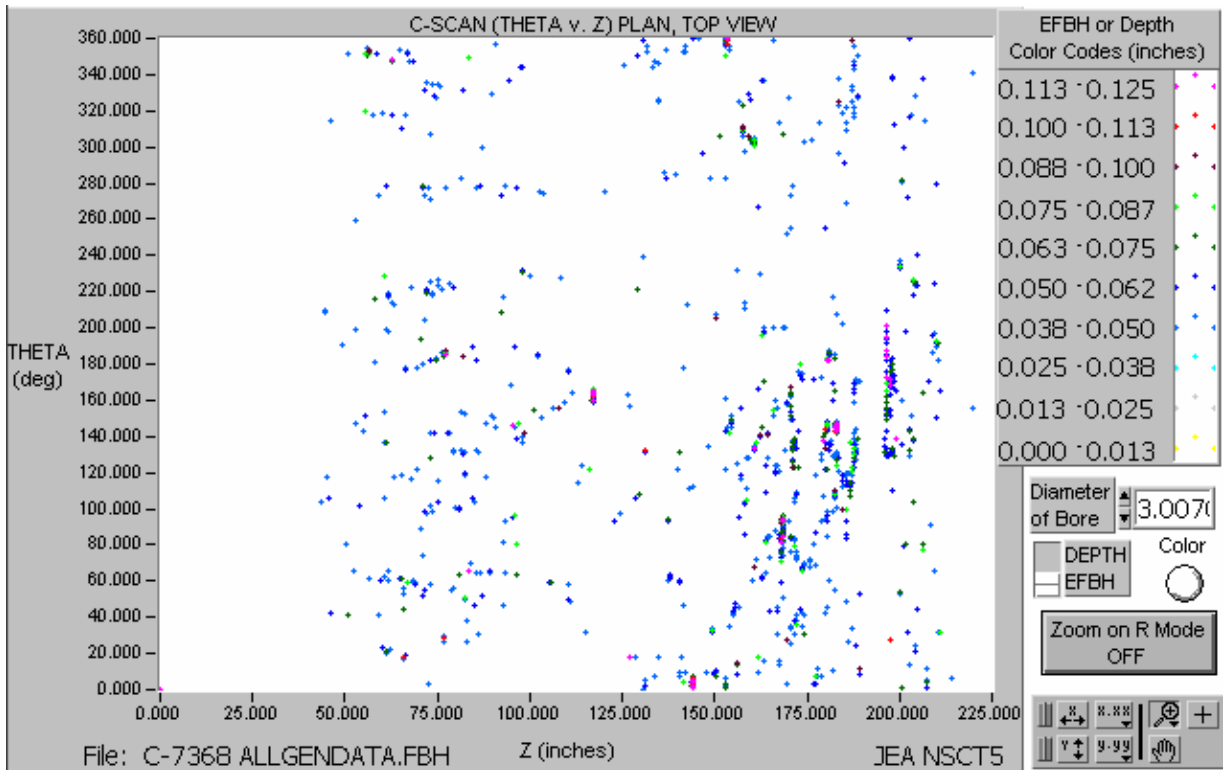
The 2007 boreside UT examination performed by R&A personnel revealed 9,682 data points. The comparison of the UT data from this examination with the UT data collected in 2002 shows no change. The heavy concentration of data points ranged in Z from 165 inches to 200 inches from the turbine end. The number of UT data points increased because the R&A B-SURE® 3000 system used for the examination collects data at a much faster rate than the systems used in 2002.

Boreside ultrasonic examination of the JEA NSCT5 generator rotor revealed a total of 9,682 data points from subsurface small point source reflectors. The circumferential (clockwise and counterclockwise) and axial (for and aft) shear wave scans are best suited for detecting a radially oriented discontinuity. Based upon the lack of "traveling" characteristics of the circumferential and axial shear wave scans, there is no evidence that a radial component exists near or at the bore surface.

Figure 5 shows a C-scan illustrating the location of all detected ultrasonic reflectors (9,682 data points) in the generator rotor defined by the angular position  $\theta$  (degrees) and axial position Z (in) along the rotor from the turbine end. The color-coding corresponds to Equivalent Flat Bottom Hole (EFBH) diameter sizing of the ultrasonic reflectors as indicated by the color-coded bar located on the top right hand side of the figure. A B-scan shown in Figure 6 depicts the distribution of all detected ultrasonic reflectors in the generator rotor as a function of radial depth or metal path MP (in) from the bore surface along the axial length of the rotor Z (in) from the turbine end. Figure 7 shows a polar plot of all detected ultrasonic reflectors in the generator rotor defined by angular location  $\theta$  (degrees) and radial depth R (in.) from the bore surface.

Figure 5. C-scan plot of all 9,682 ultrasonic data points collected during the boresonic examination of the JEA NSCT5 generator rotor.

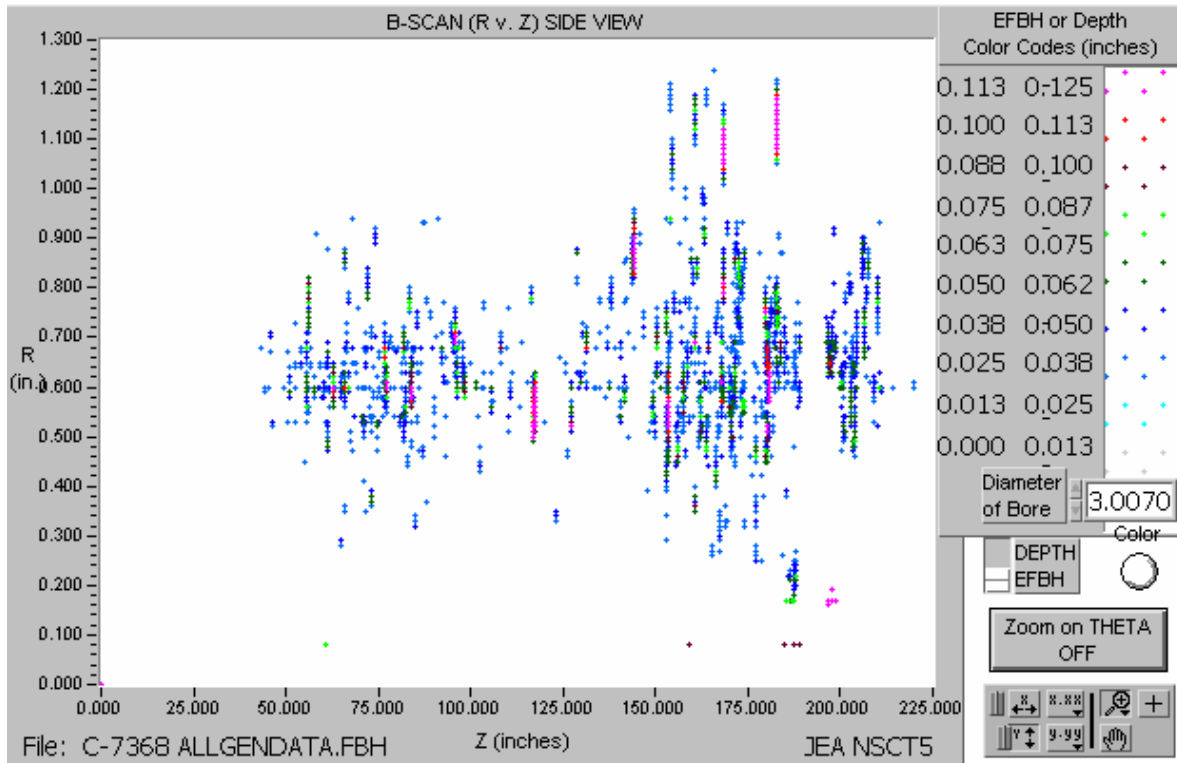
Figure 6. B-scan plot of all 9,682 ultrasonic data points collected during the boresonic examination of the JEA NSCT5 generator rotor.

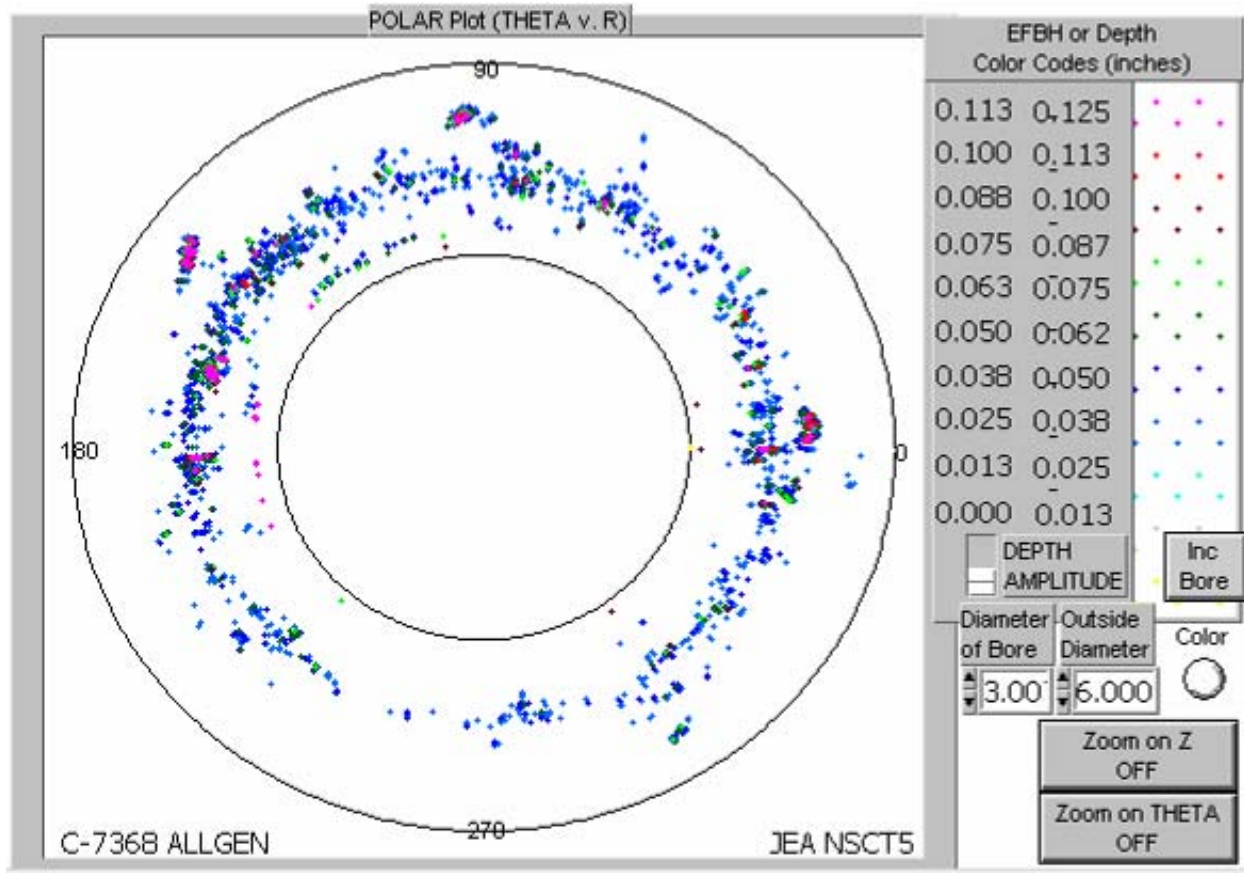
Figure 7. Polar plot of all 9,682 ultrasonic data points collected during the boresonic examination of the JEA NSCT5 generator rotor.

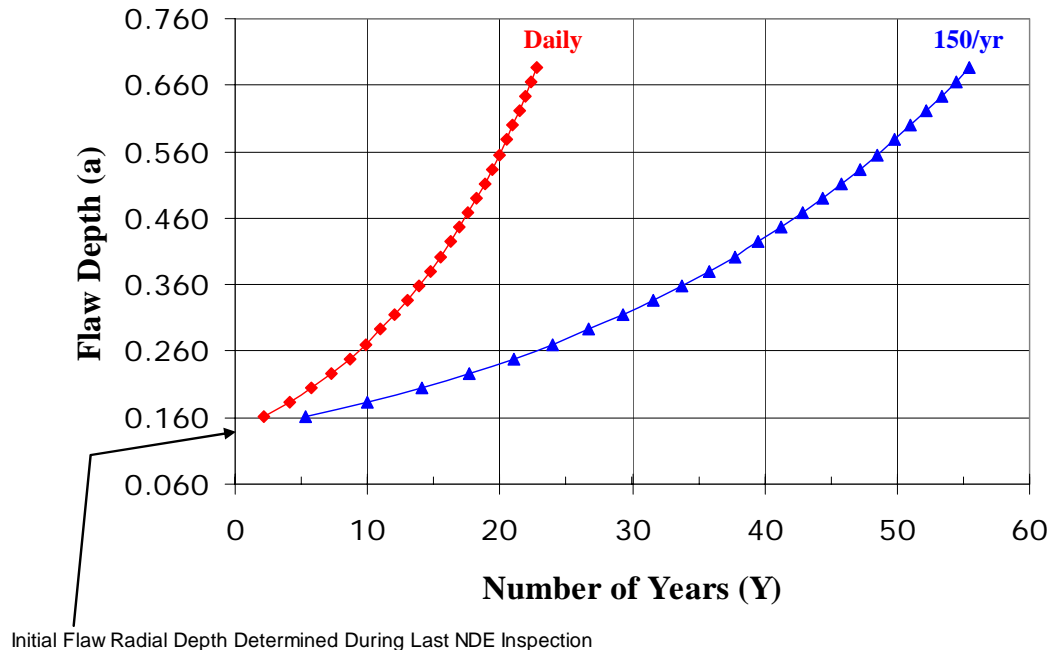
ROTOR	Bore Area	Stress Level	* $a_{cr}$	$2c_{cr}$	Number of Cycles
Generator	Main Body	54,000 psi	0.6873 in	2.7500 in	8,320

The maximum transient hoop mechanical and thermal stress in the JEA NSCT5 generator rotor was located under the middle of the rotor at 10% overspeed (3960 rpm) and was conservatively calculated as 54 ksi. The critical flaw size was calculated as 0.6873 in. radial depth and 2.7494 in. axial length. The total calculated number of start/stop cycles remaining for the Generator rotor is 8,320.

Figure 8. Life assessment plot of JEA NSCT5 showing number of years (depending on the start-stop cycles per year) versus flaw radial depth.

Based on the results and engineering analysis of the 2007 boreside NDE examination performed in by Reinhart & Associates, Inc., it is recommended that the JEA Northside Station Unit 5 Generator rotor be reinspected within the next 10 years (87,600 hrs) of additional service. The recommended reinspection interval only considers the main shaft forging and does not consider any winding reinspection interval. The recommended rotor reinspection interval may not account for the occurrence of unusual conditions or any other event that could affect the integrity of the system. Such events include rotor unbalance, changes in vibration states during run-down or start-up, motoring of the generator, overspeeding, and major rotor repairs. Borende nondestructive testing should be performed immediately after such occurrences.
