January 15, 2018

Thank you for your interest in Evoqua Water Technologies products and services and for your confidence in our ability to help solve your corrosion and odor control needs. Evoqua would like to present the results for the Inspection of the three Bio-trickling Filter Systems, comprised of a total of four Bio-trickling Filters, located at the JEA Arlington East WRF.

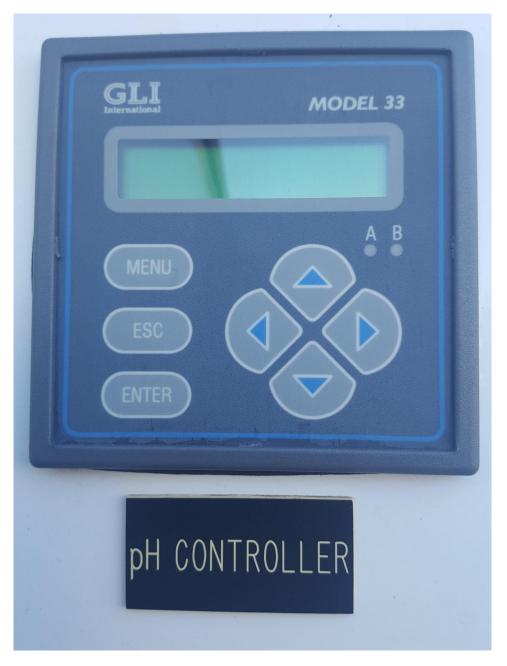
Instrumentation pH meter not operating (GLI Model 33)

Unit 2A pH Meter

Most of the deficiencies noted in the above tables were due to non-functioning flow meters, differential pressure gauges and pH meters. These units could have the Digital meters and displays replaced or have them replaced with mechanical gauges to simplify the process and be more cost effective in order to better monitor the units and keep them operating at maximum efficiency.

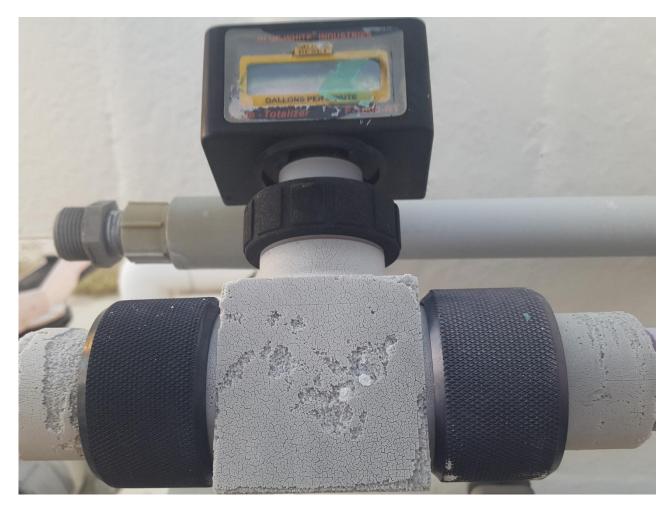
Make up water Flow meter damaged.

Unit 2B Non-working Flowmeter

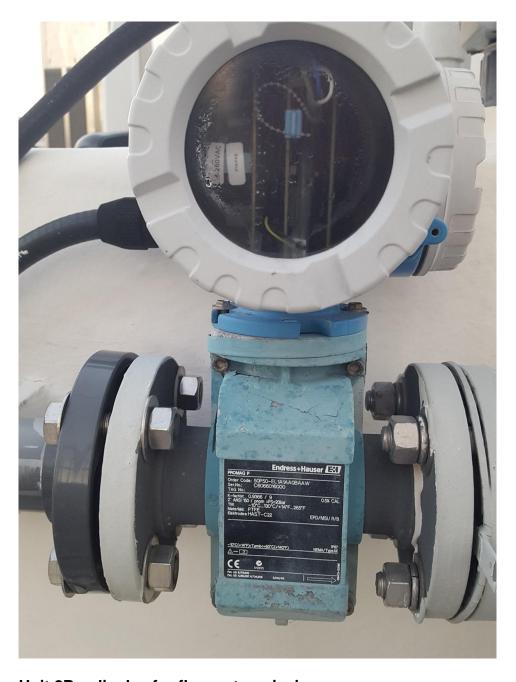
Nozzle gpm Local display is missing

Unit 2B – display for flowmeter missing

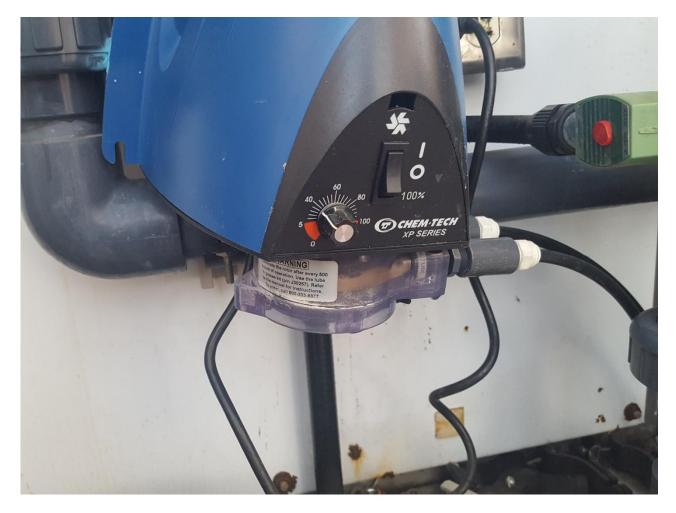
to allow flow to top nozzle Nutrient pump is leaking.

Unit 3A- Nutrient pump leaking

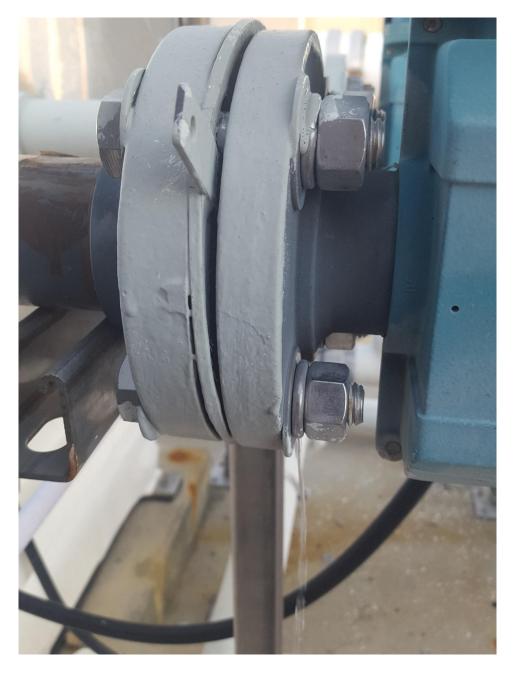
Recirc. pump leaking from flange at flow meter.

Unit 3A- leak at flowmeter flange

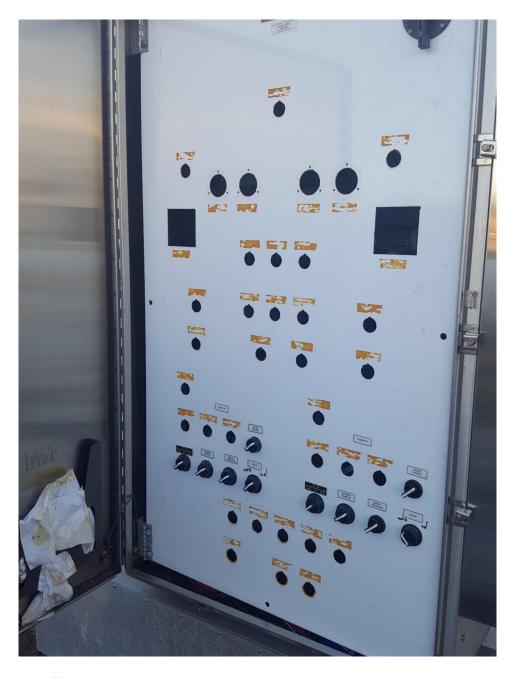
Control panel Modified.

Most lights and switches removed.

Modified control Panel 3A-3B
