2021 ANNUAL INSPECTION REPORT

Byproduct Storage Area B
St. Johns River Power Park

Golder Associates USA Inc.

January 2022

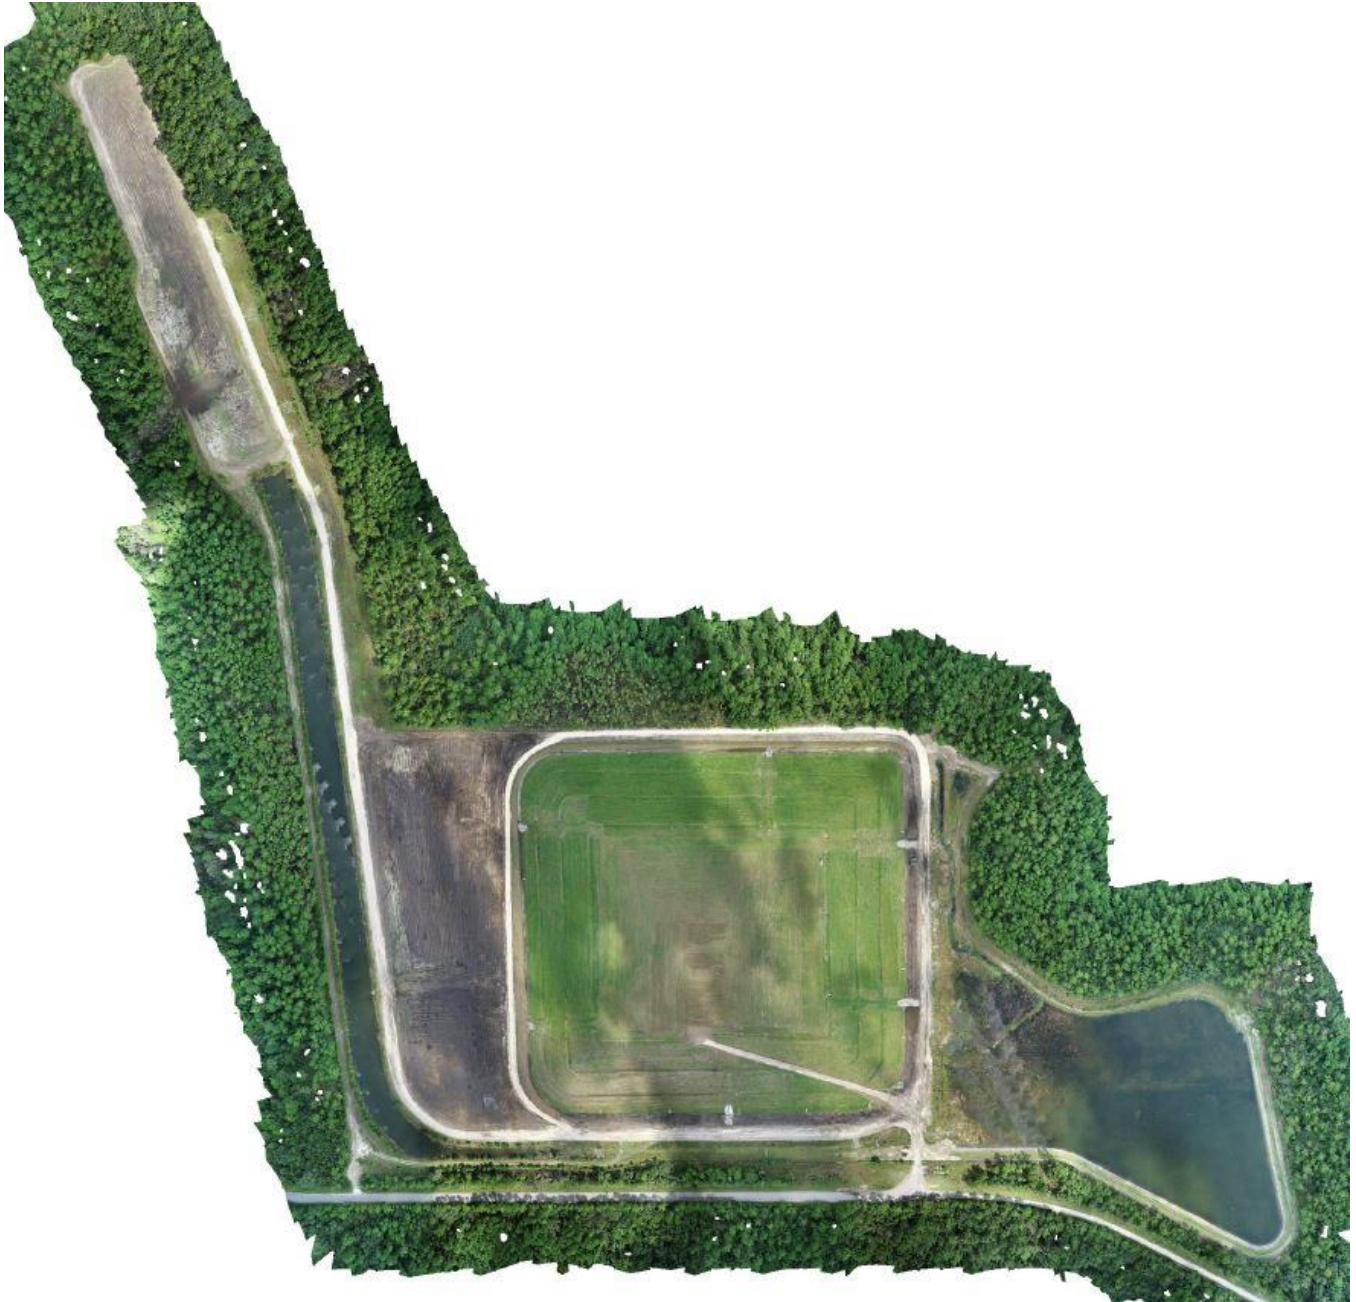
Figure 2: Figure 2 - Aerial Photograph

The primary changes in geometry of BSA-B since the past annual inspection are due to closure construction of the BSA-B and relocation of materials from the western portion of the Phase I footprint to the closed BSA-B. Closure construction entailed construction of bench ditches, stormwater management features, and geomembrane capping of CCRs. A recent aerial photograph of BSA-B (dated September 2021) is provided on Figure 2.
