2022 ANNUAL INSPECTION REPORT

Byproduct Storage Area B

St. Johns River Power Park

January 2023

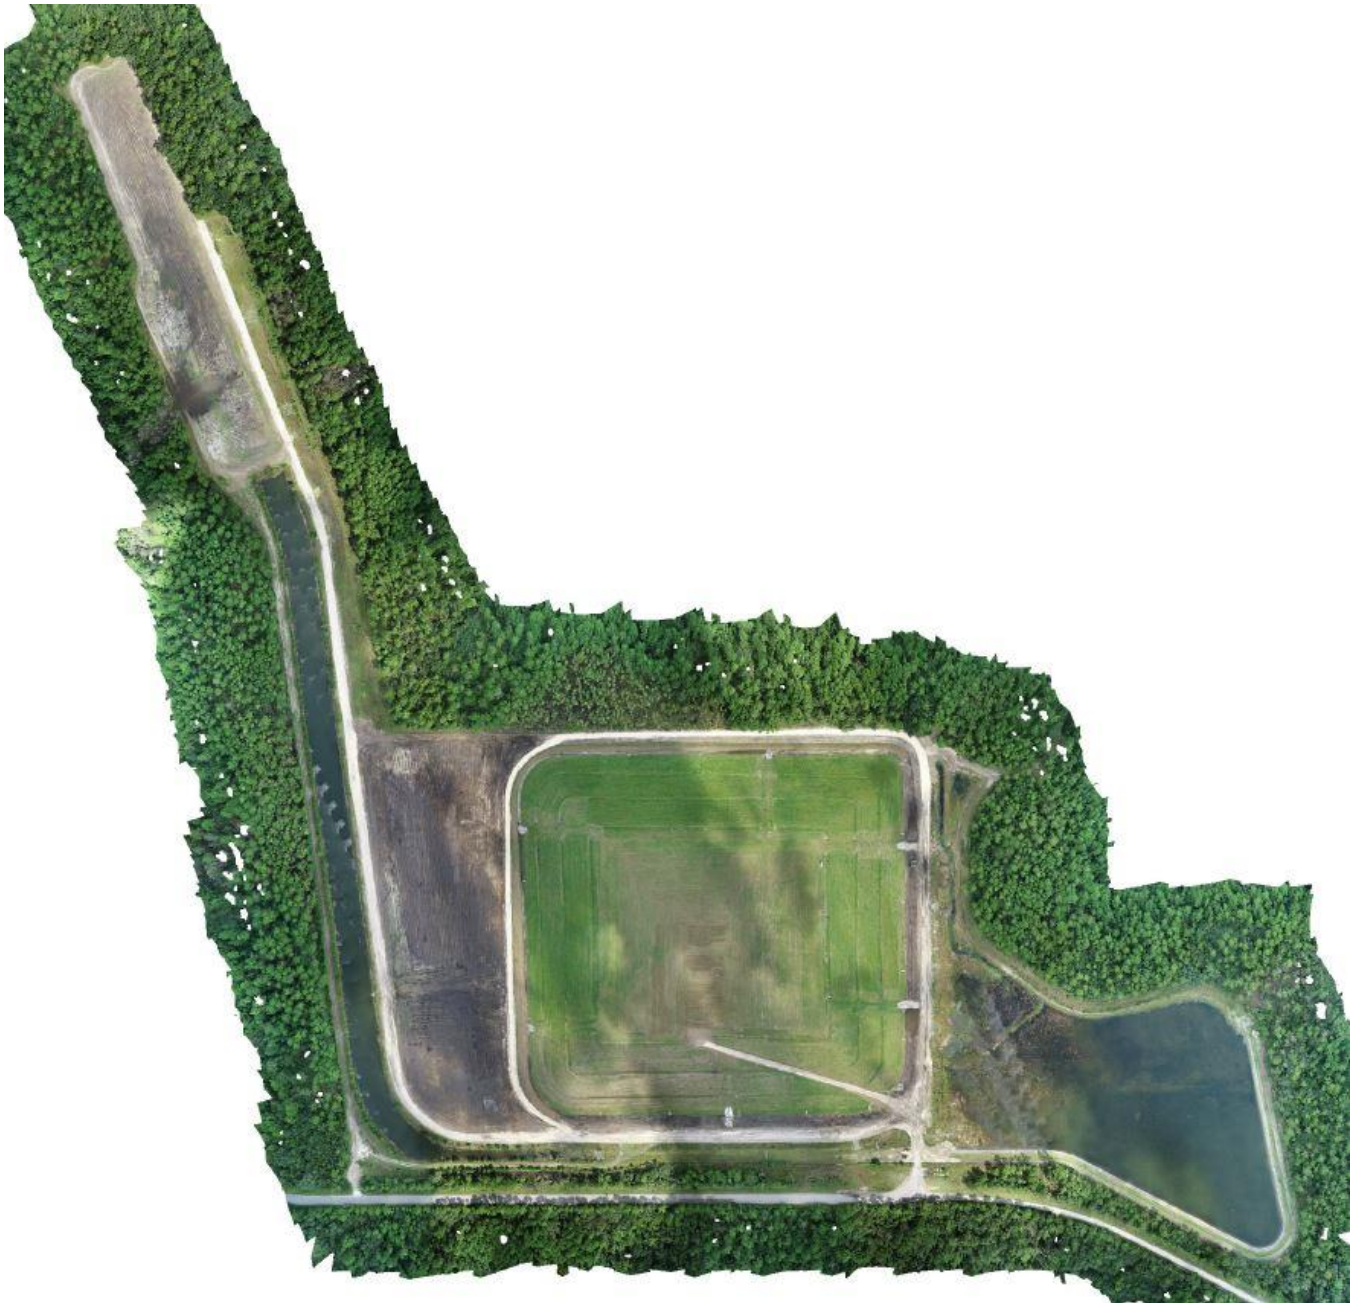
Figure 2: Aerial Photograph

The primary changes in the geometry of BSA-B since the past annual inspection are due to the closure construction of the BSA-B and the relocation of materials from the western portion of the Phase I footprint to the closed BSA-B. Closure construction entailed the construction of bench ditches, stormwater management features, and geomembrane capping of CCRs. A recent aerial photograph of BSA-B (dated September 2021) is provided on Figure 2.
