**JEA**

**Northside Generating Station**

**JEA NGS N01  
Isolated Phase Bus  
Cleaning Inspection and Repair Spring 2025**

**General Requirements and Scope of Work**

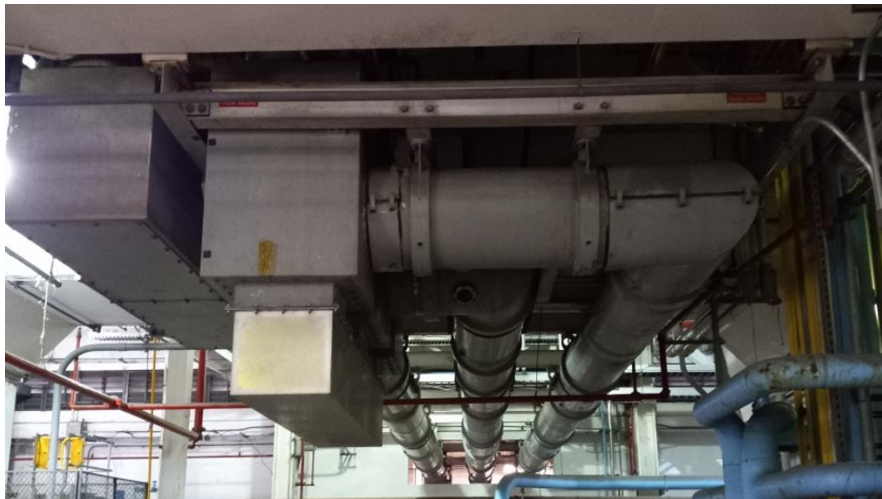
**View of IPB on Mezzanine from below Generator 2023.**

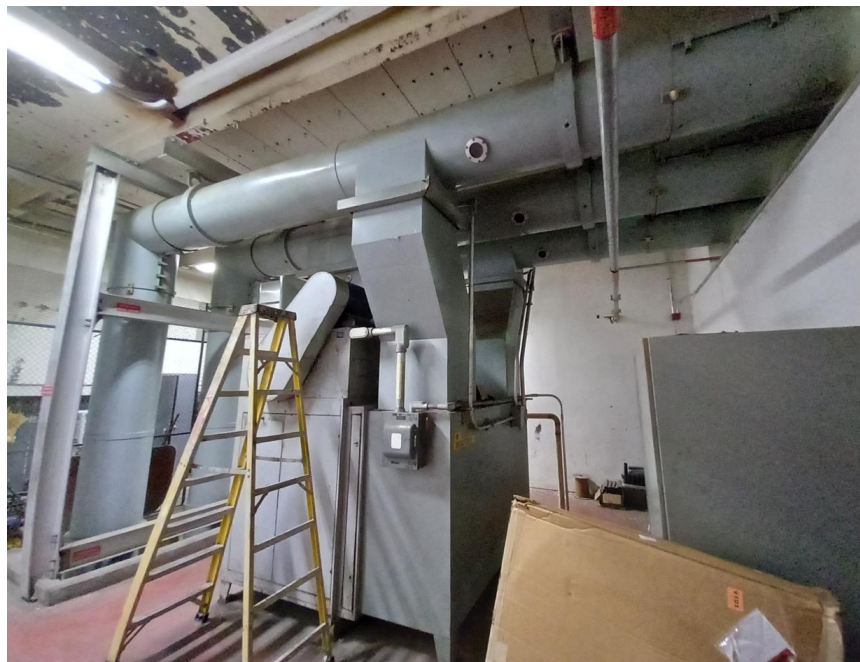
**View of Forced Air Fans 2023.**

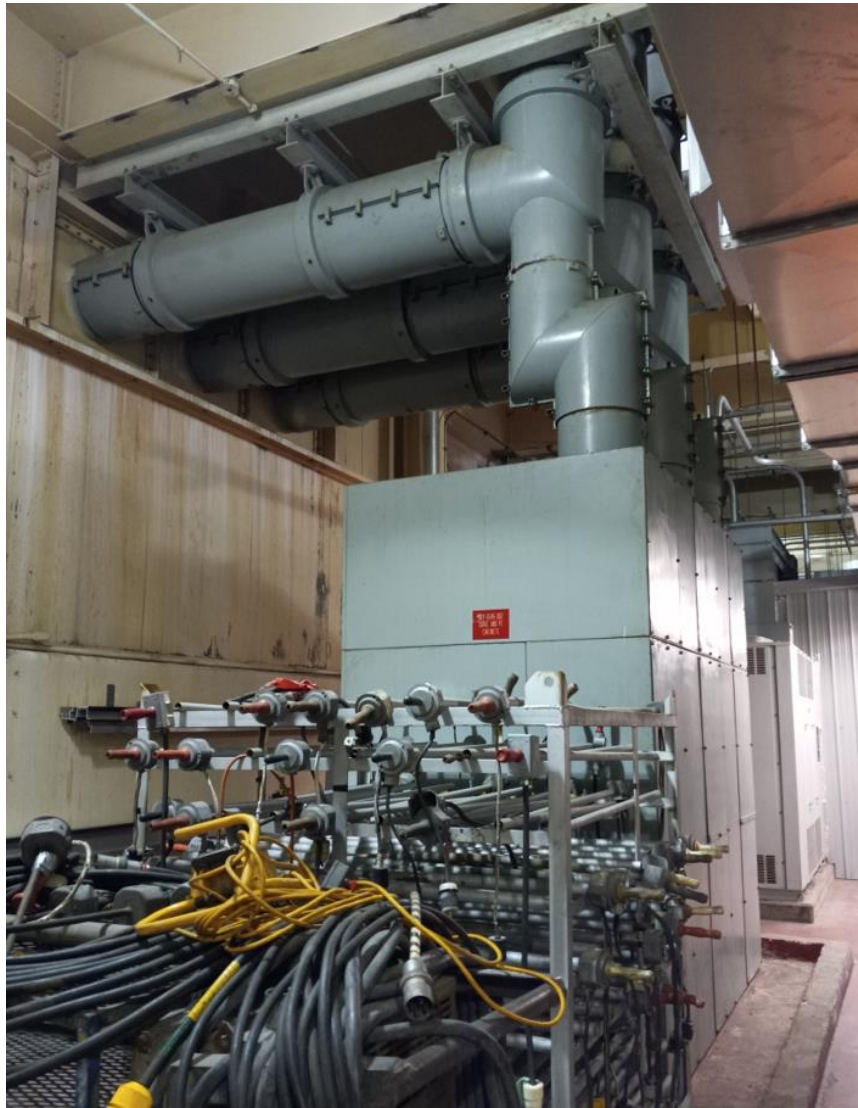
**View of PT / Relay Cabinets 2023.**

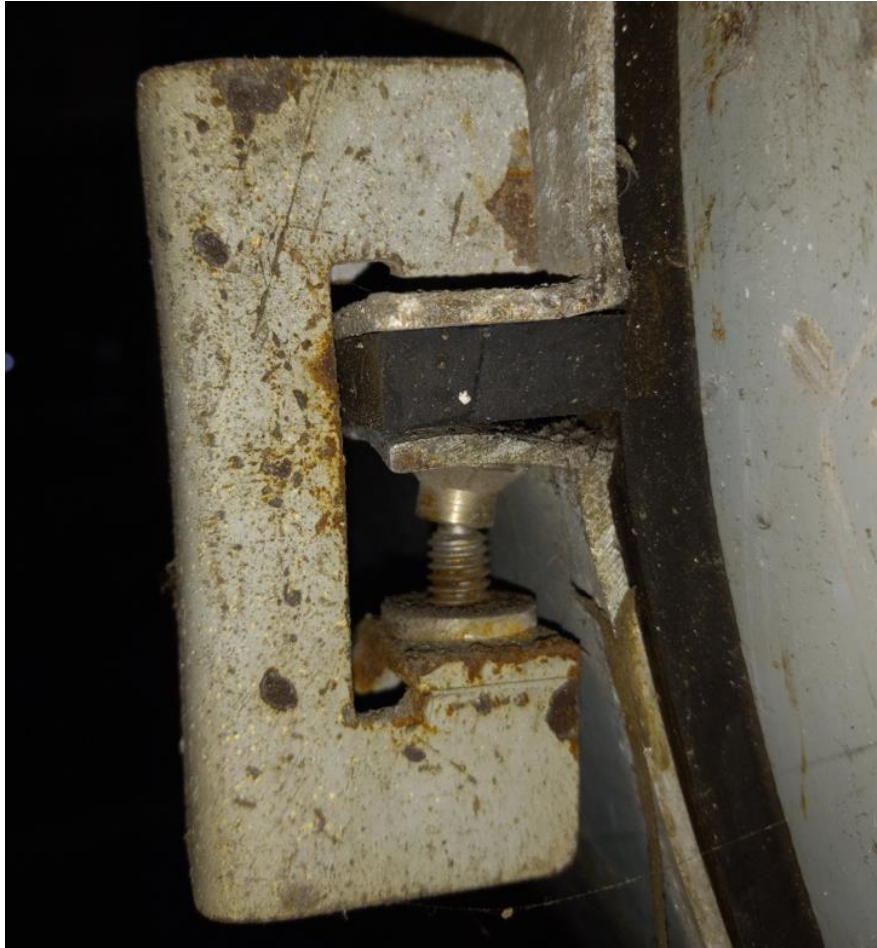
**View of Bolting Clamp for N01 Enclosure Clamshells 2023.**

1. Access hatches and gaskets - All access hatches (100) are to be removed, three at a time so that the JEA PM and or Engineer can get as found pictures alongside the Contractor. The Clamshell cover bolting clamps shall be left loose until the JEA PM directs the contractor to permanently reinstall them. Prior to removing the clamps, a small amount of Silver Grade Anti-Sieze © shall be brushed onto the threads so that when they are removed, the threading is coated with an anticorrosive. All gaskets will be replaced with new approved gaskets. The covers will be placed back into position or have plastic wrapped in such a way to create a water tight boundary for the bus, at the end of each day, shift or in the event of expected precipitation. This is to prevent wildlife from taking shelter inside of the duct and to prevent foreign material from entering the bus/ duct system. Each access cover shall be labeled top or bottom with an identifying letter for phase and an identifying number per location. The Numbering Convention for Hardware shall be discussed and agreed upon with the JEA PM and or Engineer prior to any work. It is considered critical by JEA that the access hatches and all associated hardware go back into the exact position and orientation that it was found. This will mitigate pieces not fitting together correctly and thus save time and money. All hardware will be replaced with 316 stainless steel supplied by the contractor and verified with neodymium magnet with PM present.

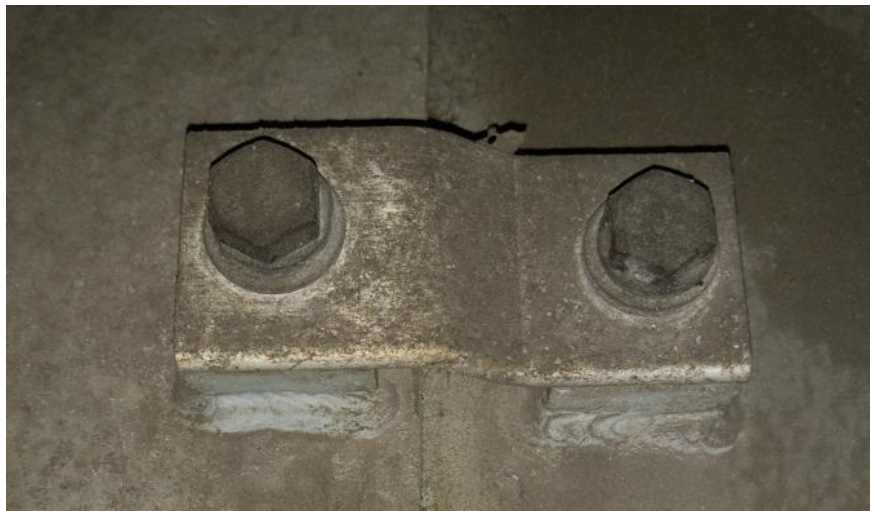
**View of Bonding Linkage Between Enclosure and Clamshell 2023.**

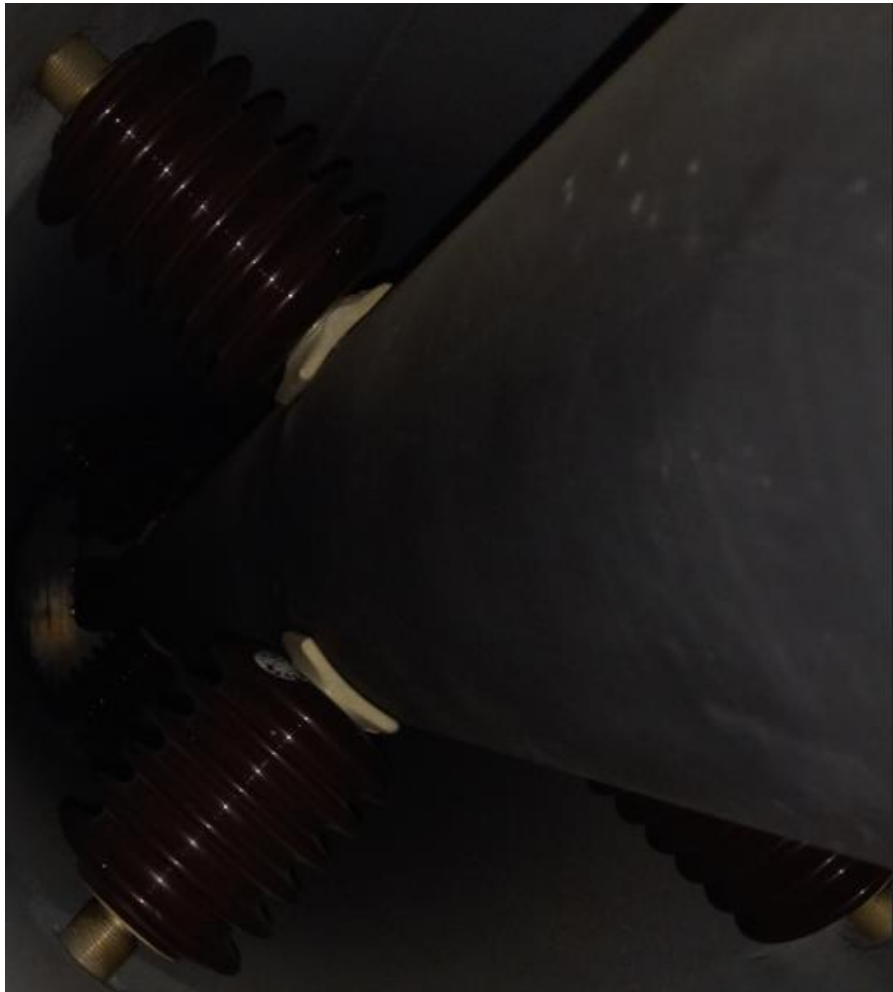
**View of Insulators – Saddles, Captures 3 of 4 at this Location 2023.**

2. Insulators and Bushings – The insulators for the conductors (624) are ninety degrees apart at each location. The Contractor shall find any damage using bore scope and or camera. Each insulator shall be assigned nomenclature per the Numbering Convention for Hardware and referred to as such in

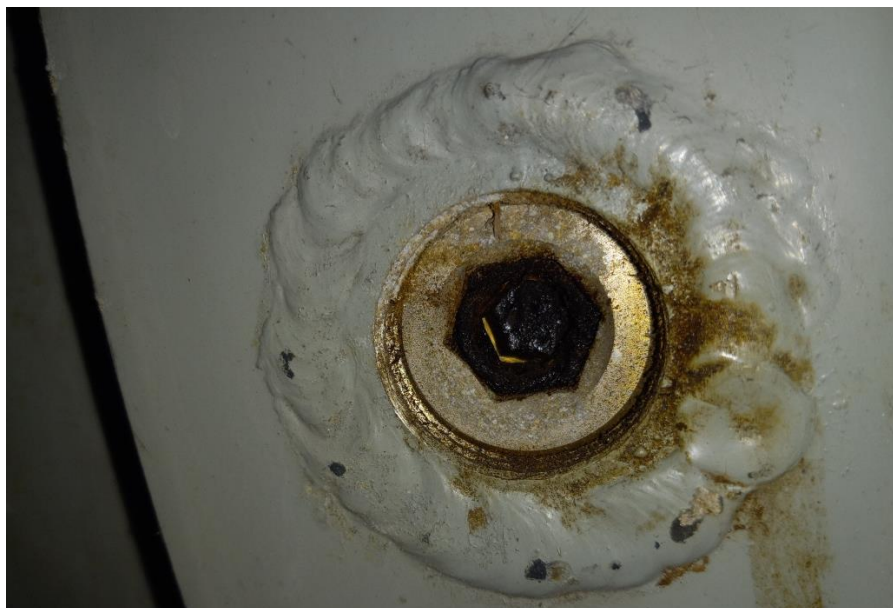
**View of Insulator Bolt on Exterior 2023.**

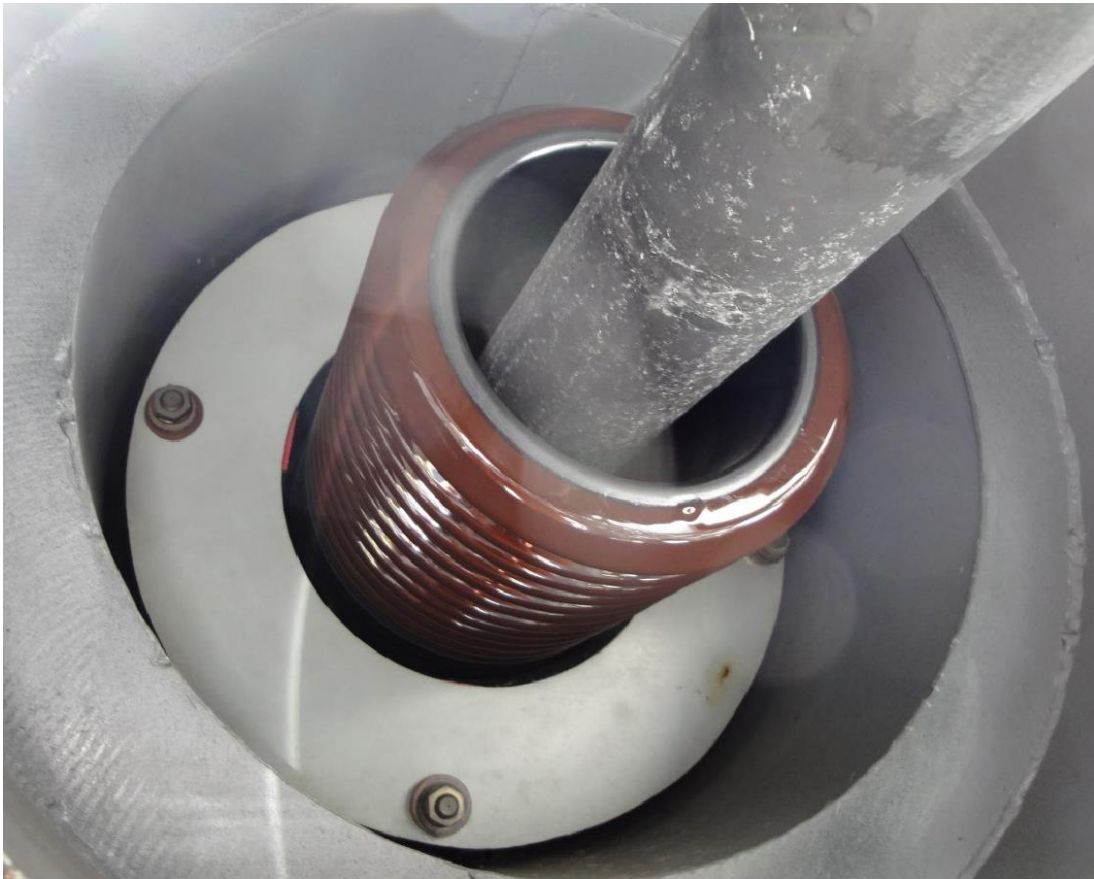
**View of Bushing N01 2016.**

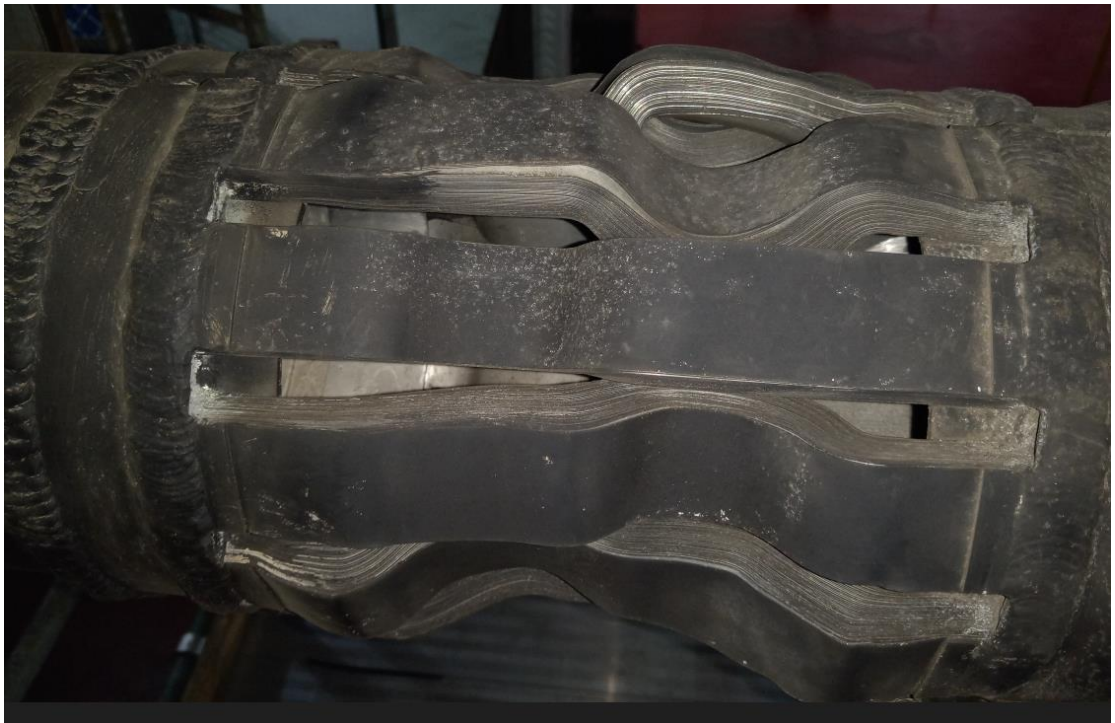
**View of 12000A Main Bus Welded Connection 2023.**

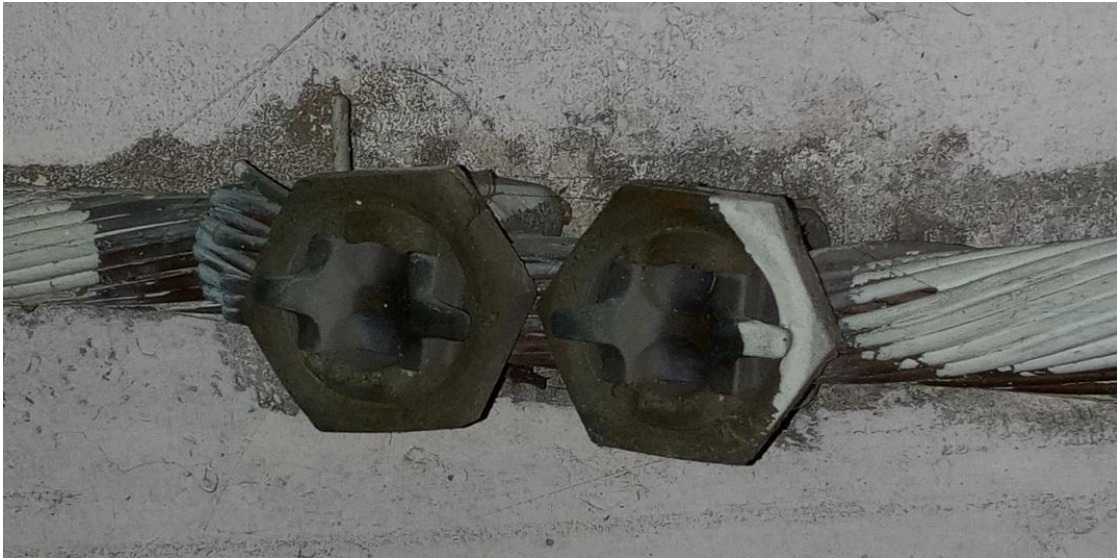
**View of 500MCM on the Mezzanine.**

5. Grounding Connections – All bare 400 MCM shall be replaced with 500MCM and cad welded to existing building steel and to the existing grounds Four (4) feet above grade. This will require scaffolding and in some locations, a harness where the scaffolding cannot be “green tagged”. There is approximately 350’ that shall be replaced. Tap cons with stainless steel straps shall be used every 18 to 24 inches. There are existing studs which There are 8 locations that require a cad weld 500MCM to 500MCM parallel, and 6 locations that require a cad weld to building steel. The bare copper ~ 15’ that is bonded to the NGR shall also be replaced. These cables can be measured with a caliper during the walk down to verify sizing.

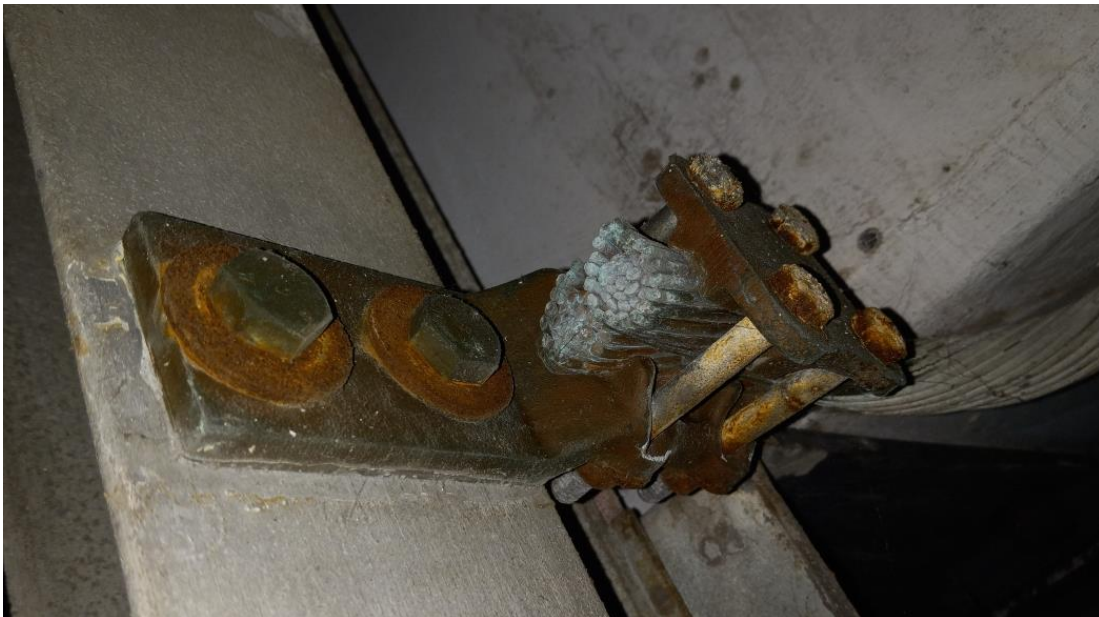
**View of Bonding connection between Aluminum bus and cable.**

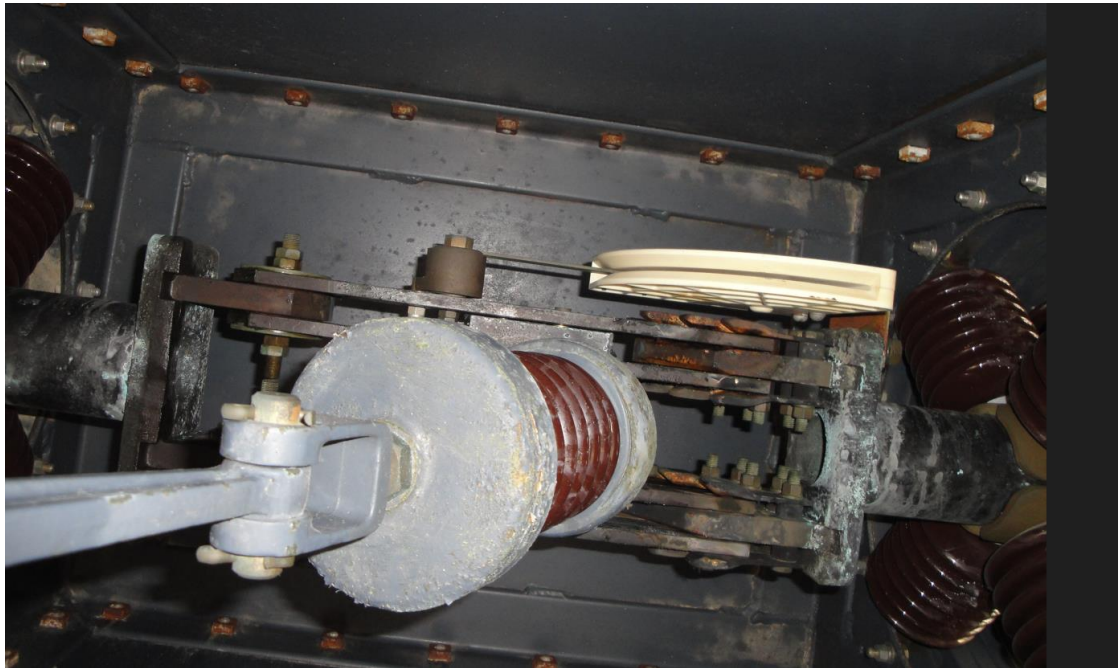
View of the Station Service Isolation Outdoor Switch – DWG 001888

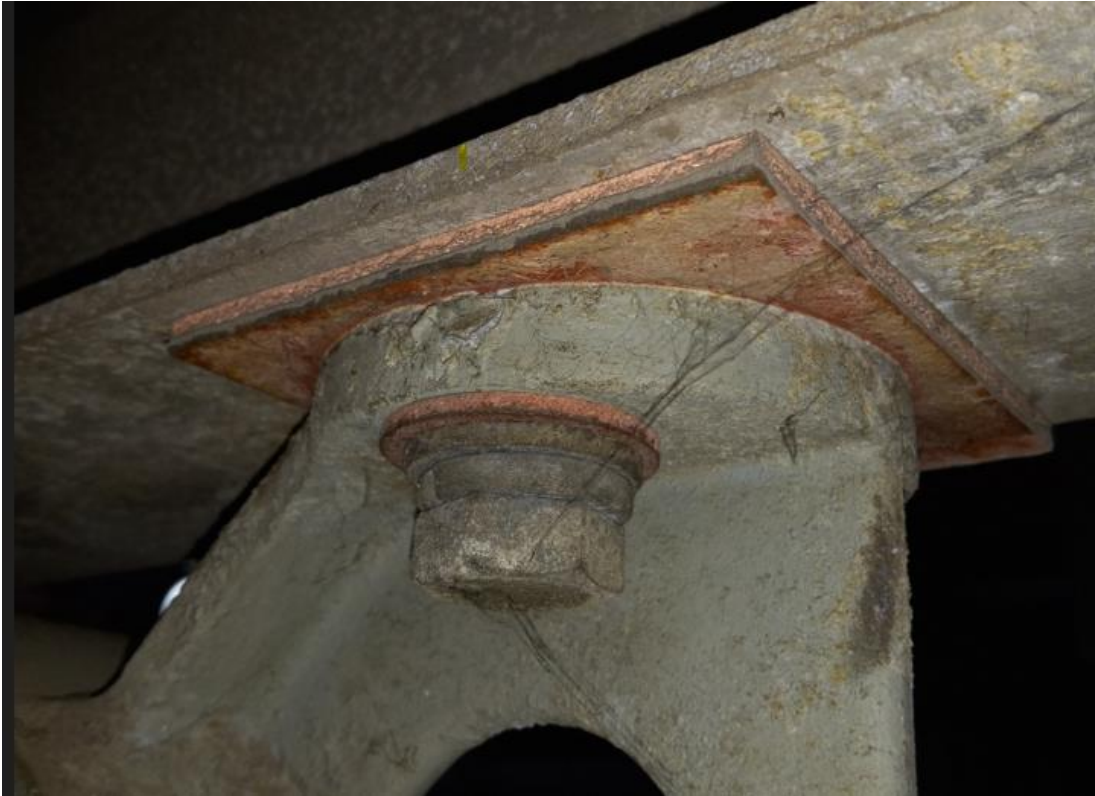
**View from below of one Insulated Connection for Enclosure.**

The insulated locations shall be megger tested and the measurement should be within 3% from one location to another. The expected values will be at least 20Mohm. The bolts that are removed to replace insulation will require a G10 or G11 sleeve or bushing to maintain electrical isolation between the threading and the enclosure. All bolts shall be checked for tightness and torqued based on hardware size and consensus with PM.

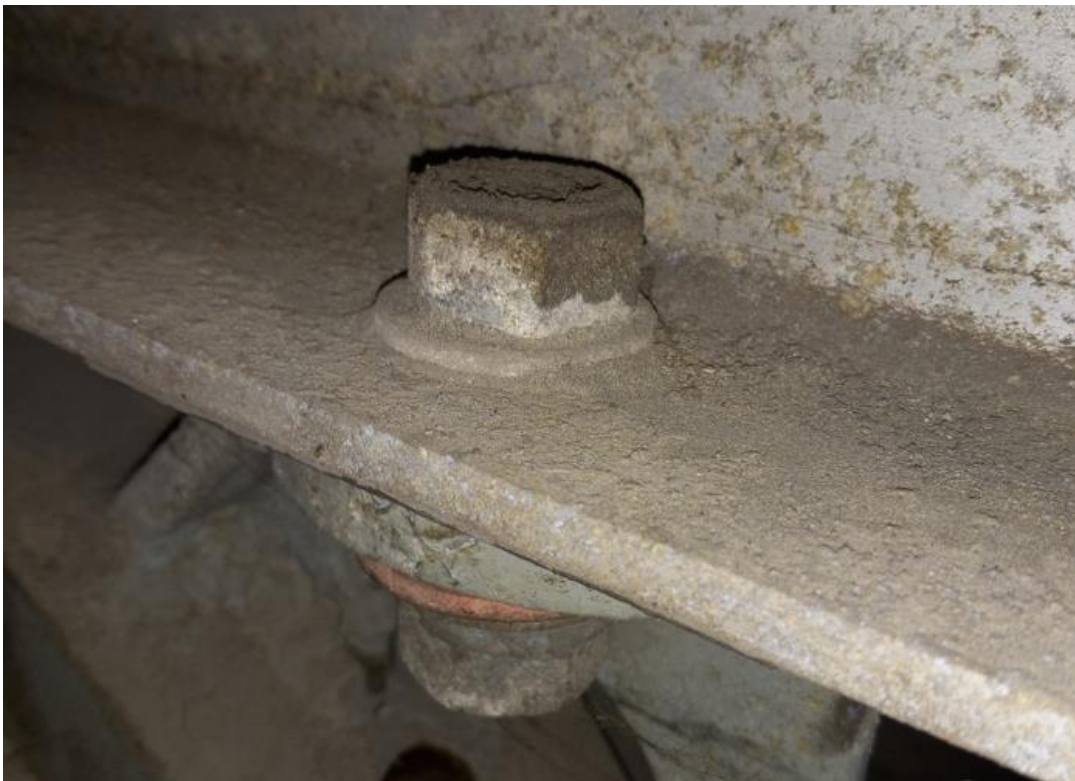
**View from above of One Insulated Connection for Enclosure.**

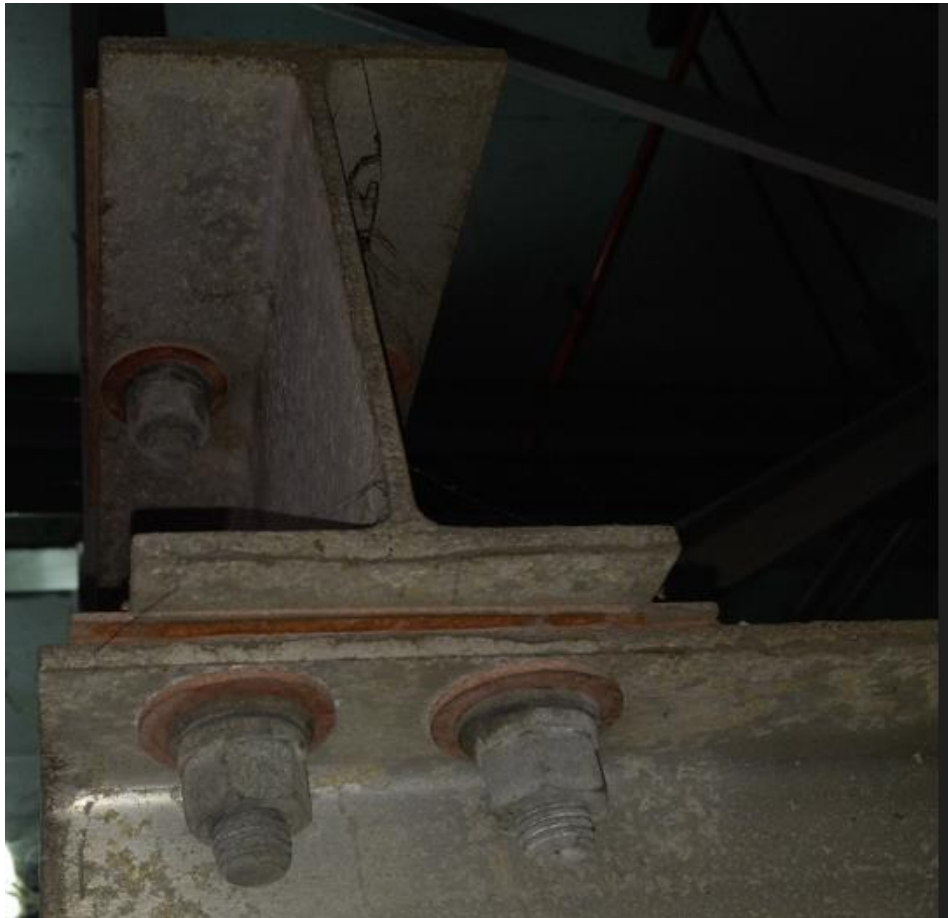
View of Insulation between Building Structure and IPB Bonding Structure.

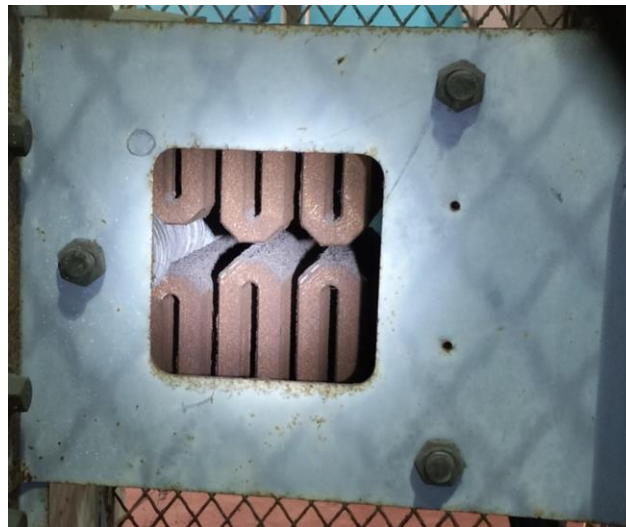
N01 NGR – Test resistance with calibrated (within 1 year) Ohm-meter.

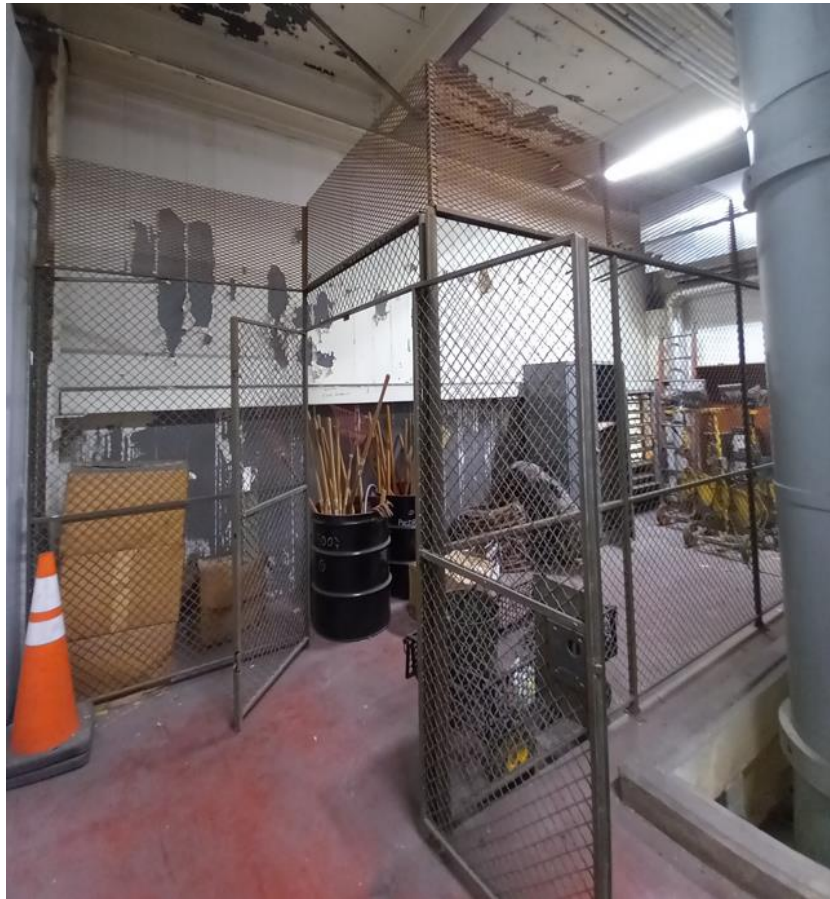
**Metal Cage Behind IPB on Mezzanine – 10' Tall, 30' Length.**

14. Demolish metal cage behind Vertical IPB on Mezzanine – 10' High, 30' Wide. The steel cage shall be placed in the metal recycling bin north of the turbine building west of the employee parking lot.
