Northside Generating Station

**JEA NGS N01
Isolated Phase Bus
Cleaning Inspection and Repair**

General Requirements and Scope of Work

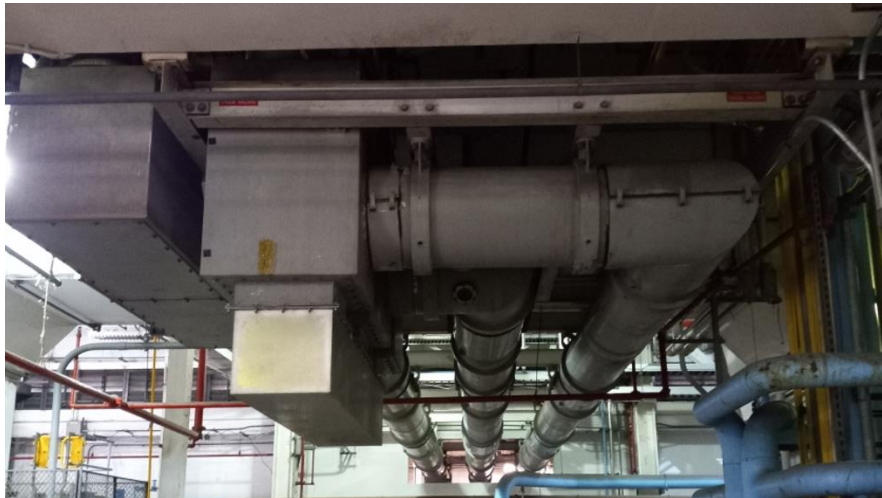
View of IPB on Mezzanine from below Generator 2023.

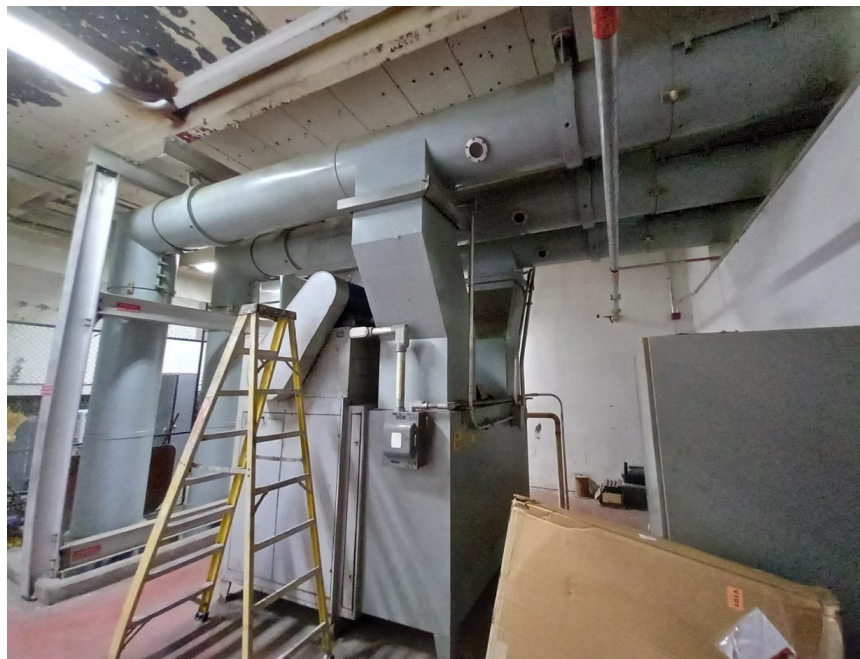
View of Forced Air Fans 2023.

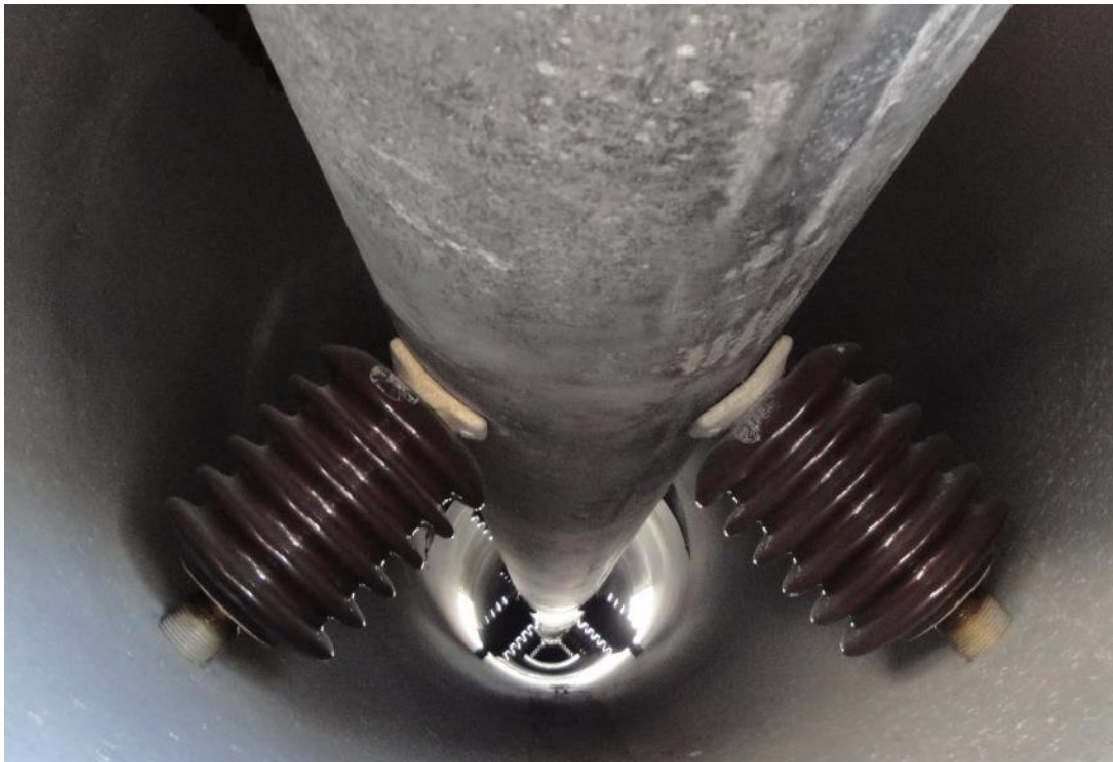
View of Insulators N01 2016.

2. Insulators and Bushings – The insulators for the conductors (624) are ninety degrees apart at each location. The Contractor shall find any damage using bore scope and or camera. Each insulator shall be assigned nomenclature per the Numbering Convention for Hardware and referred to as such in

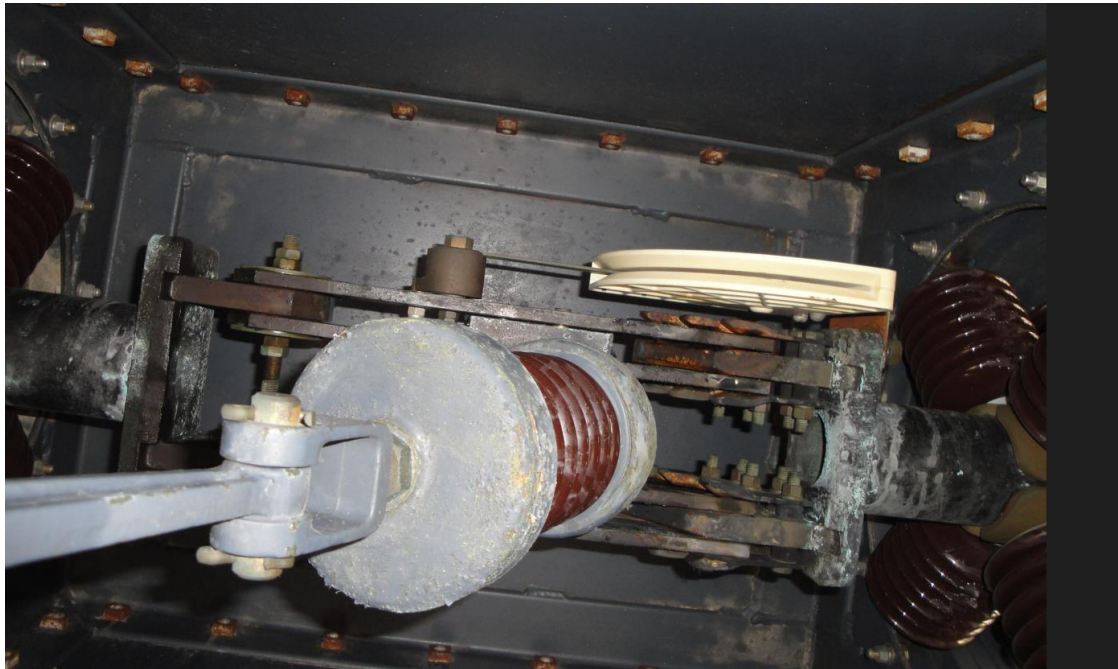
View of the Station Service Isolation Outdoor Switch – DWG 001888

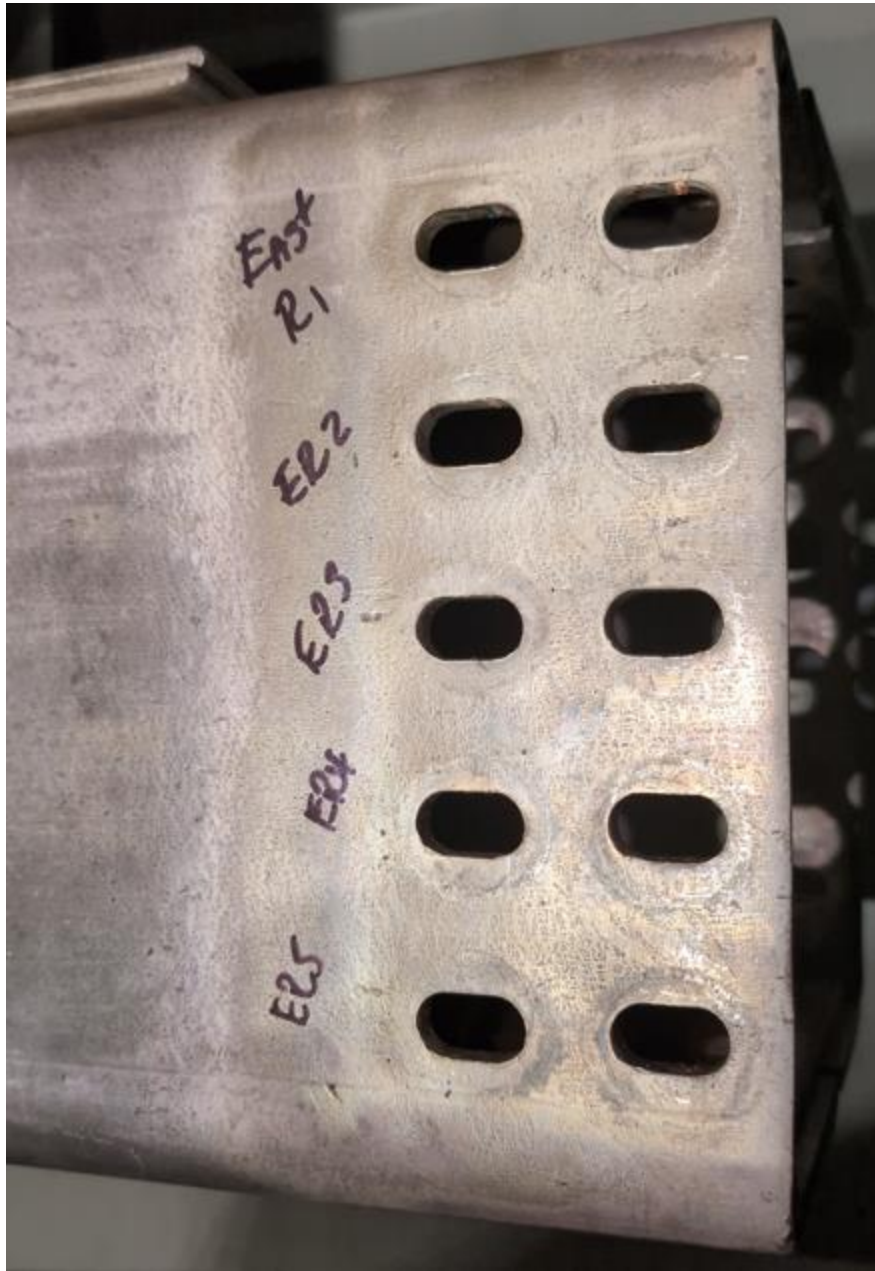
Neutral Bus Slotted Holes on Top, Bottom and both Sides.

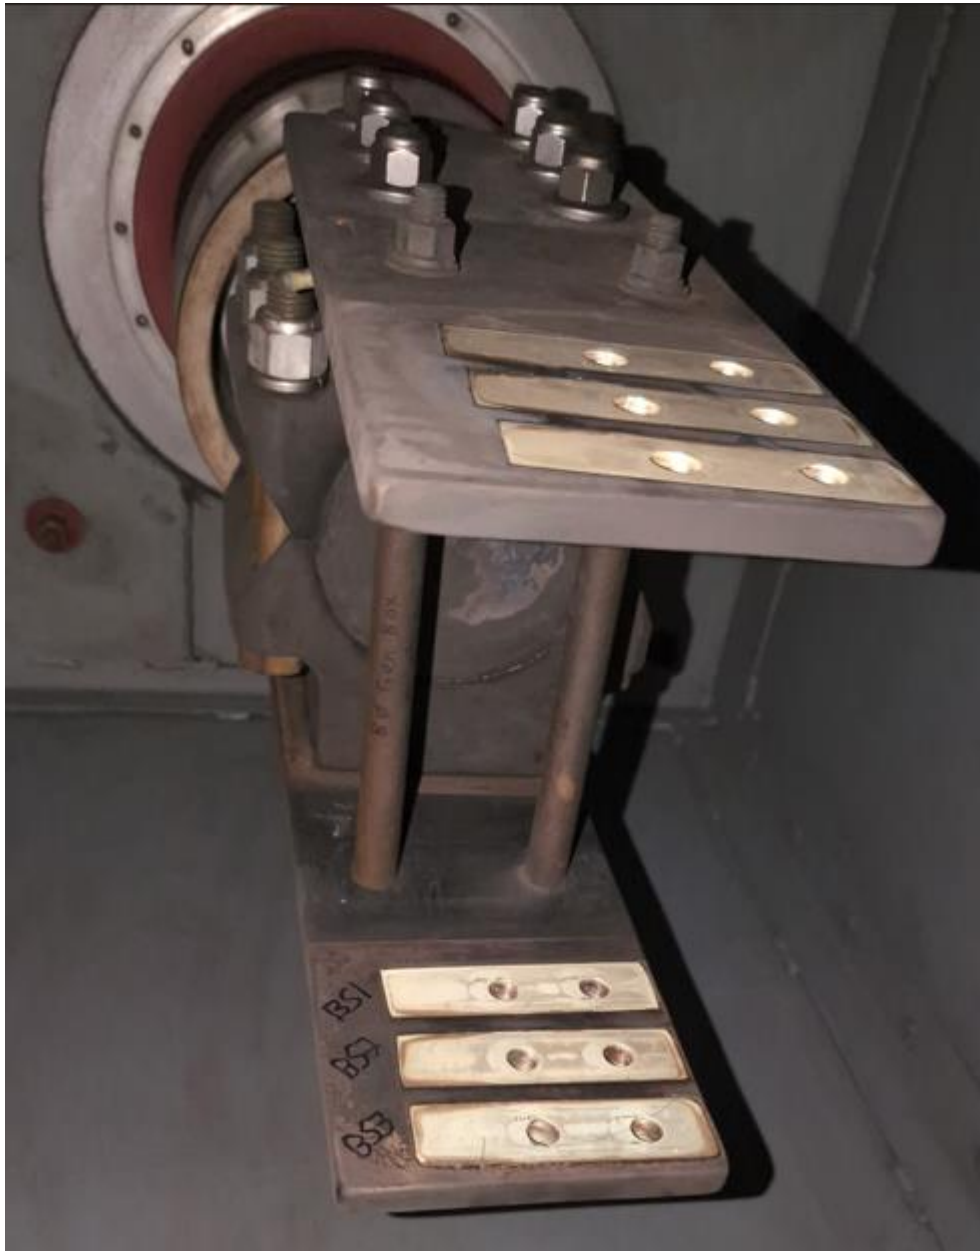
C Phase Generator Bushing Flex Links bolt to Inboard and Outboard Sides.

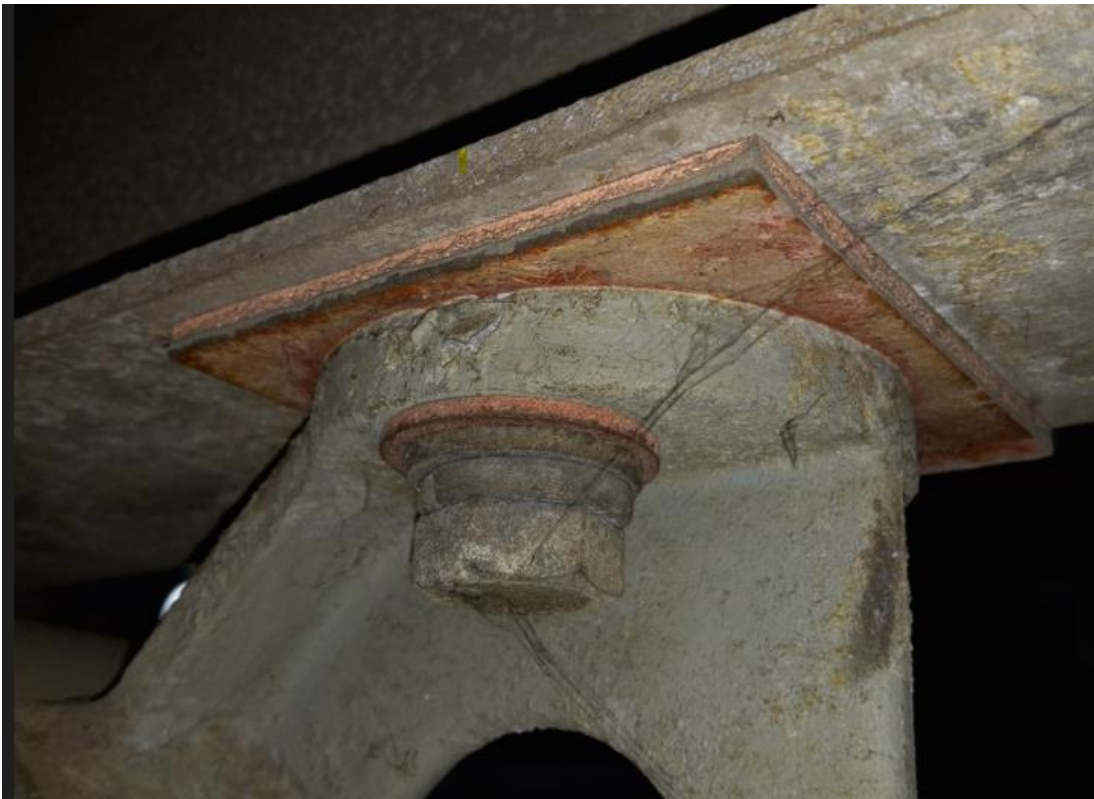
View from below of one Insulated Connection for Enclosure.

The insulated locations shall be megger tested and the measurement should be within 3% from one location to another. The expected values will be at least 20Mohm. The bolts that are removed to replace insulation will require a G10 or G11 sleeve or bushing to maintain electrical isolation between the threading and the enclosure. All bolts shall be checked for tightness and torqued based on hardware size and consensus with PM.

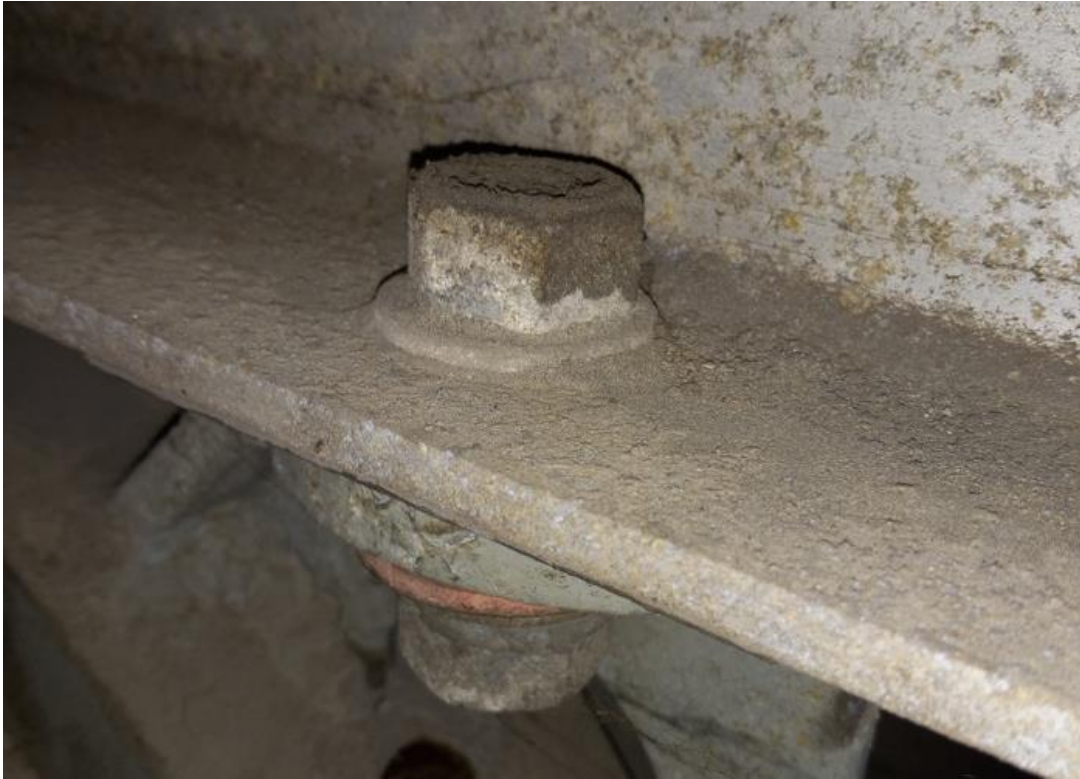
View from above of One Insulated Connection for Enclosure.

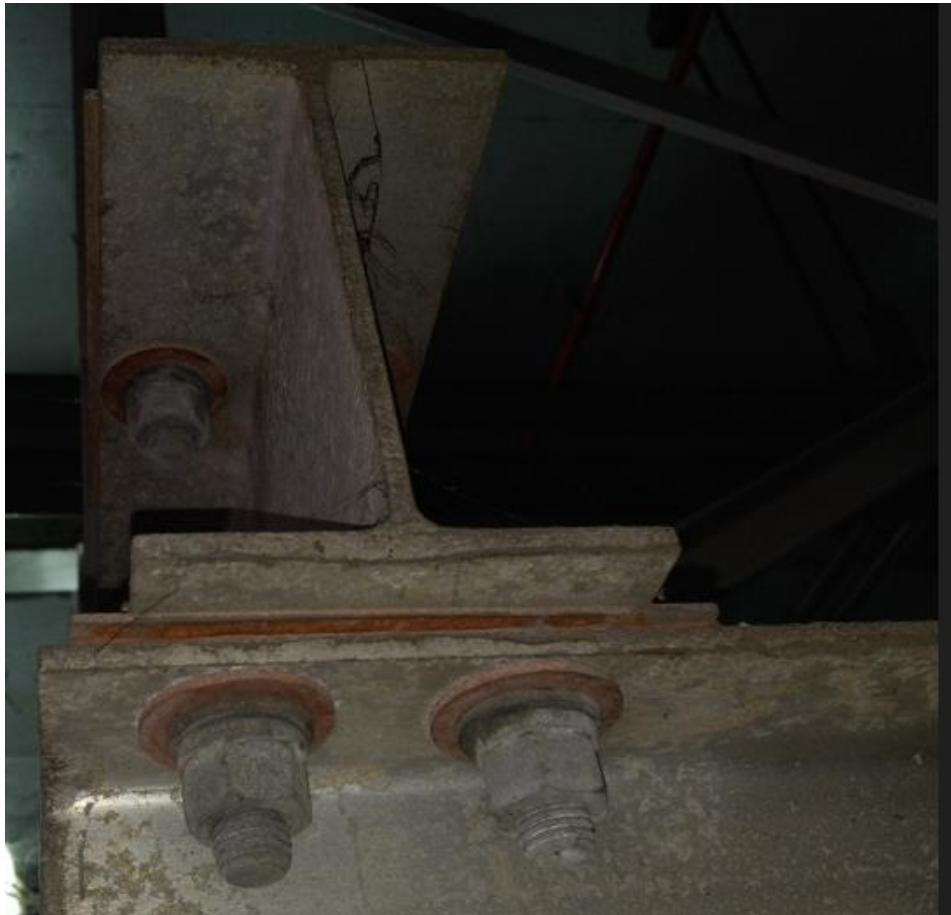
View of Insulation between Building Structure and IPB Bonding Structure.

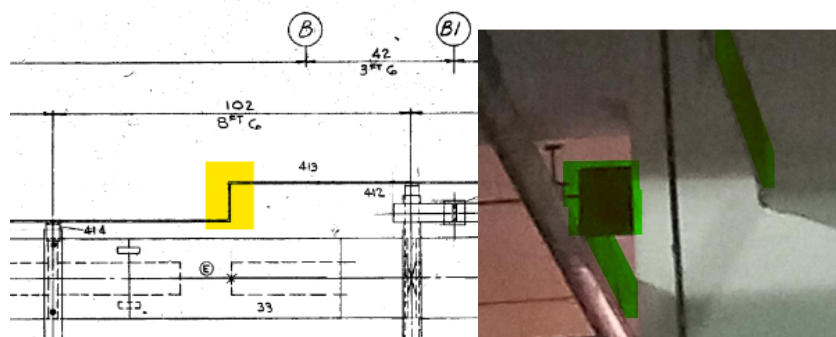
GND Bus Shown on 001888 Plan View "A6 - A6".

12. Expose Ground Bus inside wall – A sheet rock wall was constructed over the ground bus and will need to be cut back to inspect. If there are bolted connections in the wall, they will need to be unbolted to disassemble the external ground bus and silvered. A key hole saw shall be used to puncture a hole in the wall so that a visual inspection can be done before cutting into the wall with power tools.

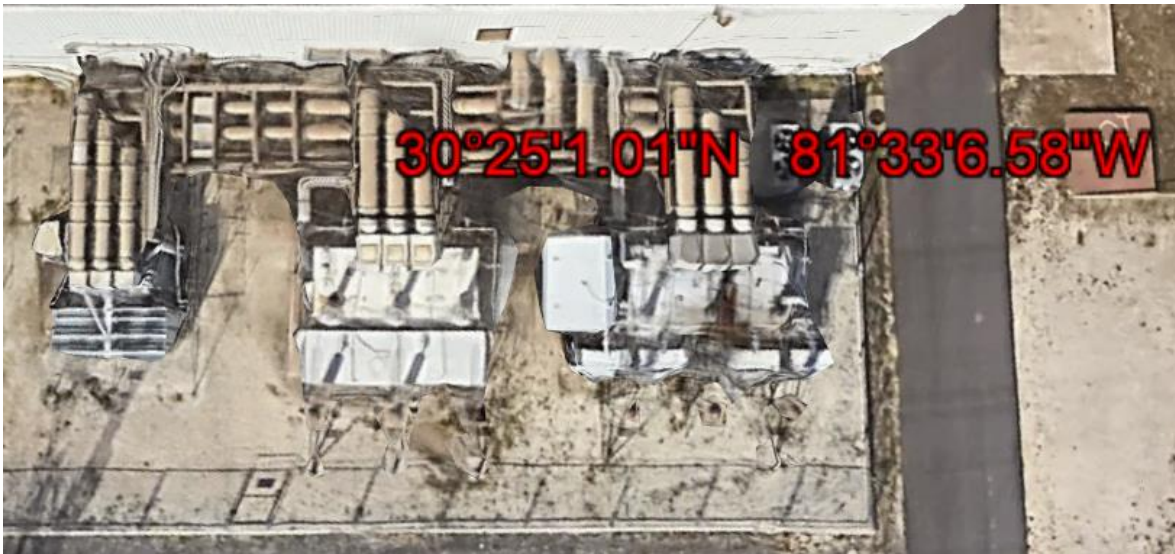
View of Location and Outdoor IPB 2023.
