JEA

Northside Generating Station

**JEA NGS N01
Isolated Phase Bus
Cleaning Inspection and Repair**

General Requirements and Scope of Work

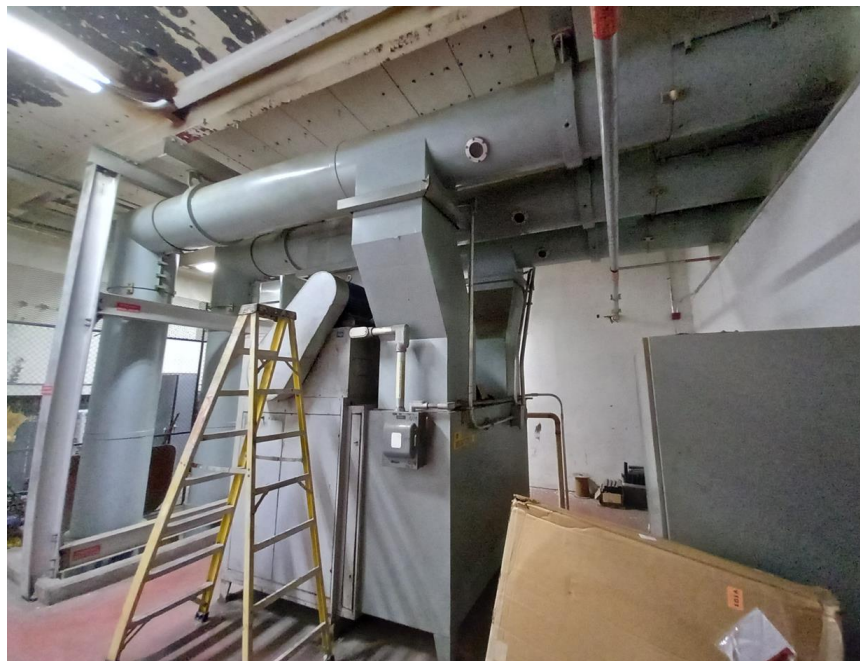
View of Forced Air Fans 2023.

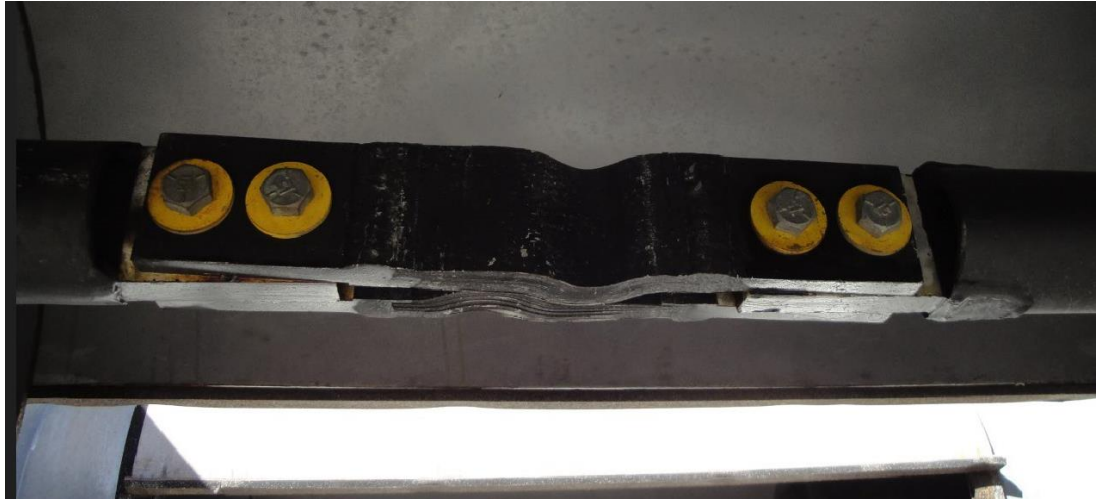
View of 1.2kA Tap Bus Connection 2009.

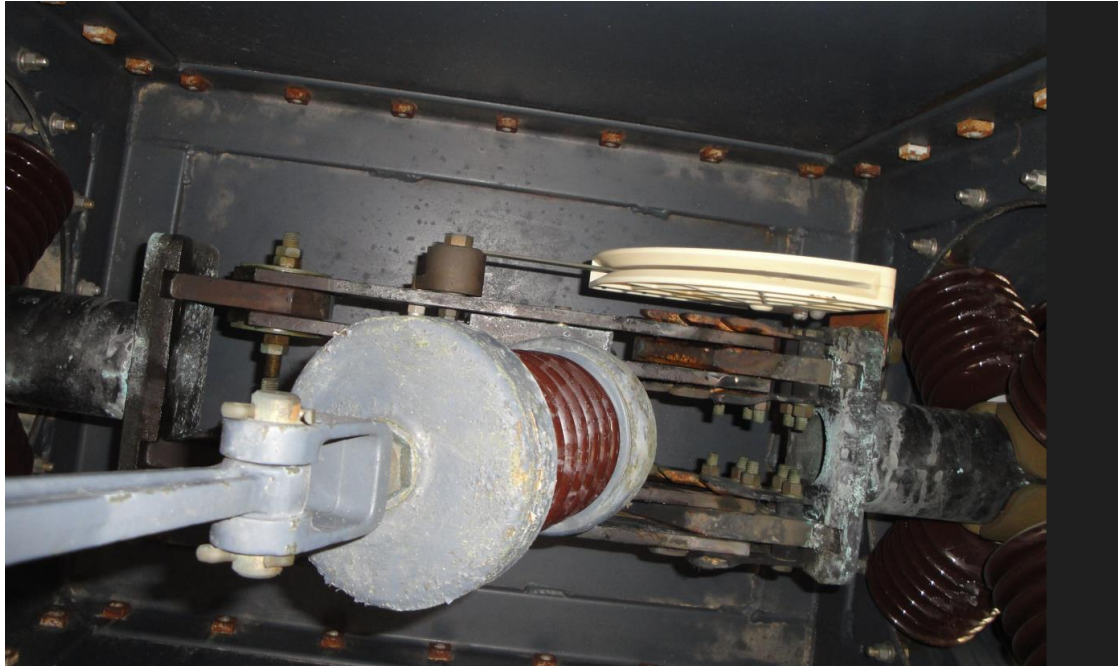
View of the Station Service Isolation Outdoor Switch – DWG 001888

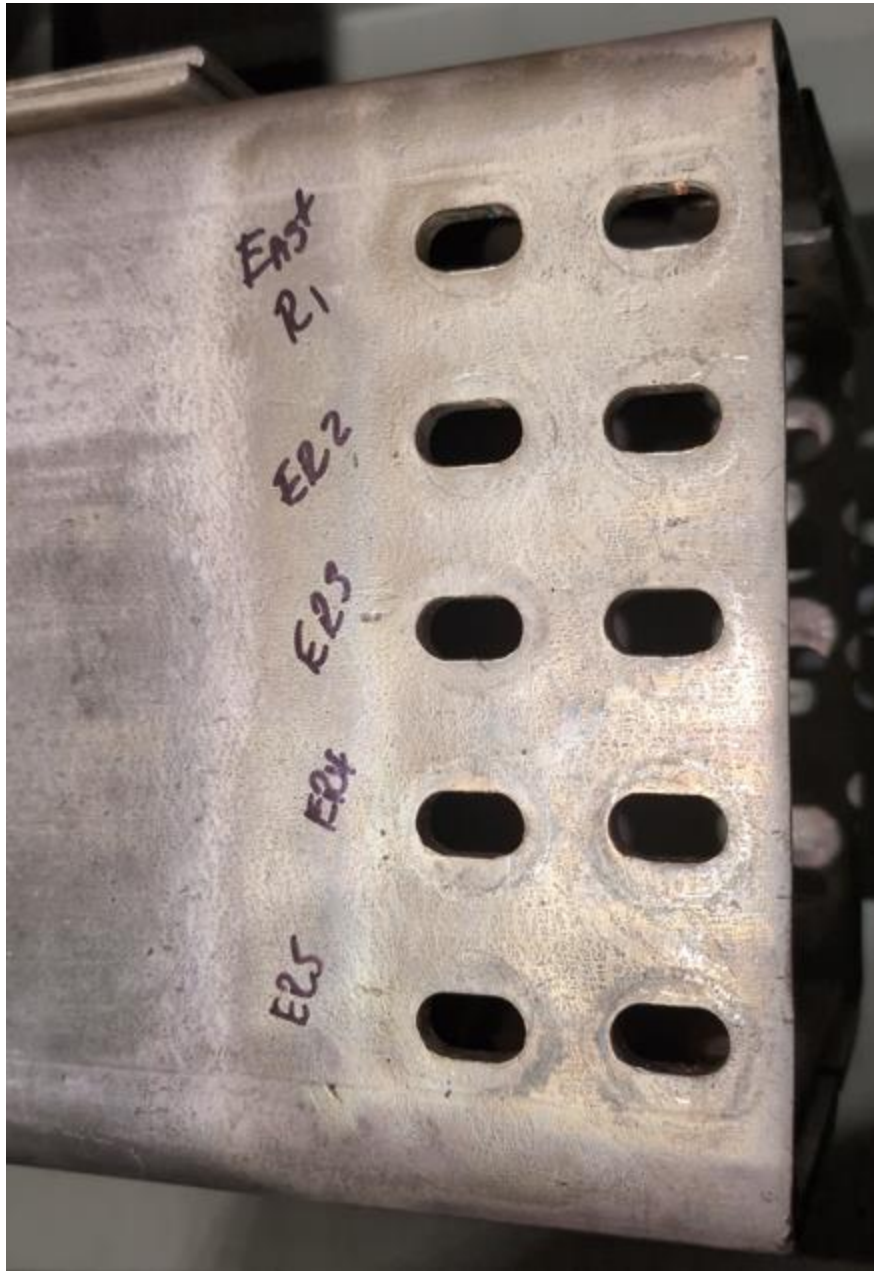
Neutral Bus Slotted Holes on Top, Bottom and both Sides.

5. 20 kV Connections – All electrical bolted connections in the bus duct are believed to be silver plated copper or copper clad silver plated aluminum. If damaged, it will be up the JEA PM to decide if the stab/connector is to be silver plated, or cut out and replaced with a new silver plated connector. All stainless steel conical washers and hardware to be replaced with 316 stainless steel. The drawings show mostly welded connections. The generator neutral and phase bushings need to be silver plated which is a total of **960** square inches.
