Northside Generating Station

**JEA NGS N03
Isolated Phase Bus
Cleaning Inspection and Repair Fall 2026**

Technical Specifications

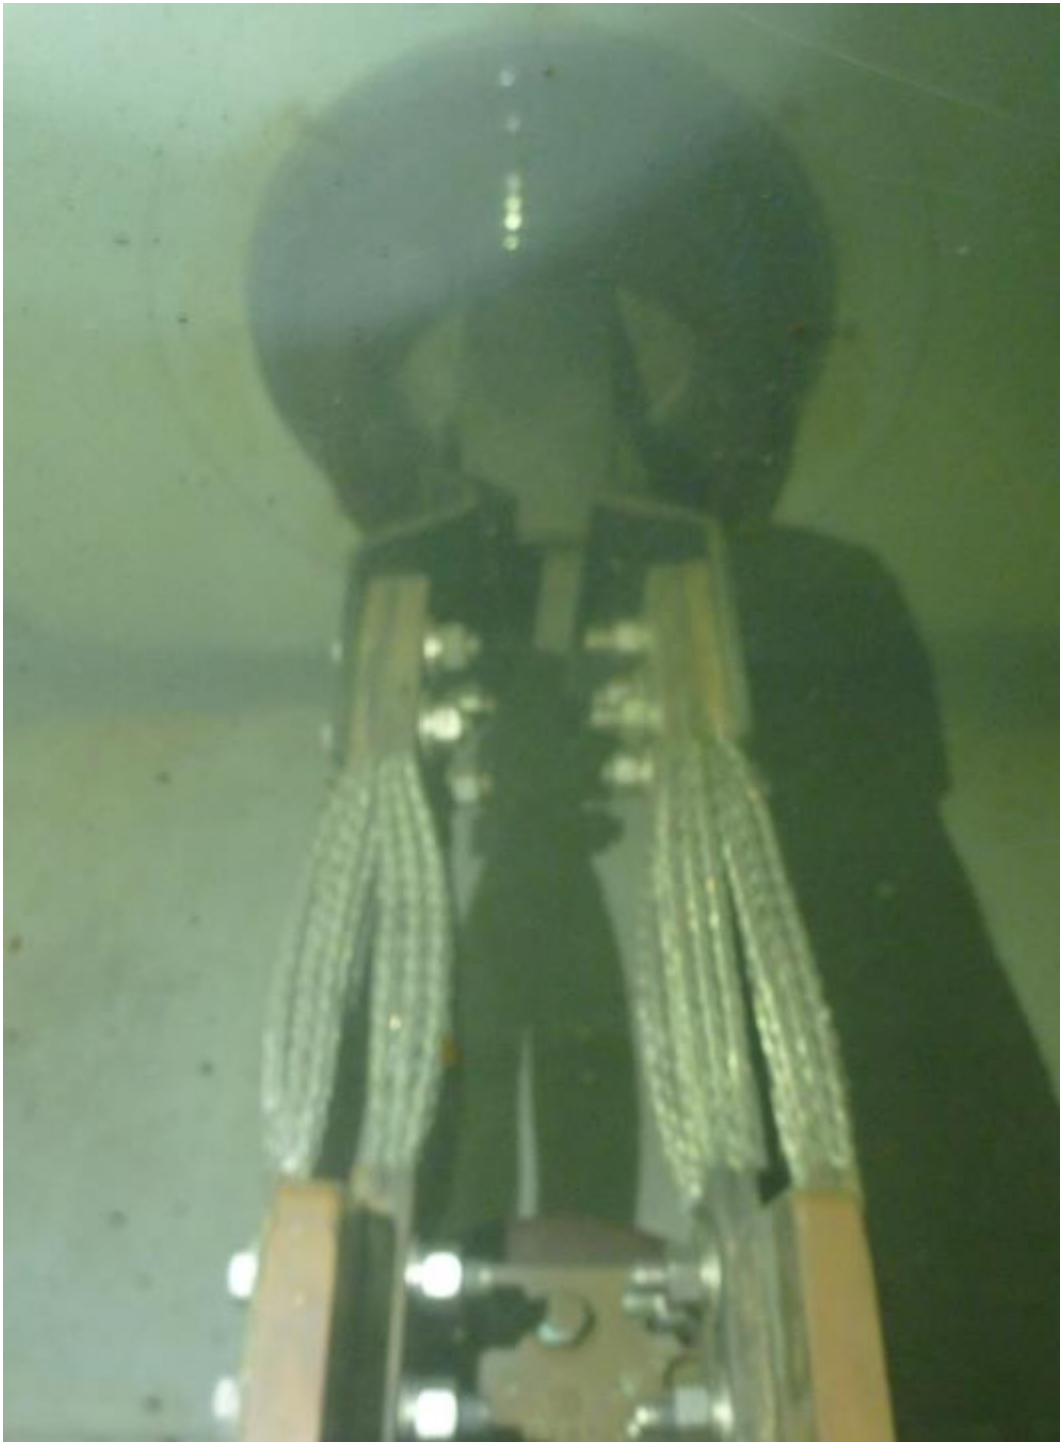
End near bushing.

An abandoned switch shall be removed and replaced with 6061 or equivalent Aluminum bar rated for a minimum of 2000A. This switch is located in the N03 switchgear room and is accessed from above very close to the ceiling which is roughly eighteen feet 18' above grade. Each phase is in a junction box which have Plexi-glass covers that can be removed to gain access.

New laminates will need to be manufactured in order to connect the existing four inch tubular bus bar to the new bar that is mounted on top of the existing B50 insulators.

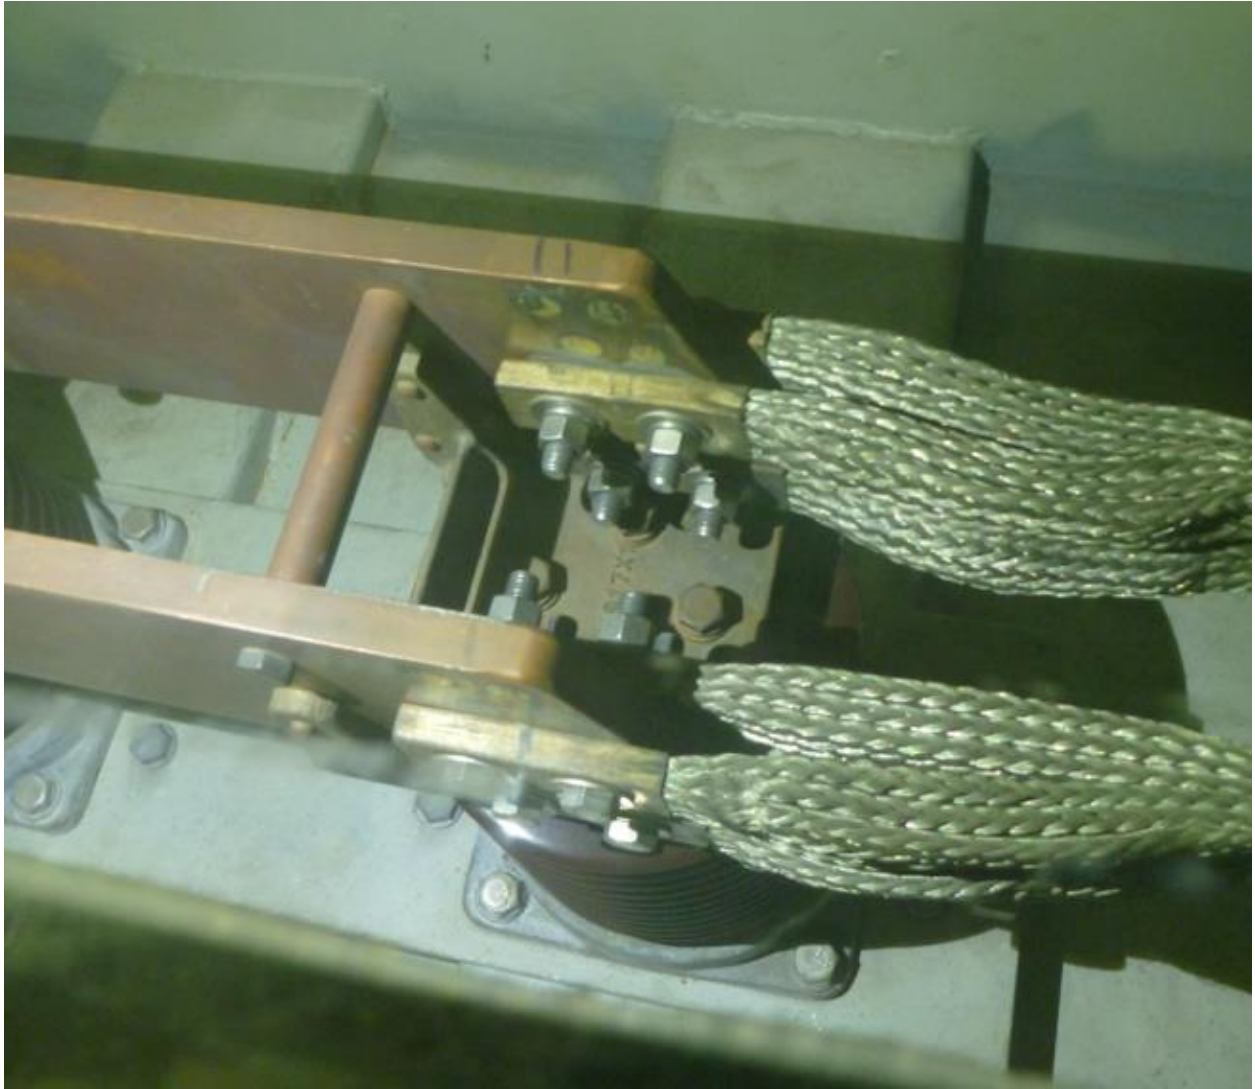
Middle of abandoned switch.

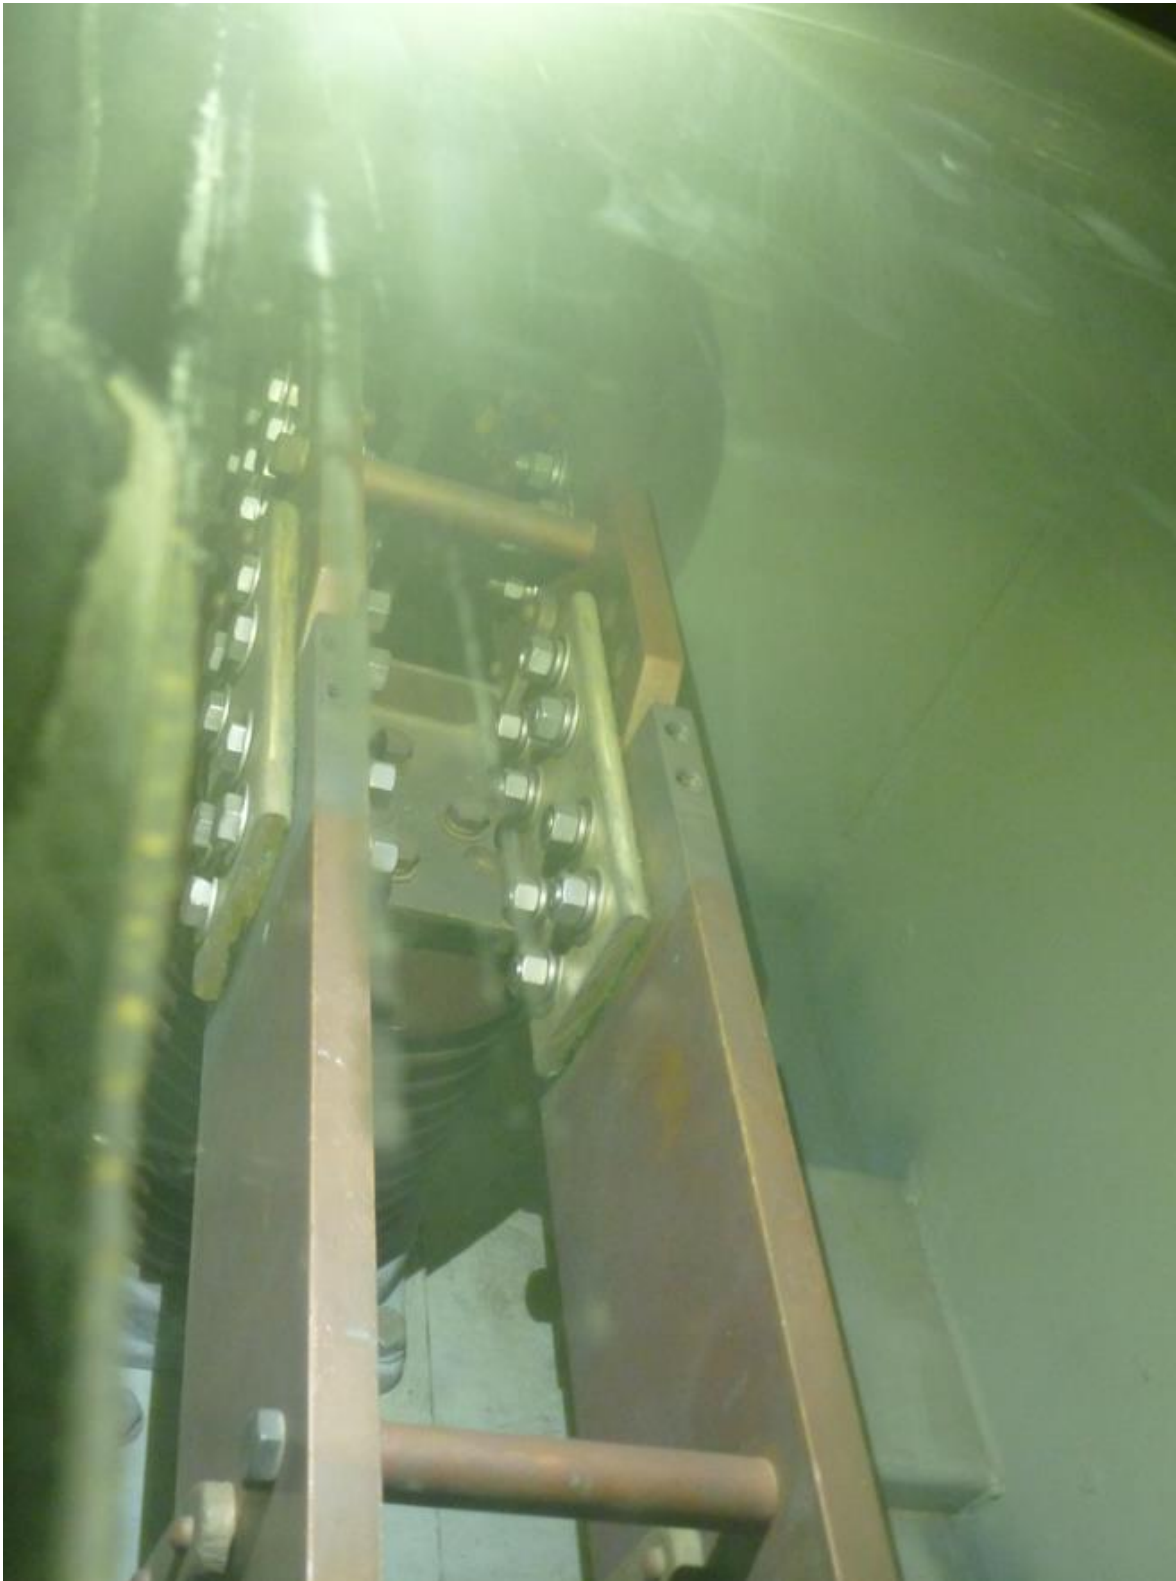
Modified to abandon switch.

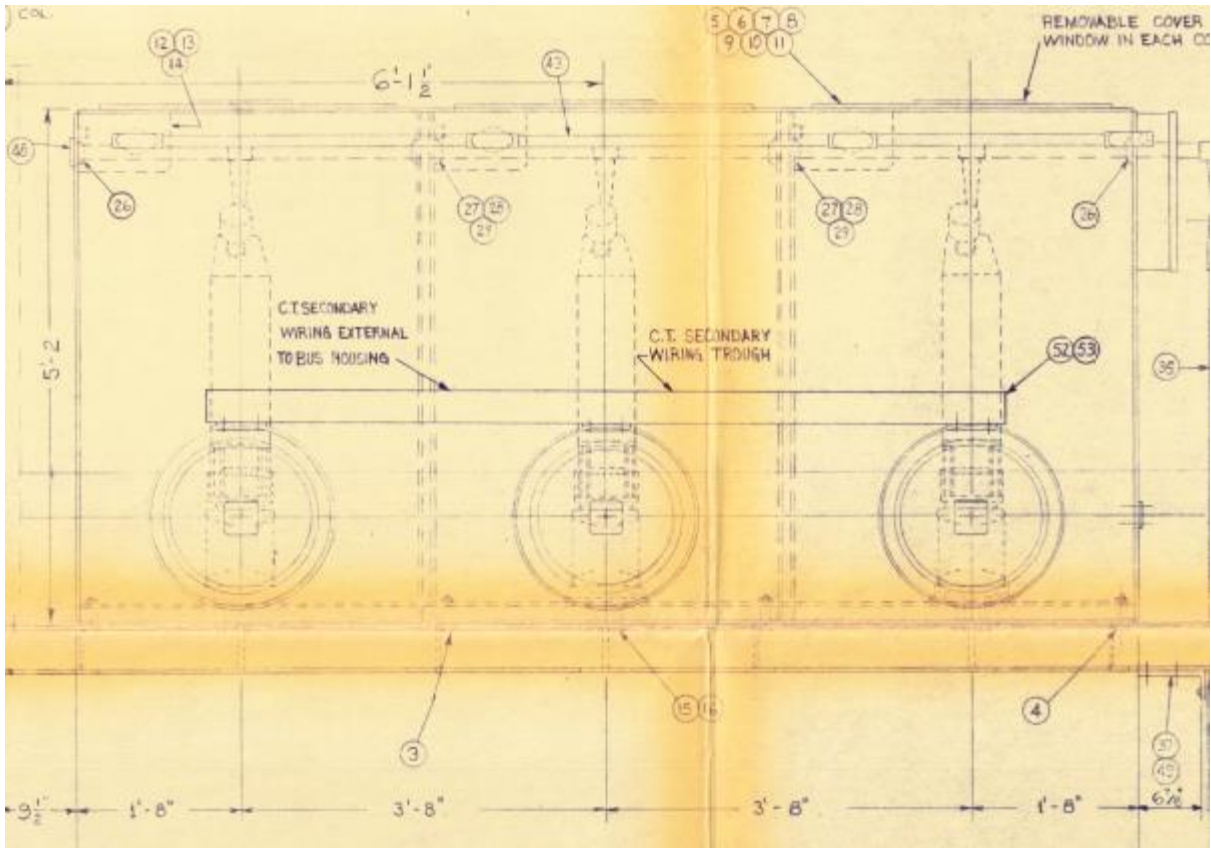
Grid 11 Abandoned Switch width and height.

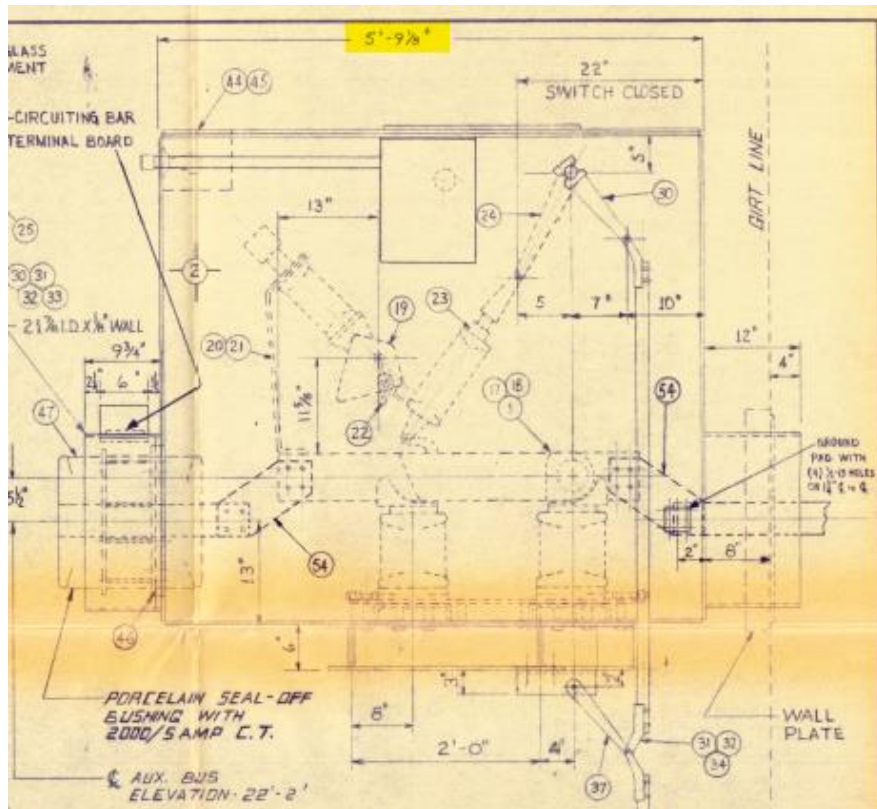
Abandoned Switch depth.

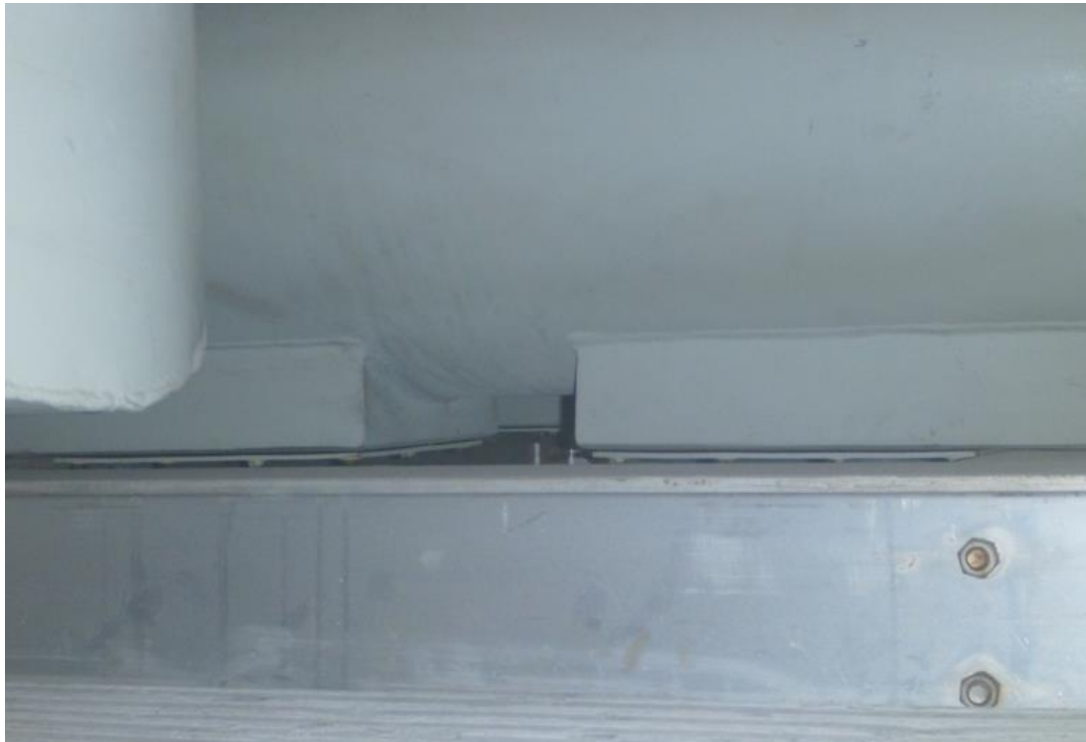
Five hard to access insulators.

Five (5) of the insulators located next to the abandoned switch in the switchgear room are extremely difficult to get to. The contractor shall cut open the enclosure and weld a new access port for each of these three insulators.

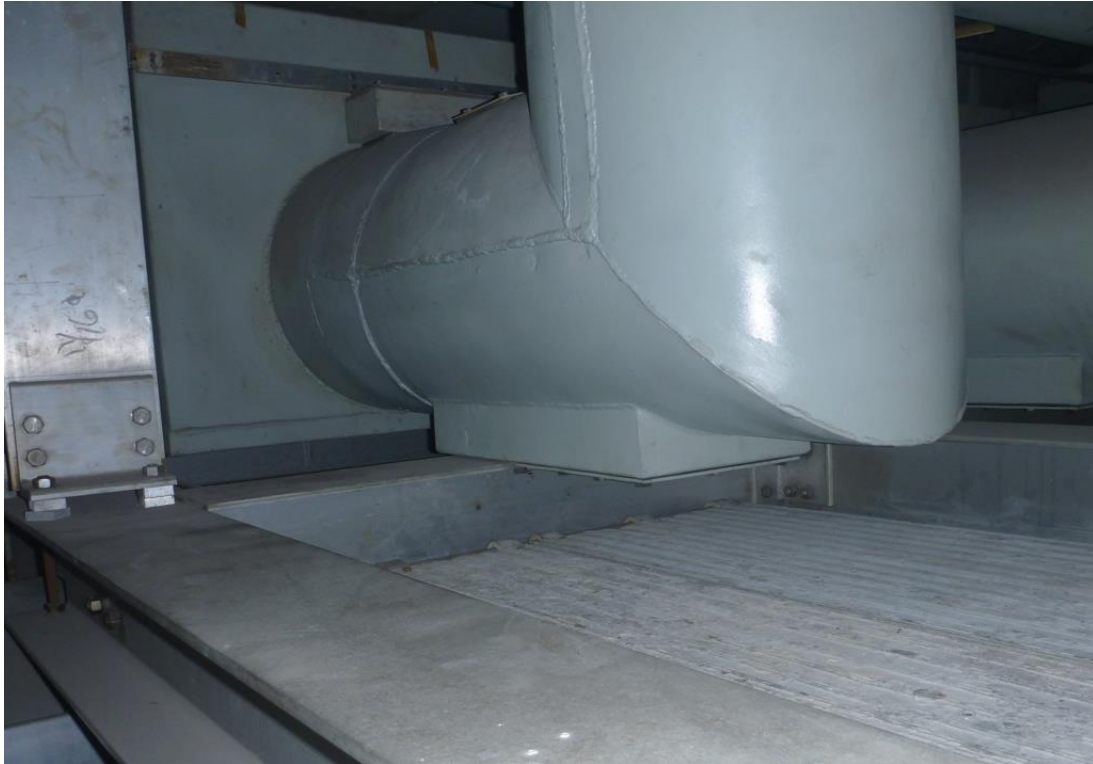
Five hard to access insulators.
