Monterey Wastewater Treatment Facility Improvements Project

Project Definition

PREPARED FOR: JEA

PREPARED BY: CONSTANTINE ENGINEERING, INC

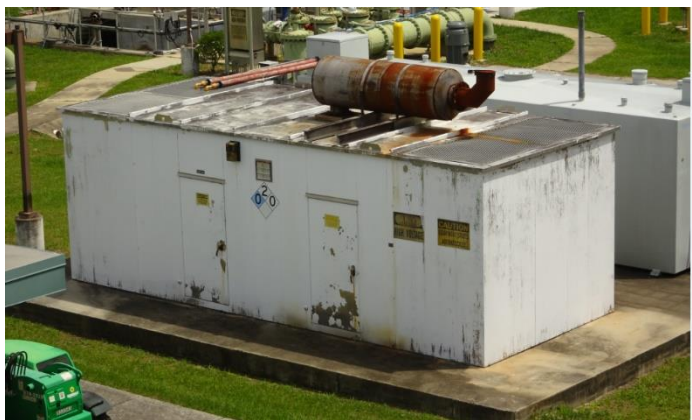
Generator

well. Due to the age of the generator, it is recommended that the generator be exercised regularly. Repainting the enclosure is recommended.

The generator is 23 years old and considered to be in “Fair” condition. Existing generators can be repaired instead of being replaced. However, the 3412-model generator is no longer in production so renovation may not be possible. Due to the age of the generator and the difficulties presented due to the unit being obsolete, replacement with a similar generator is recommended.

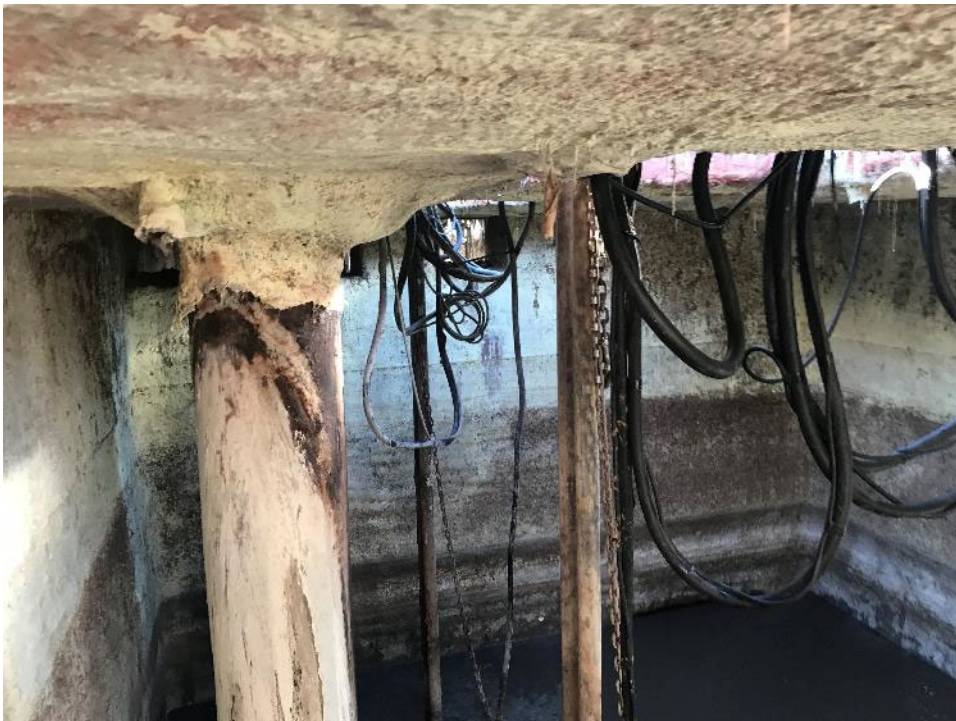
Photograph #2: View within pump station wet well.

1. Several areas of the wall below or at the normal waterline showed signs of concrete degradation along with exposed reinforcement which was visibly corroded. (See Photographs #1 & #2). The coating system in these areas was not intact and had been deteriorated.
2. The coating system throughout the structure was in poor condition and was either missing as indicated above or was delaminated.
3. Spalled concrete was visible at the beams and channel walls on either side of the screening channels (See Photographs #3 & #4).
4. Severe concrete degradation and spalling appeared to be located at the walls in the vicinity of the gate frames partitioning the wet wells (See Photograph #5).
5. The various miscellaneous metal components (grating, access hatches, etc.) appeared to be in good condition with no major signs of corrosion or inoperability.

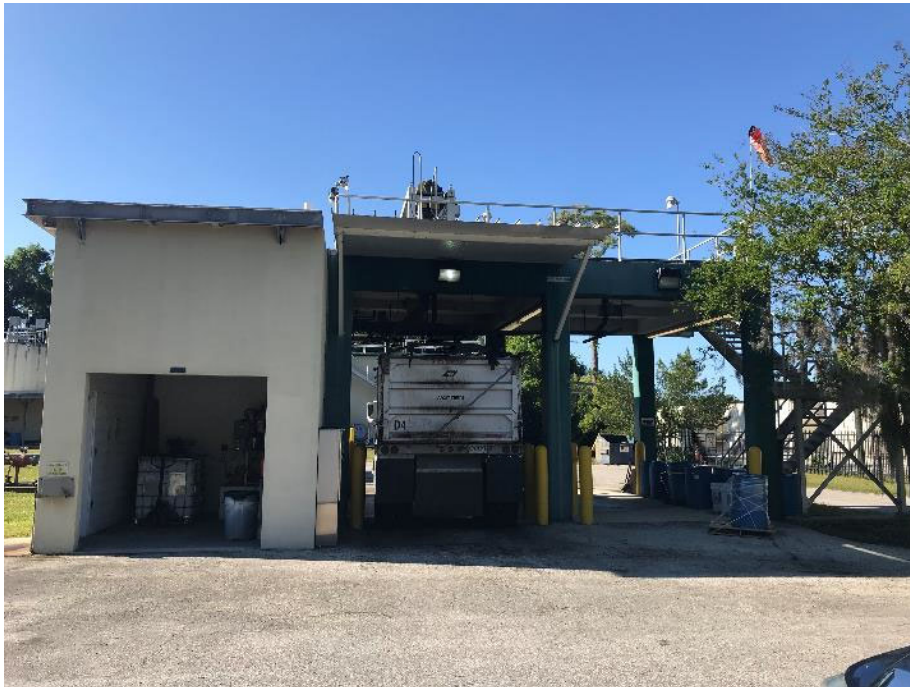
Photograph #6: Exterior view of Centrifuge Facility.

1. The aluminum awnings attached to the elevated platform should be removed. These items did not appear to be adequately designed to accommodate the design wind loads for this type of structure (See Photograph #6).

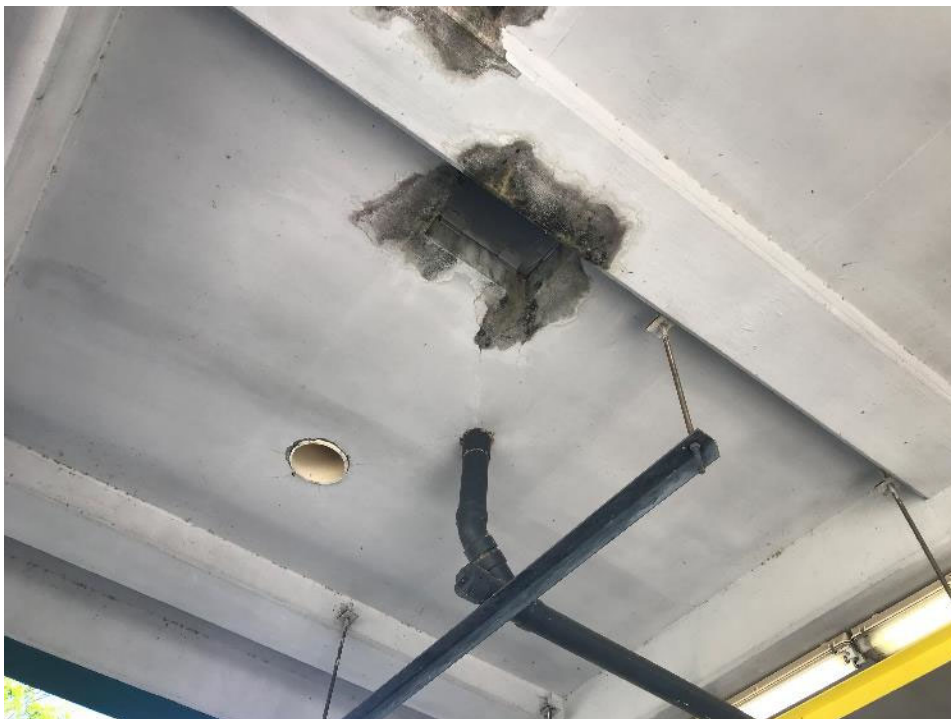
Photograph #8: View of elevated platform at Centrifuge Facility.

2. The exterior paint on the masonry building and elevated platform is chalky and stained.
3. Corrosion is visible at several areas of the metal roof deck and the screws attaching the deck to the roof framing. The roof framing itself appears to be in good condition although some minor corrosion is visible (See Photograph #7).
4. Staining of underside of the elevated platform was visible from below at several penetrations through the slab (See Photograph #8).
5. Minor cracking was visible on the top of the elevated platform slab. These cracks emanated from the various penetrations.

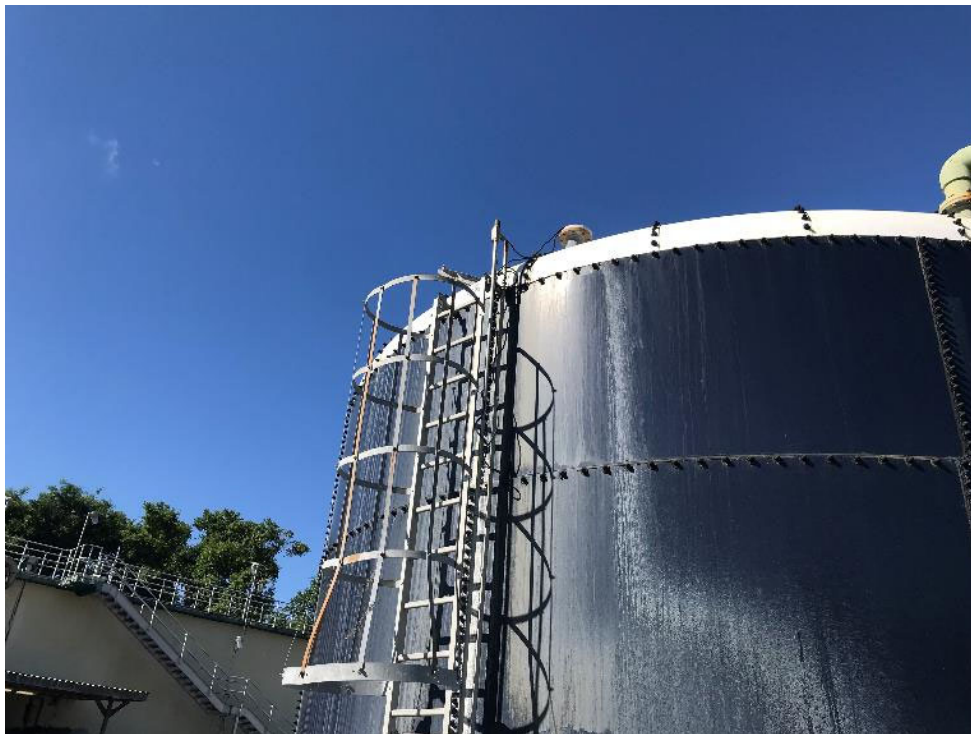
Photograph #9: View of exterior of Sludge Storage Tank.

1. Some corrosion and staining are visible at the various bolted connections (See Photograph #9).
2. The sealant at the bolted wall panel seams was cracked and failing in several places (See Photograph #10).

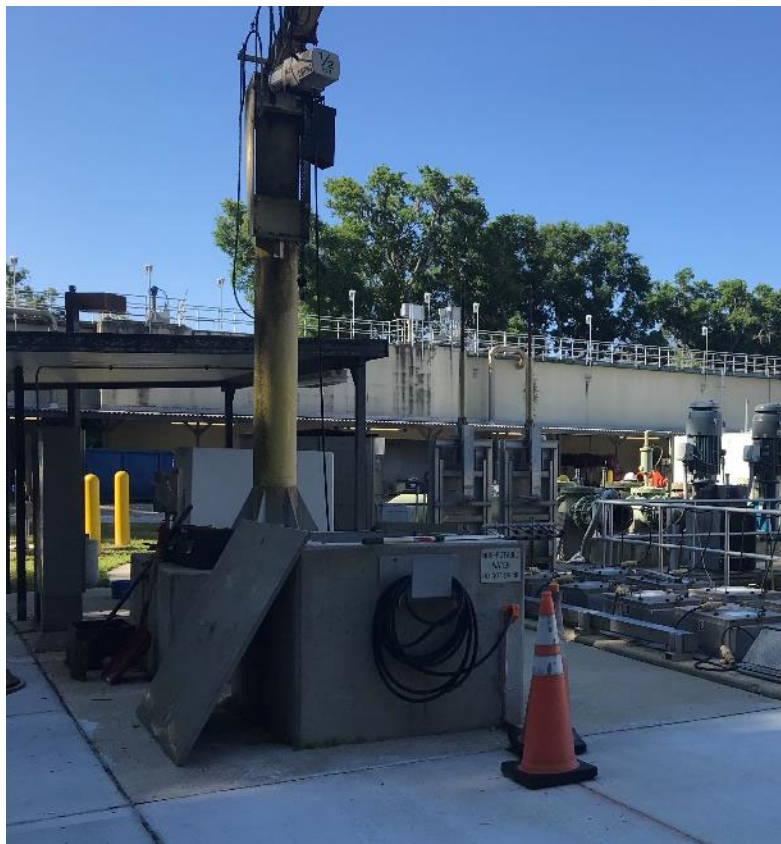
Photograph #22: View of davit crane at the UV Structure.

1. Some guardrail anchor bolts are corroded (See Photograph #19).
2. The pump base plate anchorage assembly was in poor condition. One pump was missing grout below the base plate and the anchors appeared to be too close the edge of the opening which has produced several cracks (See Photograph #20).
3. Multiple concrete pipe supports are cracked at the strap anchor locations (See Photograph #21).
4. The davit crane had visible corrosion at several areas. The hoist and trolley were in poor condition (See Photograph #22).

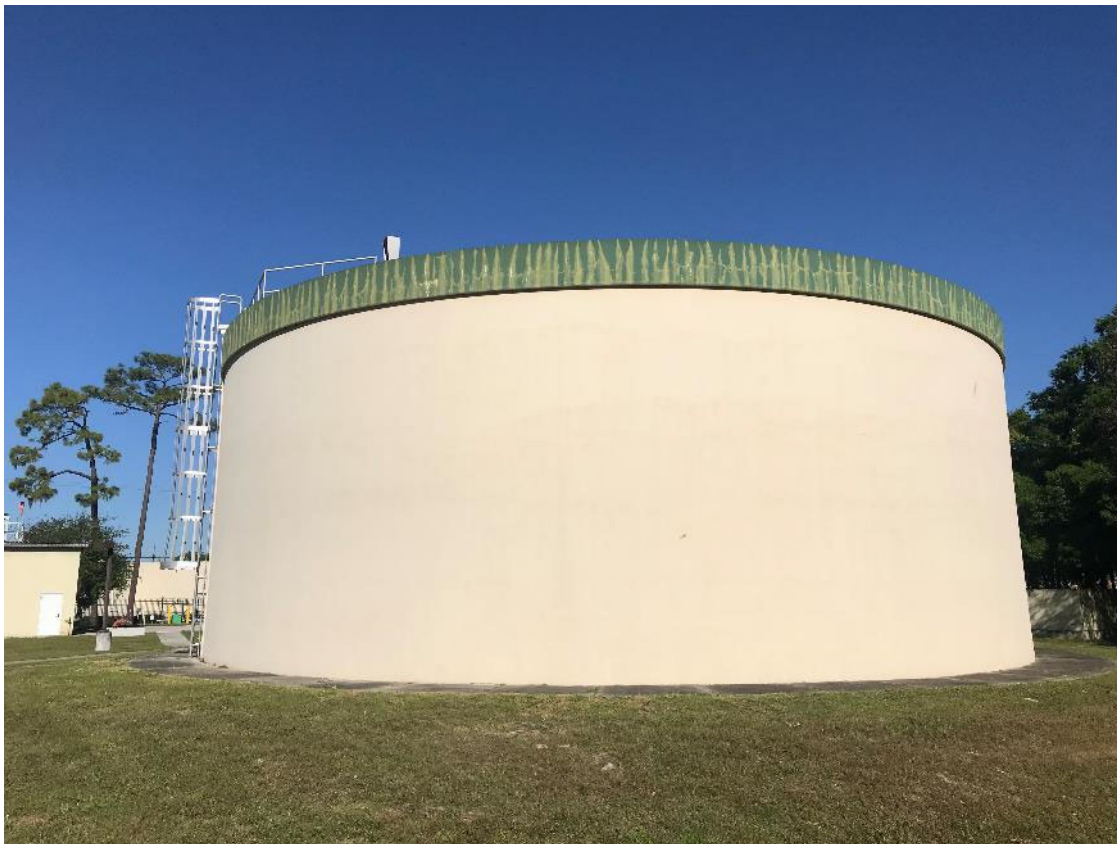
Photograph #23: View of Ground Storage Tank.

The structure is a prestressed concrete tank (See Photograph #23).

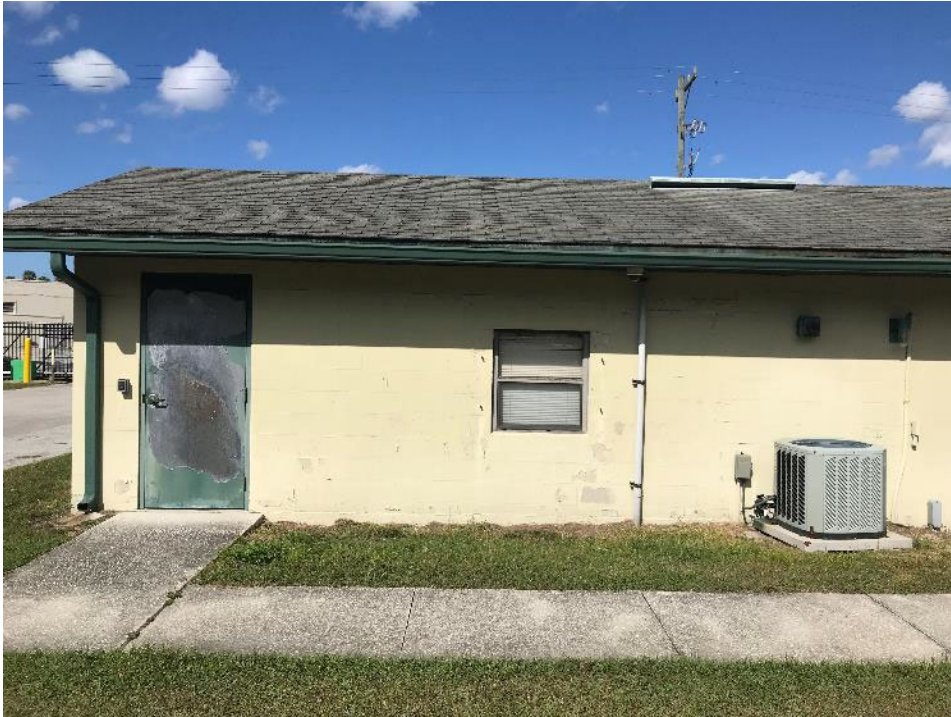
Photograph #29: View of exterior of Miscellaneous Storage Building.

1. The exterior paint system was chalky and in poor condition on the walls, exterior doors and the fascia (See Photograph #29 & #30).
2. The roof system appeared to be in fair condition although the drip edge was corroded and not properly fastened in some areas.
3. The overhead door was in poor condition.

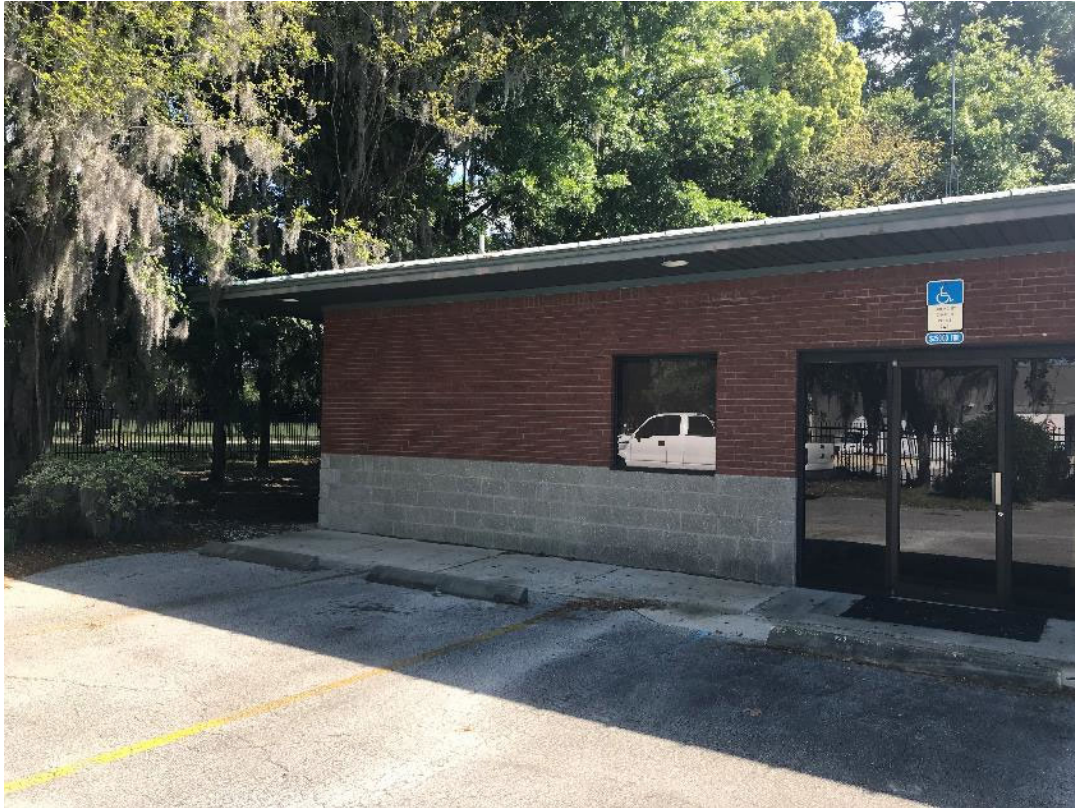
Photograph #31: View of exterior of Operations Building.

1. The structure was generally in very good condition (See Photograph #31).
2. The standing seam roof panels appeared to be in poor condition with signs of corrosion and paint loss.
3. The door and window sealant were cracked and losing adhesion in several areas.
