# Subsurface Utility Engineering Test Hole Report

Produced For: J. COLLINS ENGINEERING ASSOCIATES, LLC.

Project Name: JEA - JAMMES RD - WILSON BLVD. TO HARLOW BLVD. - WATER MAIN REPLACEMENT  
 Location: JAMMES RD @ GRAVES ST  
 Road Name: JAMMES RD Utility Owner: TECO  
 WO Number: W104320 Job Number: J062490 Task WO #: N/A City: JACKSONVILLE  
 Client Number: C08867 FPN #: N/A County: DUVAL  
 Station: Offset:  
 Collection Date: 9/30/2019 PM: RWG Ground Cover: ASPHALT Utility Chief: JUBA  
 Weather: CLEAR Soil Type: DIRT Utility Crew: JUBA  
 Time: N/A Soil Condition: HARD-WET Crew Number: 1

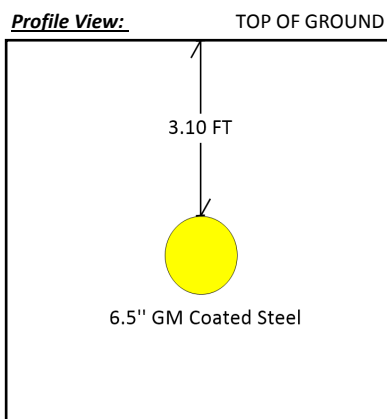
## Profile View:

Utility Type: GAS Utility Material: COATED STEEL Size (OD): 6.5 X 6.5  
 Utility Condition: GOOD Testhole Marker: NAIL AND DISK Height (in): 6.5 Width (in): 6.5  
 Top of Pipe: 3.1  
 Utility Note:

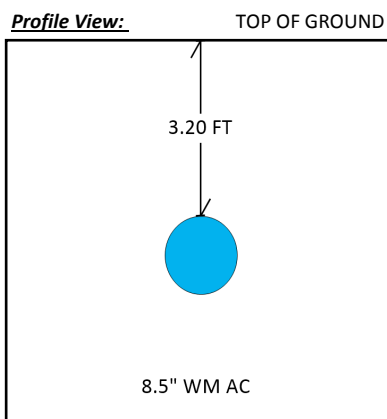
## Profile View:

Utility Type: WATER Utility Material: AC-ASBESTOS CONCRETE Size (OD): 8.5 X 8.5  
 Utility Condition: GOOD Testhole Marker: NAIL AND DISK Height (in): 8.5 Width (in): 8.5  
 Top of Pipe: 3.2  
 Utility Note:

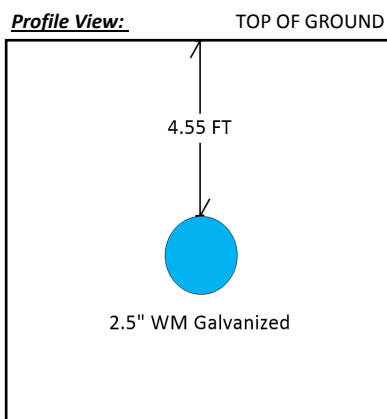
## Profile View:

Utility Type: WATER Utility Material: GALVINIZED Size (OD): 2.5 X 2.5  
 Utility Condition: FAIR Testhole Marker: NAIL AND DISK Height (in): 2.5 Width (in): 2.5  
 Top of Pipe: 4.55  
 Utility Note:

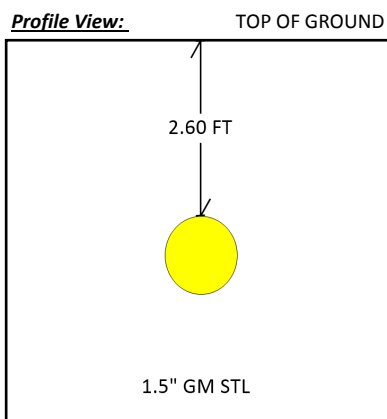
## Profile View:

Utility Type: GAS Utility Material: STEEL Size (OD): 1.5 X 1.5  
 Utility Condition: GOOD Testhole Marker: NAIL AND DISK Height (in): 1.5 Width (in): 1.5  
 Top of Pipe: 2.6  
 Utility Note: OWNERS MARKS SHOW 3/4 LINE. MOST LIKELY INTERIOR DIAMETER

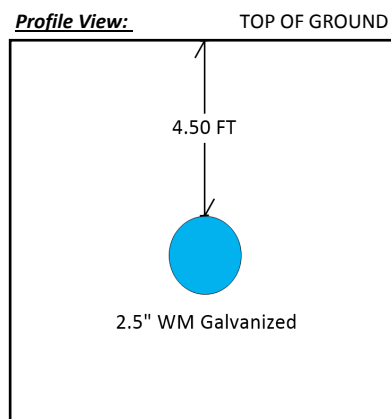
## Profile View:

Utility Type: WATER Utility Material: GALVINIZED Size (OD): 2.5 X 2.5  
Utility Condition: FAIR Testhole Marker: NAIL AND DISK Height (in): 2.5 Width (in): 2.5  
Top of Pipe: 4.5  
Utility Note:

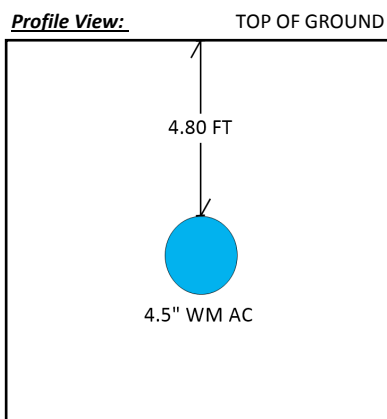
## Profile View:

Utility Type: WATER Utility Material: AC-ASBESTOS CONCRETE Size (OD): 4.5 X 4.5  
 Utility Condition: GOOD Testhole Marker: NAIL AND DISK Height (in): 4.5 Width (in): 4.5  
 Top of Pipe: 4.8  
 Utility Note:

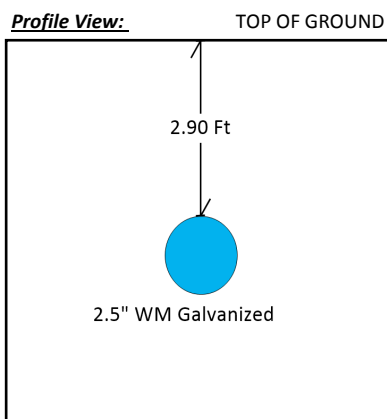
## Profile View:

Utility Type: WATER Utility Material: GALVINIZED Size (OD): 2.5 X 2.5  
 Utility Condition: FAIR Testhole Marker: NAIL AND DISK Height (in): 2.5 Width (in): 2.5  
 Top of Pipe: 2.9  
 Utility Note:

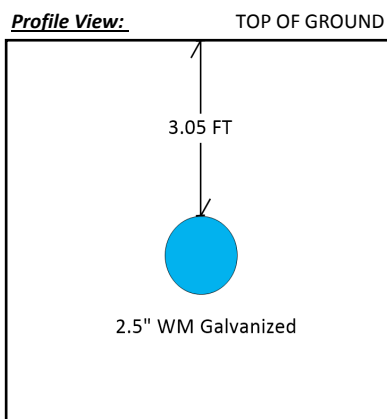
## Profile View:

Utility Type: WATER Utility Material: GALVINIZED Size (OD): 2.5 X 2.5

Utility Condition: POOR Testhole Marker: NAIL AND DISK Height (in): 2.5 Width (in): 2.5

Top of Pipe: 3.05

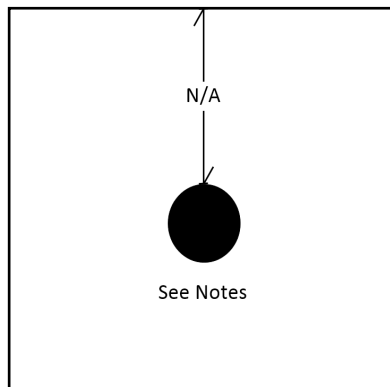
## Profile View:

Utility Type: SANITARY FM Utility Material: HDPE-HIGH DENSITY POLYETHYLENE Size (OD): 0 X 0  
 Utility Condition: OTHER Testhole Marker: NAIL AND DISK Height (in): 0 Width (in): 0  
 Top of Pipe: 0  
 Utility Note: COULD NOT MAKE CONTACT WITH UTILITY. TEST HOLE WAS FILLING UP WITH WATER, CAUSING POTENTIAL PATCH ISSUES. LANCED TO 10FT. EQUIPMENT SHOWS LINE IS 12FT+.

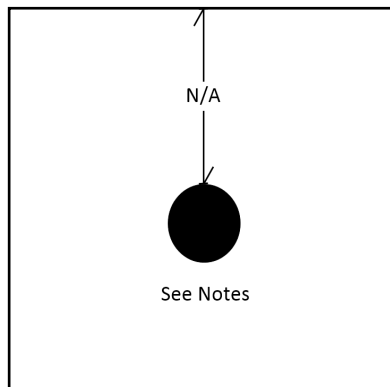
## Profile View:

Utility Type: SANITARY FM Utility Material: HDPE-HIGH DENSITY POLYETHYLENE Size (OD): 0 X 0  
 Utility Condition: OTHER Testhole Marker: NAIL AND DISK Height (in): 0 Width (in): 0  
 Top of Pipe: 0  
 Utility Note: COULD NOT LOCATE UTILITY DUE TO HARD PAN BEING INPENETRABLE AT 8FT. EQUIPMENT IS SHOWING PIPE AT 11FT+
