# Intracoastal Builders Corporation

## BUILDING INSPECTION REPORT

FOR THE PROPERTY AT  
**10855 New Berlin Rd, Jacksonville, FL 32226**

**April 16, 2020**

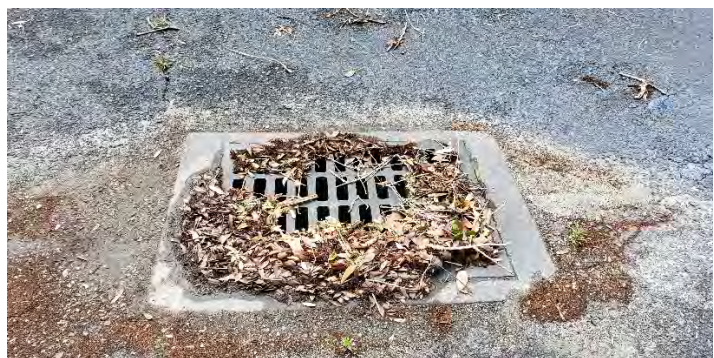
1 B

22.	Exterior	19B	Mitered Endwall Structure is overgrown
23.	Exterior	1A / 1B	Asphalt paving has cracking throughout
24.	Exterior	1C	Debris has accumulated over inlets and drainage areas

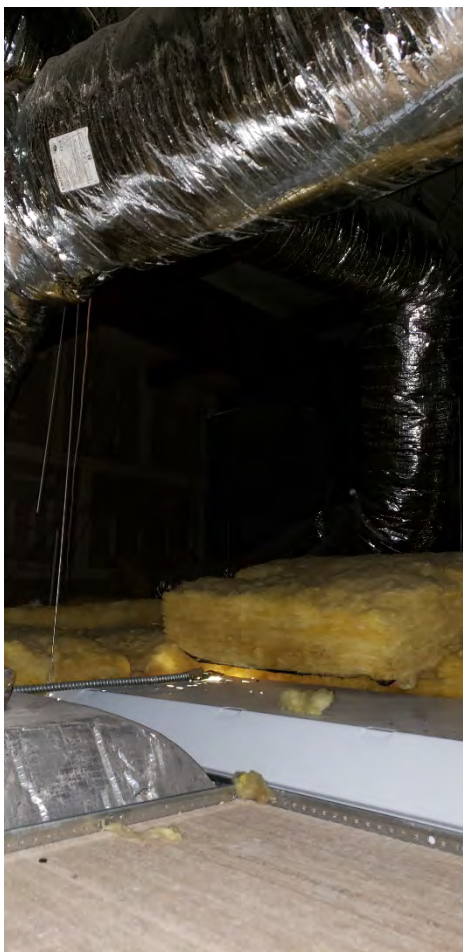
1 D

32.	Office	1D / 2A 2B	Insulation over the ceiling has been removed and or is out of place in several areas
33.	Office	2C	Caulk is missing at wall/window frame juncture

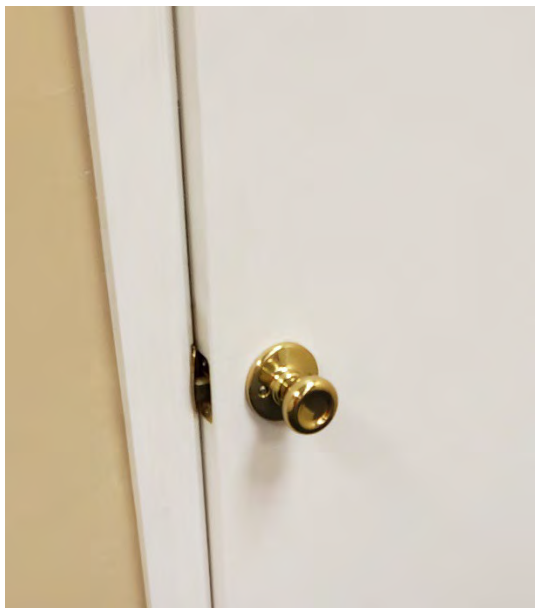
2 D

34.	Office	2D	Ceiling grid is sagging at lobby area
35.	Office	3A	Interior door hardware is not ADA compliant
36.	Office	3B / 3C	The east exterior block wall shows some signs of possible moisture wicking and/or moisture intrusion including some staining of the ceiling tile in Sales Office

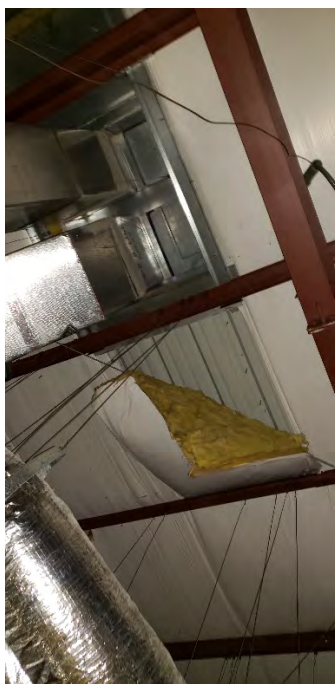
3 D

37.	Office	3D / 4A	Insulation at the roof level has come loose in several locations
38.	Office	4D	Several ceiling tiles have been replaced and do not match the original tiles throughout the office area

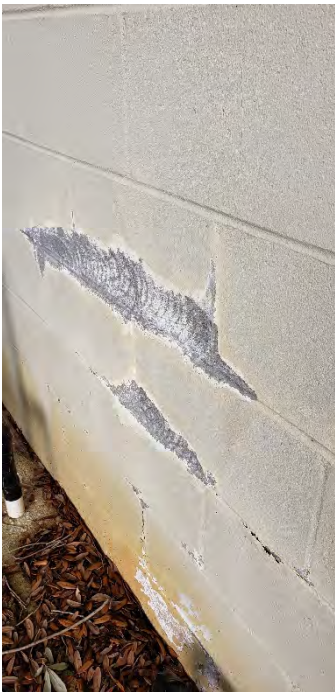
9 B

25.	Exterior	4B / 4C	The lids to the septic tank are covered by several feet of dirt
26.	Exterior	9B / 9C	The east exterior block wall paint is failing which may be a contributory factor to the moisture wicking mentioned in other comments

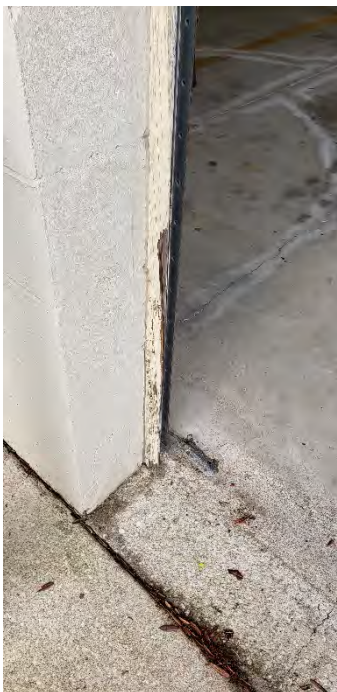
9 D

27.	Exterior	9D	The door and frame adjacent to the well equipment in the Warehouse are rusting. In addition, the door will not open.
28.	Office	13B	There is visible staining under the sink of the secondary bathroom

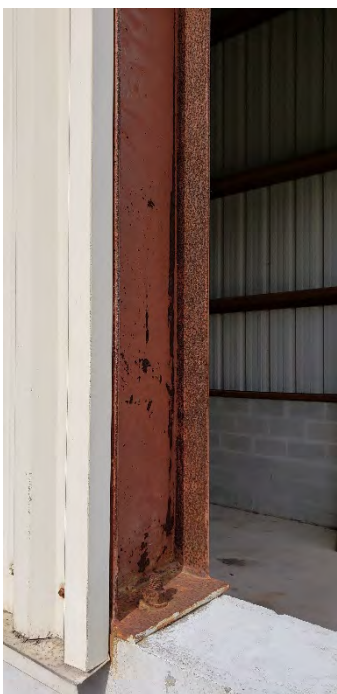
10 B

4.	Exterior	10B	Exterior screw heads are rusted - <i>See J.C. Harward &amp; Associates report for additional details.</i>
5.	Exterior	11B	Stucco has been damaged on the northwest exterior corner of the office

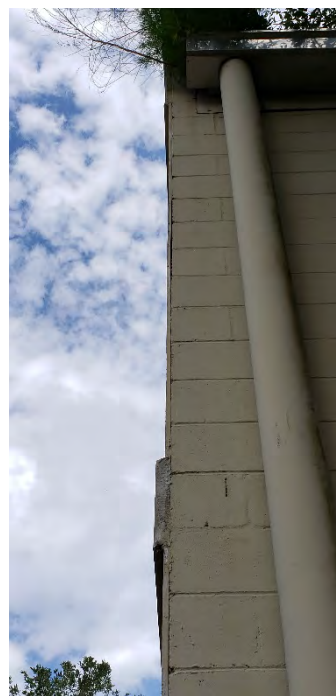
11 C

6.	Exterior	11C	The stucco has cracked under several of the office exterior windows
7.	Exterior	12A	The concrete blocks under a window on the east exterior wall have cracked below the window

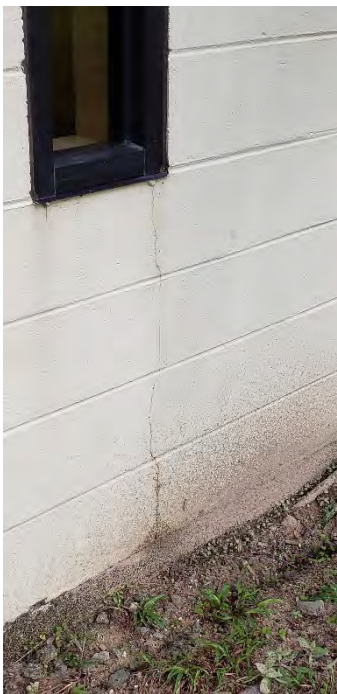
11 D

8.	Exterior	11D	The stucco on the south exterior office wall is not sealed to the east exterior block wall
9.	Exterior	12D / 13A	Asphalt has been damaged by equipment or structures on the northeast corner of the yard lot.
