## **Geotechnical Exploration and Evaluation Report**

### **JEA Bernita Street Force Main Replacement Jacksonville, Florida**

**CSI Geo Project No.: 71-18-329-05  
Client Project No.: 95205-438-17  
Contract No.: JEA #153003**

**March 22, 2018**

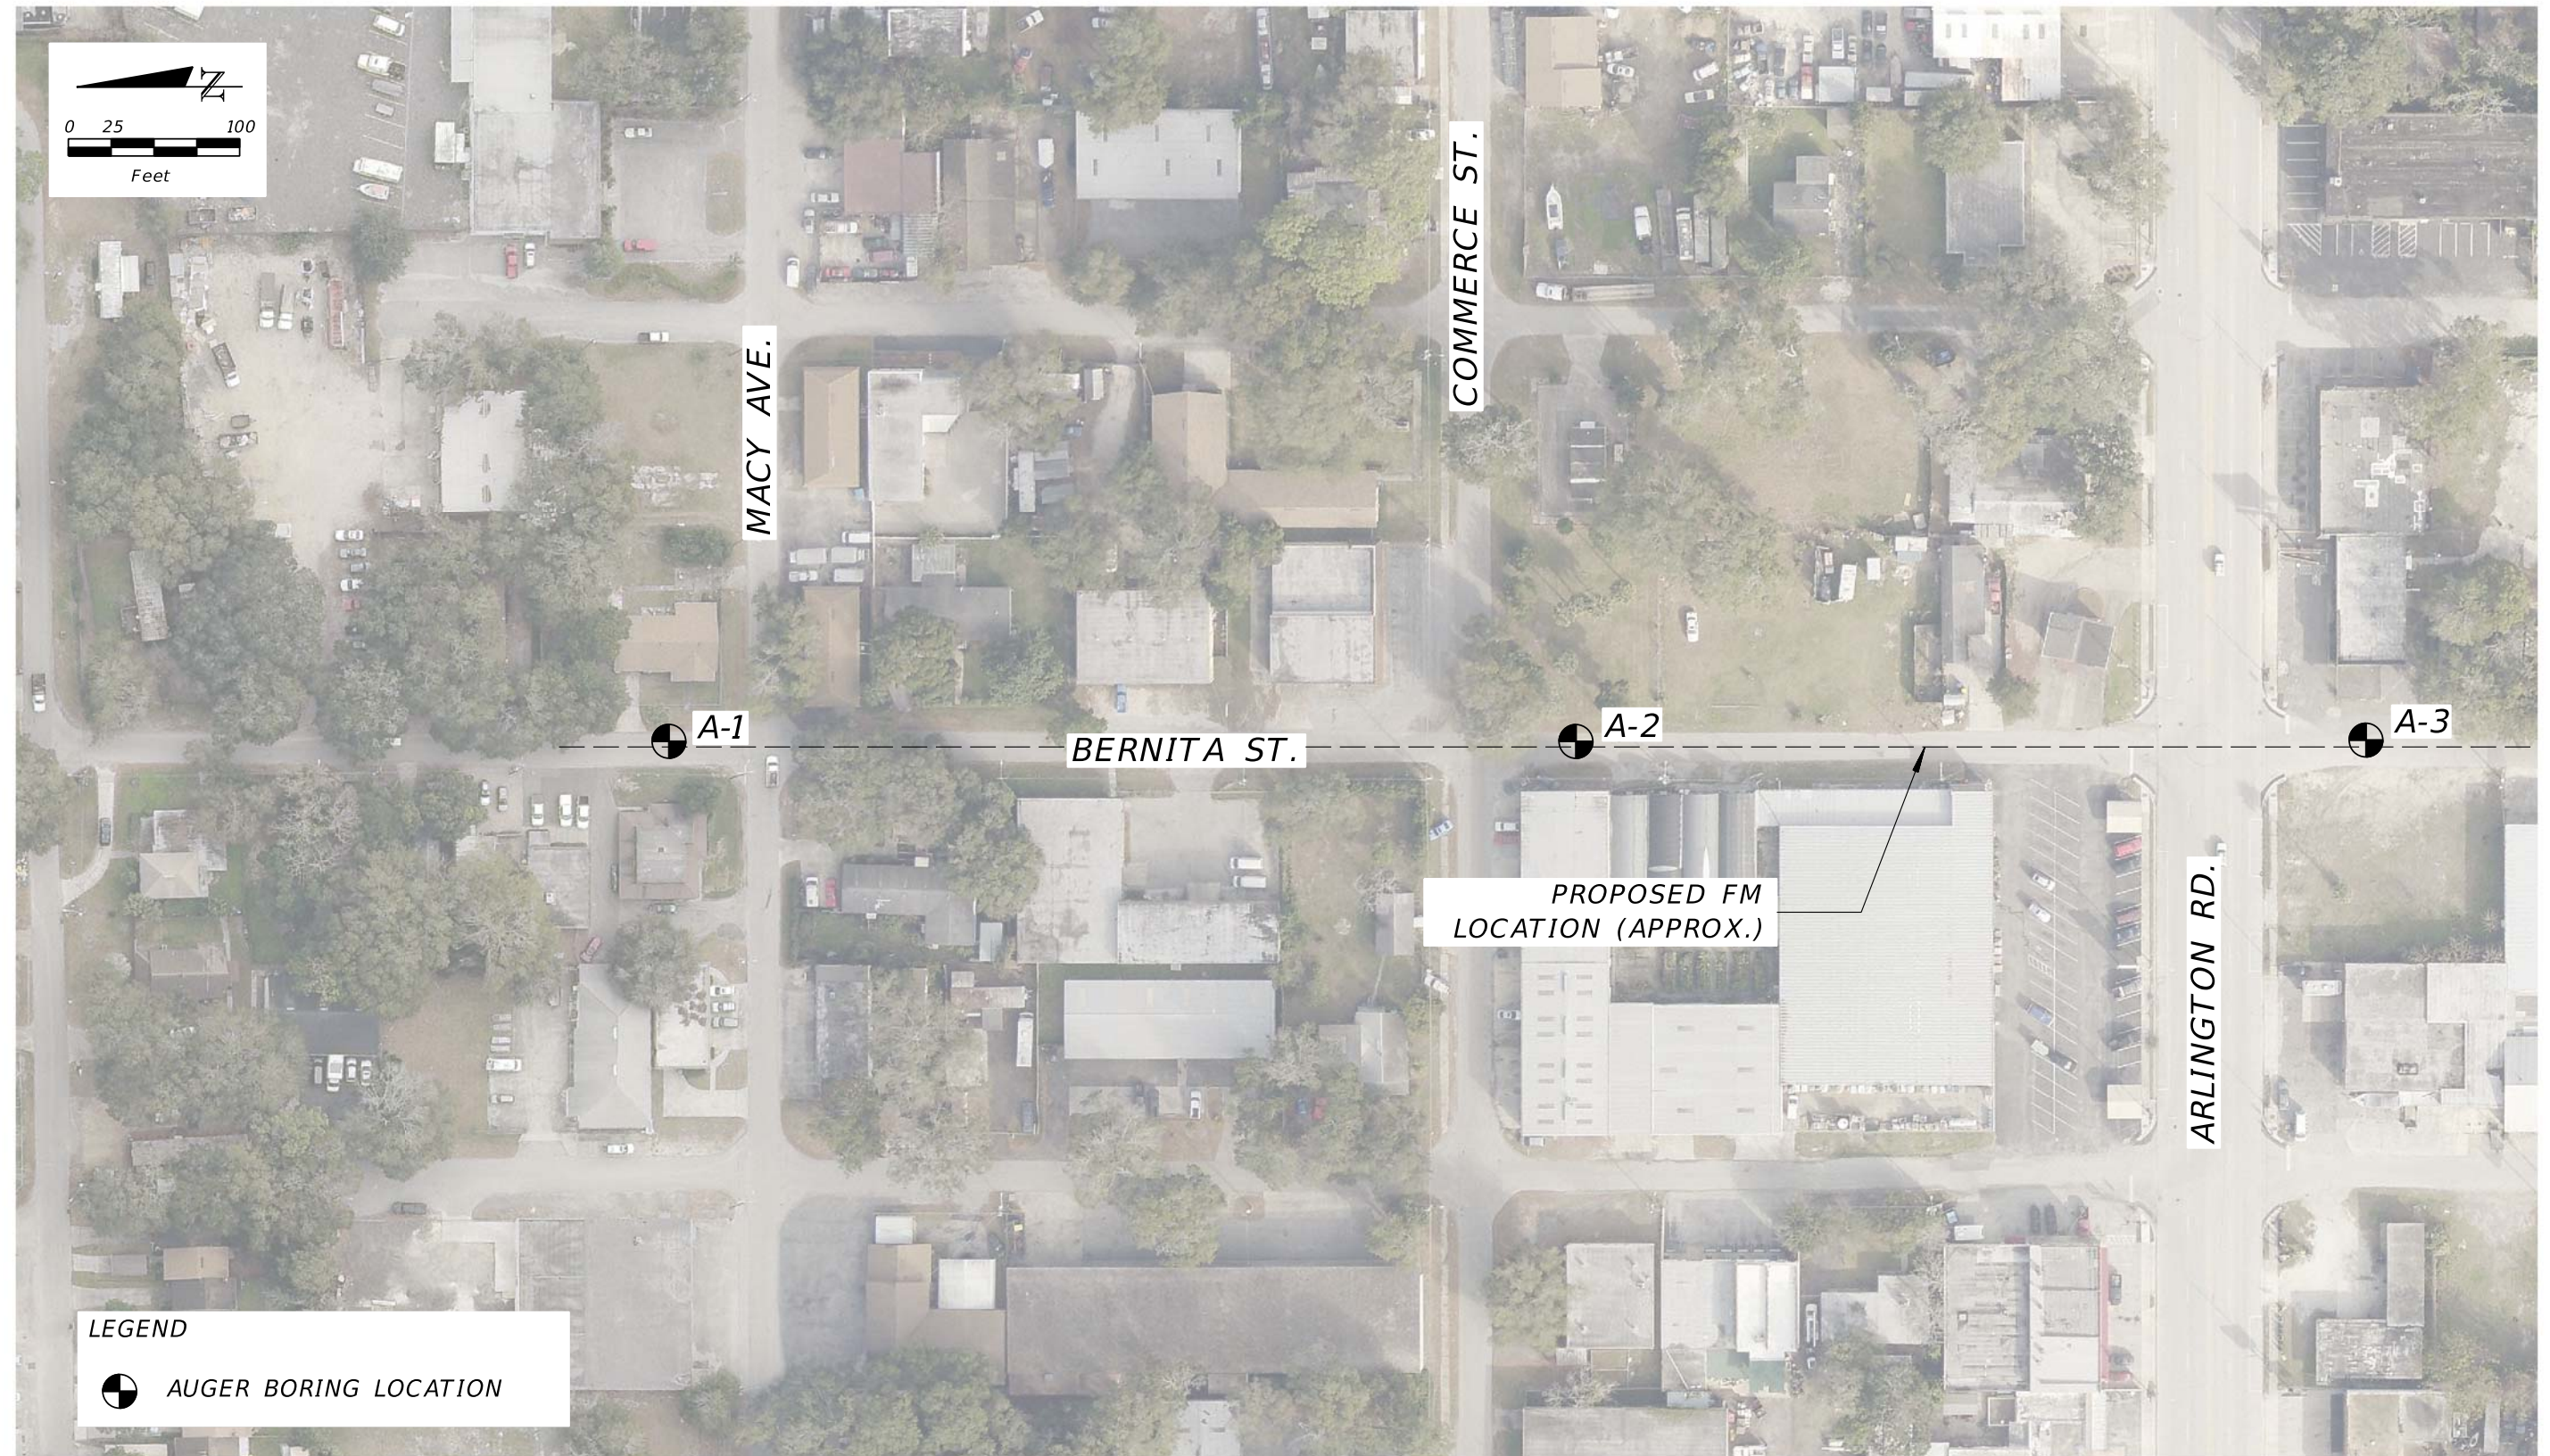
# **Field Exploration Plan**

FIELD EXPLORATION PLAN  
 JEA BERNITA STREET FORCE MAIN REPLACEMENT  
 JACKSONVILLE, FLORIDA
