GE 7B Combustion Turbine parts Refurbishment

Technical Specification Northside Generating Station GE 7B Combustion Turbine parts Refurbishment

A solicitation of inspection and repair/ refurbishment, on selected sets of current inventory in various forms of needed repair. JEA NGS reserves the right to award all or part of the following work under this solicitation.

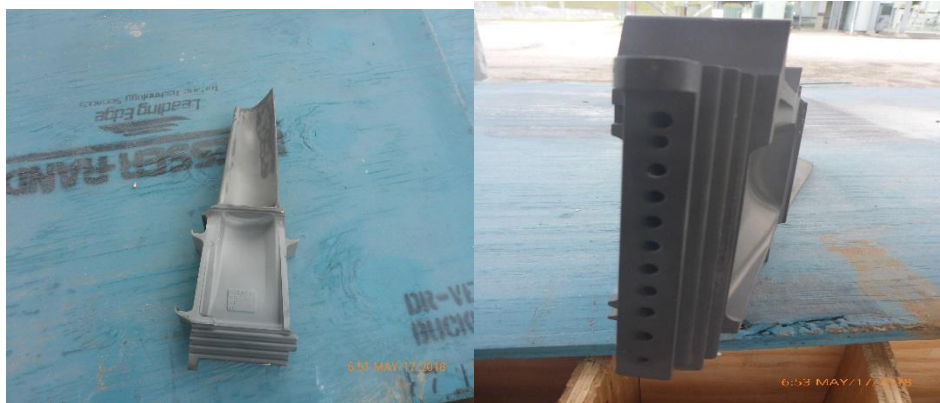
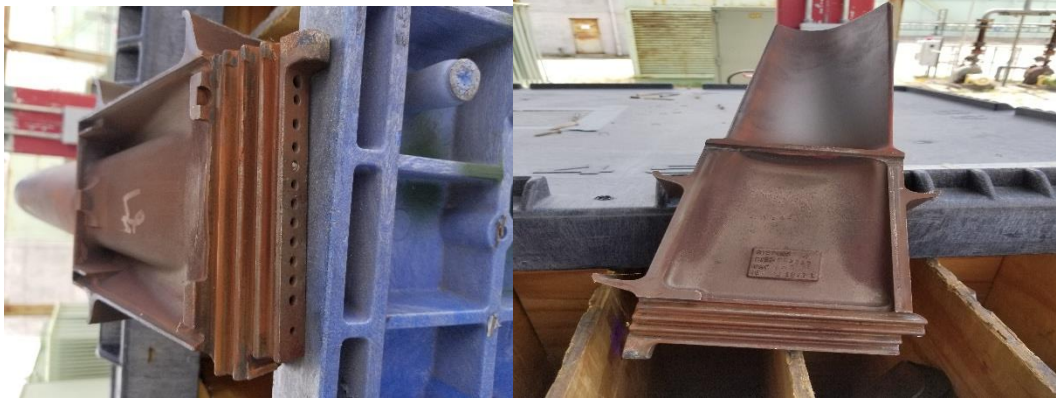
- **F7B 1st Stage Buckets = 2 sets, A Final full set, 92 pieces (PN#932E103P2H1 as on each Bucket)**

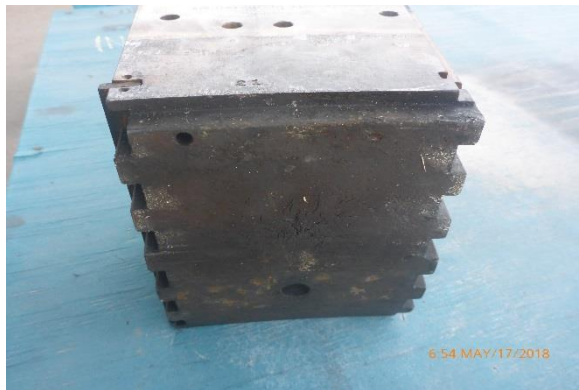
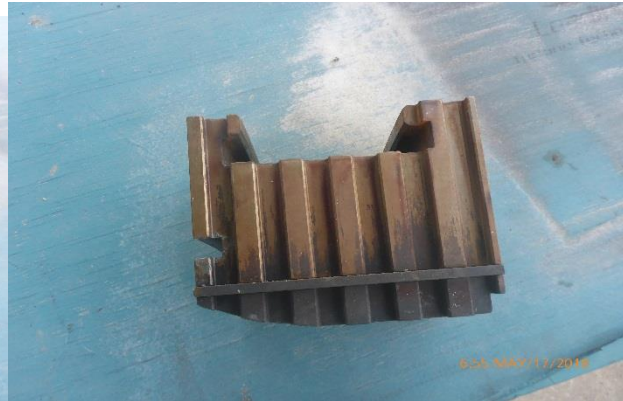
- **1st Stage Shroud Blocks = 2 sets, A Final full set (48pcs), The PN# 118D6432P005, OEM, Coated w/hardware**

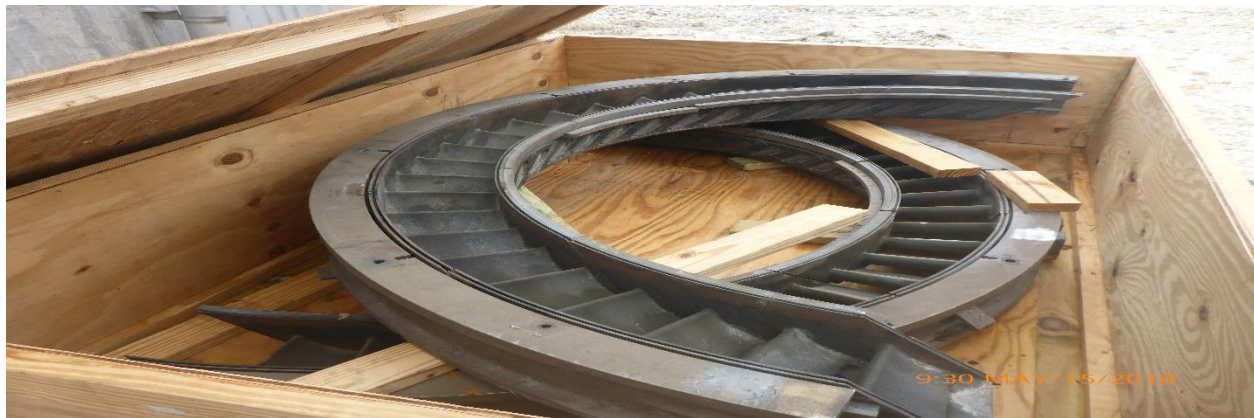
- **F7B 1st Stage Nozzle 2 sets, A Final full set**

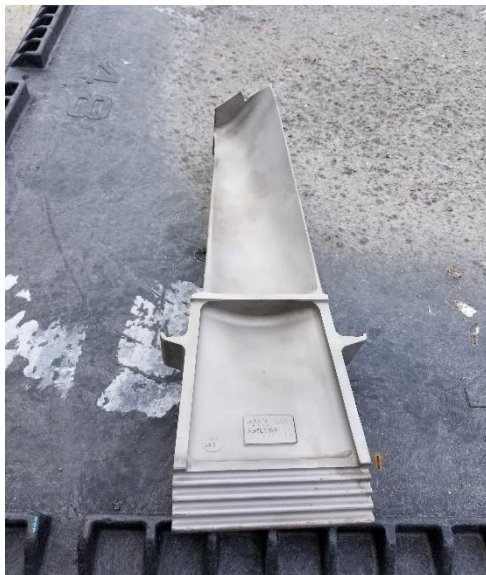
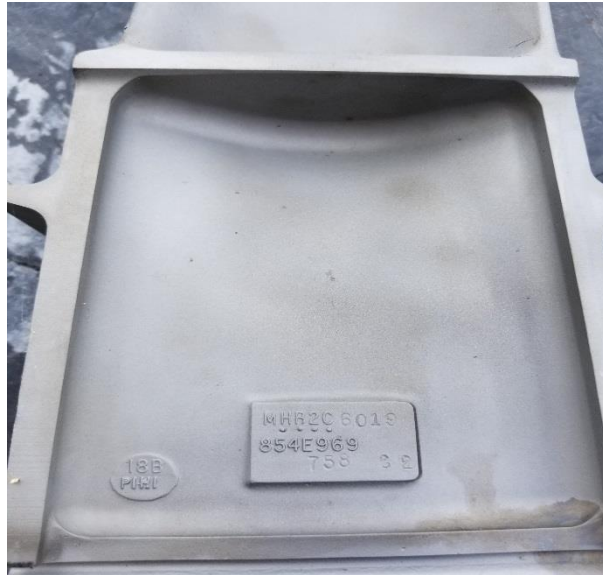
- **2nd Stage Buckets, 1 full set, A Final full set, Inspection Workscope**

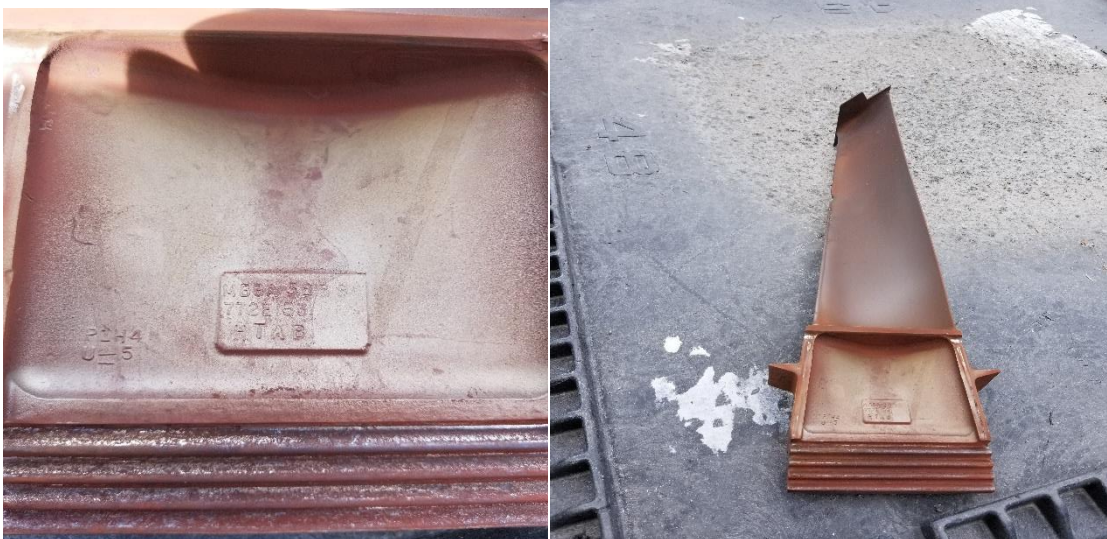
- **3rd Stage Buckets, A full set, A Final full set, Inspection Workscope**

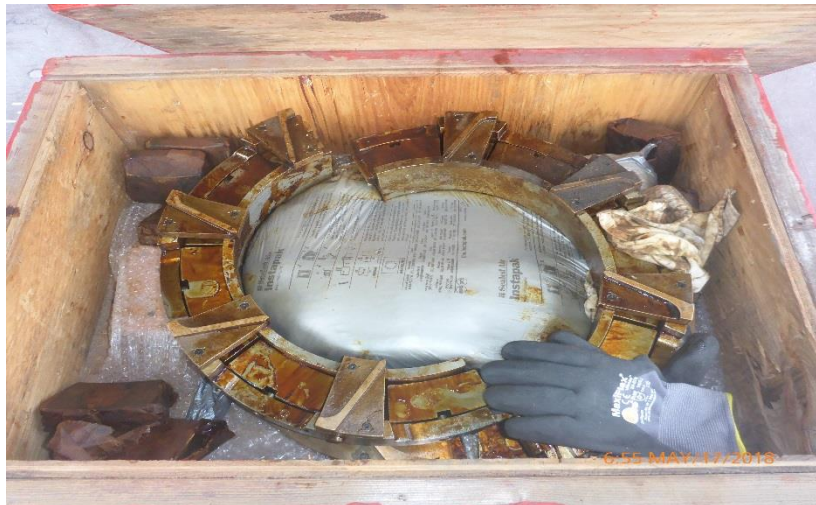
- **Thrust Bearing (226A1151P001)**

The active/inactive tilt pad thrust bearing is a clean verify all is there and NDE all parts to make ready for installation. This has been on the shelf for (who knows)?, or if it is all there.
