043-18 APPENDIX TECHNICAL SPECIFICATIONS

UNIT 1 & UNIT 3 – ISOLATED PHASE BUS CLEANING AT BRANDY BRANCH GENERATING STATION (BBGS)

043-19 Brandy Branch Generating Station Unit 1 and 3 Isolated Phase Bus Cryogenic Clean and Inspection

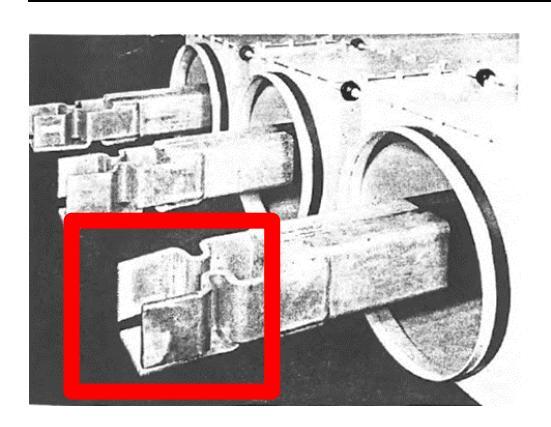
Figure 1 - Plating of Conductor Stab

Base silver plating cost on up to 100 square inches each. This is an approximate surface area to silver plate one end of one conductor/stab. Pricing includes all labor, materials and equipment to remove, plate and reinstall.

- 7. 18 kV Connections All 18 kV electrical bolted connections in the iso-phase bus duct are believed to be silver plated copper or copper clad silver plated aluminum. If damaged, it will be up the JEA Project Manager to decide if the stab/connector is to be repaired (re-silver plated) or cut out and replaced with a new silver plated connector. All stainless steel conical washers to be replaced with 316 stainless steel. (contractor supplied)
