# DEGROVE SURVEYORS, INC.

## VACUUM TEST HOLE REPORT

PROJECT NAME: <u>GATE PARKWAY</u>	TEST HOLE #: <u>1</u>
DATE: <u>08.23.19</u>	DSI PROJECT #: <u>2019.111</u>
CLIENT: <u>JEA</u>	CREW: <u>BS, DK, AN</u>
EXPECTED UTILITY: GAS STORM SAN COMM UNK FM CATV H2O TEL <u>ELEC</u> IRRIGATION REUSE	SURFACE TYPE: <u>ASPHALT</u> CONCRETE ASPHALT OVER CONCRETE BRICKS SIDEWALK DIRT/GRASS N/A
UTILITY FOUND: GAS STORM SAN COMM UNK FM CATV H2O TEL <u>ELEC</u> IRRIGATION RW	PAVEMENT CONDITION: <u>GOOD</u> FAIR POOR N/A
MATERIAL: DIP C/I STEEL CABLE PLASTIC VCP CLAY RCP CMP <u>PVC</u> HDPE PE UNK	SOIL CONDITION: HARD <u>SOFT</u> WET MOIST DRY SAND CLAY <u>ROCK</u> <u>DIRT</u> DEBRIS
OTHER: COLOR: <u>GREY</u>	SURVEY LOCATION BY: <u>DSI</u>

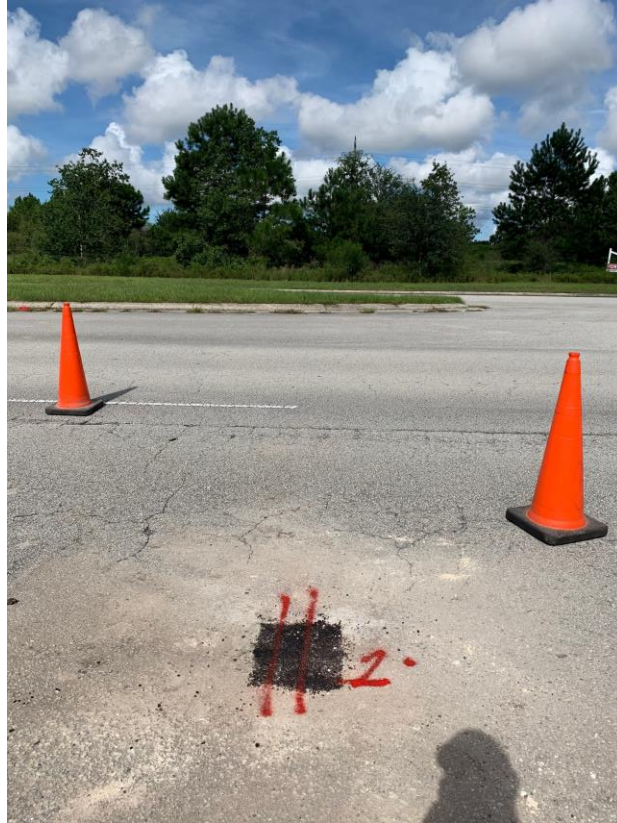
# TEST HOLE #1

LOOKING WESTERLY ACROSS GATE PARKWAY

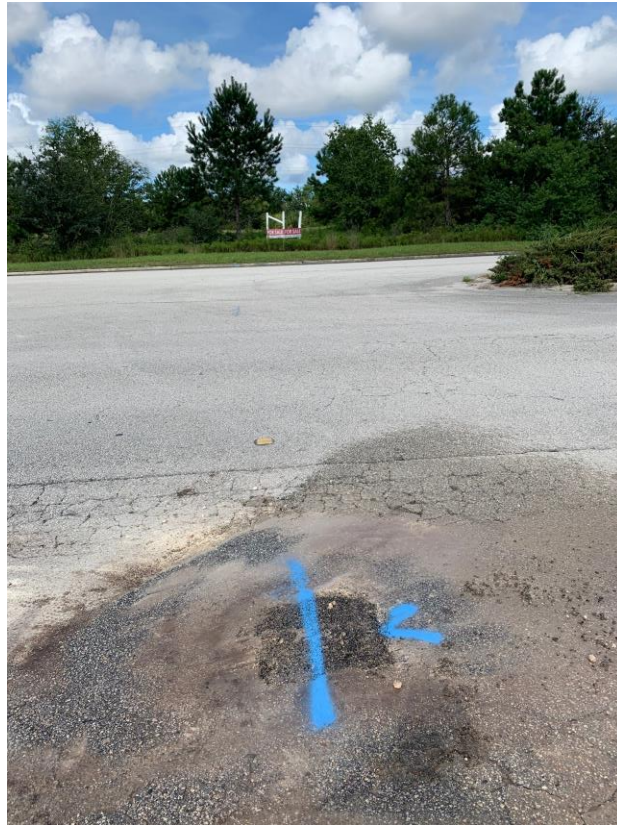
## TEST HOLE #2

LOOKING WESTERLY ACROSS GATE PARKWAY

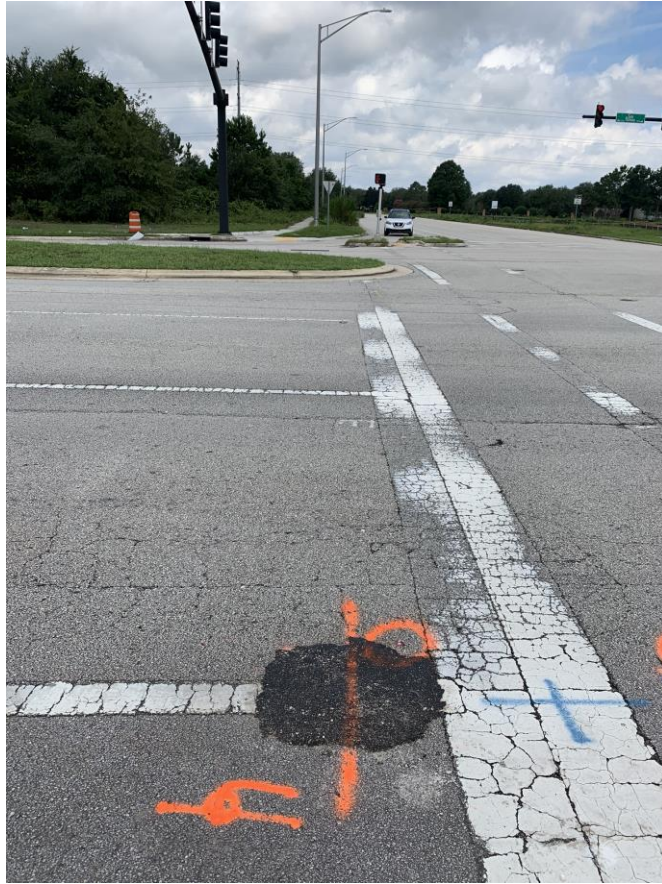
# TEST HOLE #4

LOOK NORTHERLY ACROSS GATE PARKWAY DOWN BURNT MILL ROAD

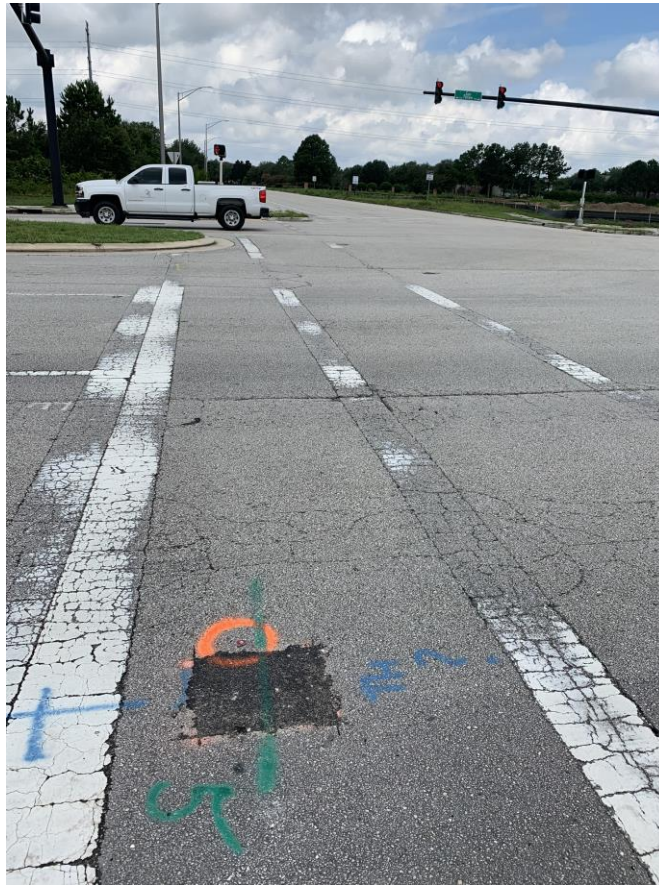
TEST HOLE #5

LOOK WESTERLY ACROSS GATE PARKWAY DOWN BURNT MILL ROAD

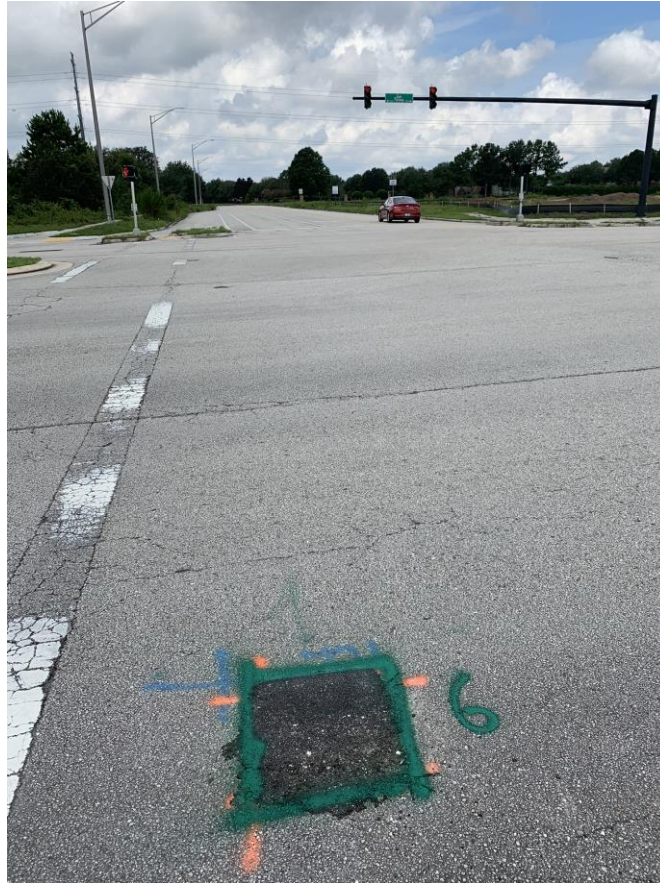
TEST HOLE #6

LOOK WESTERLY ACROSS GATE PARKWAY DOWN BURNT MILL ROAD

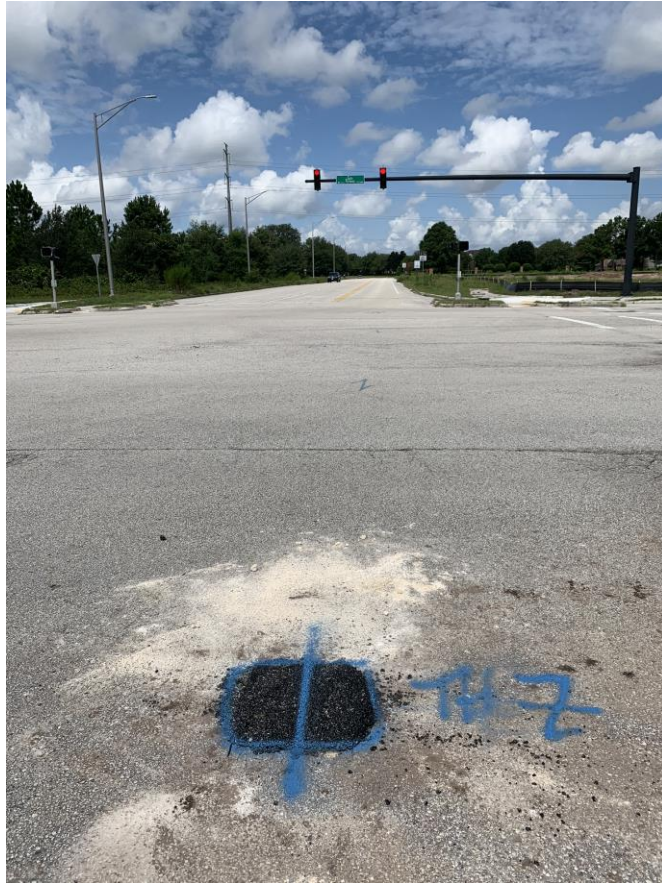
TEST HOLE #7

LOOKING WESTERLY ACROSSGATE PARKWAY DOWN BURNT MILL ROAD

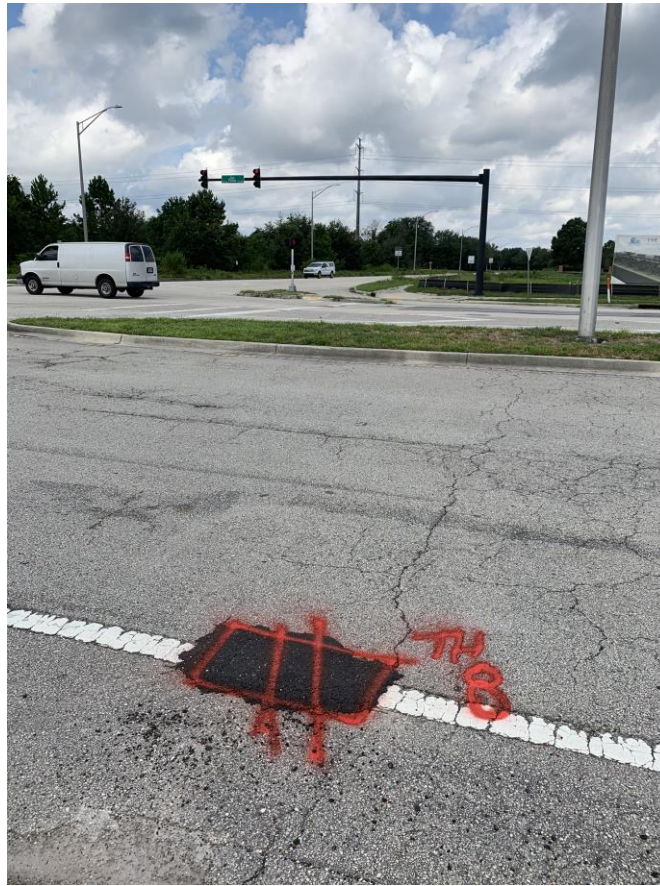
## TEST HOLE #8

LOOKING WESTERLY ACROSS GATE, NORTH OF BURNT MILL ROAD

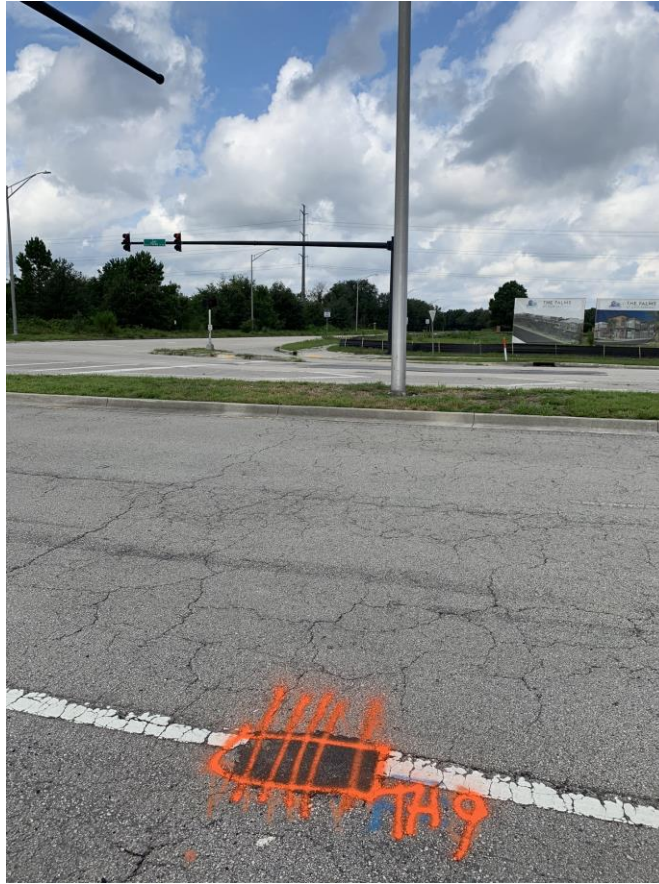
TEST HOLE #9

LOOKING WESTERLY ACROSS GATE, NORTH OF BURNT MILL ROAD

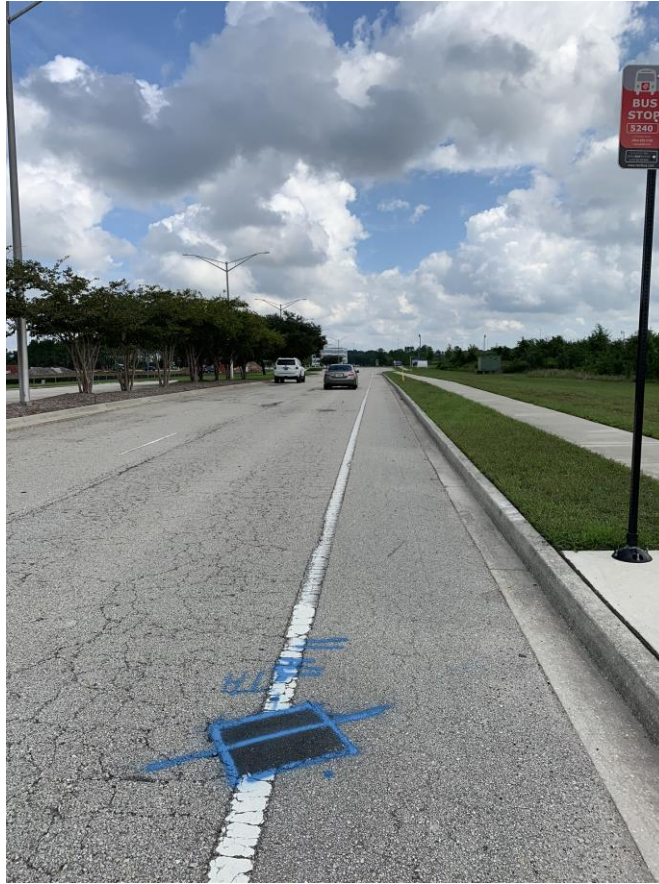
## TEST HOLE #11

LOOKING NORTHERLY ALONG GATE PARKWAY, NORTH OF BURNT MILL ROAD

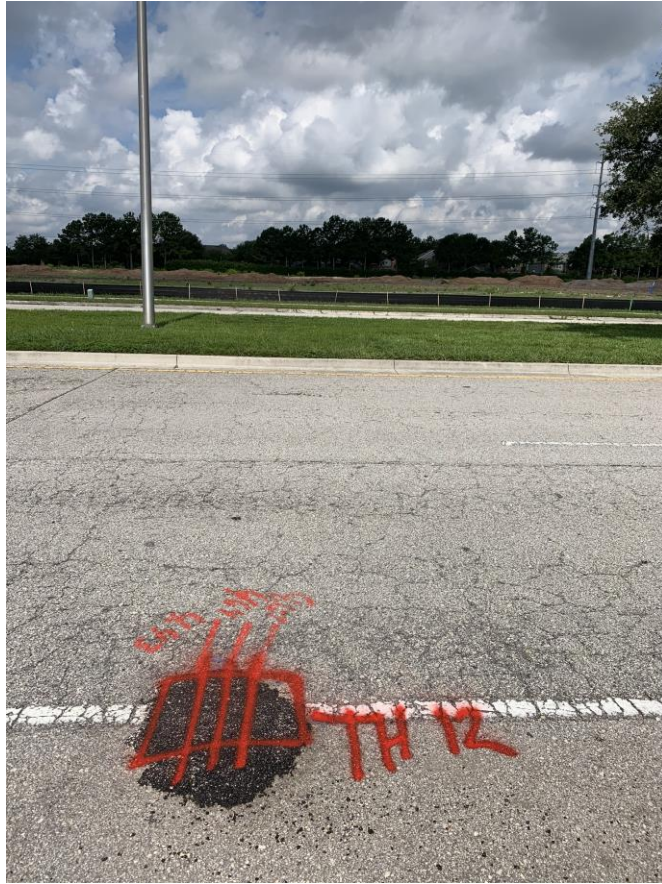
## TEST HOLE #12

LOOKING WESTERLY ACROSS GATE PARKWAY, NORTH OF BURNT MILL ROAD

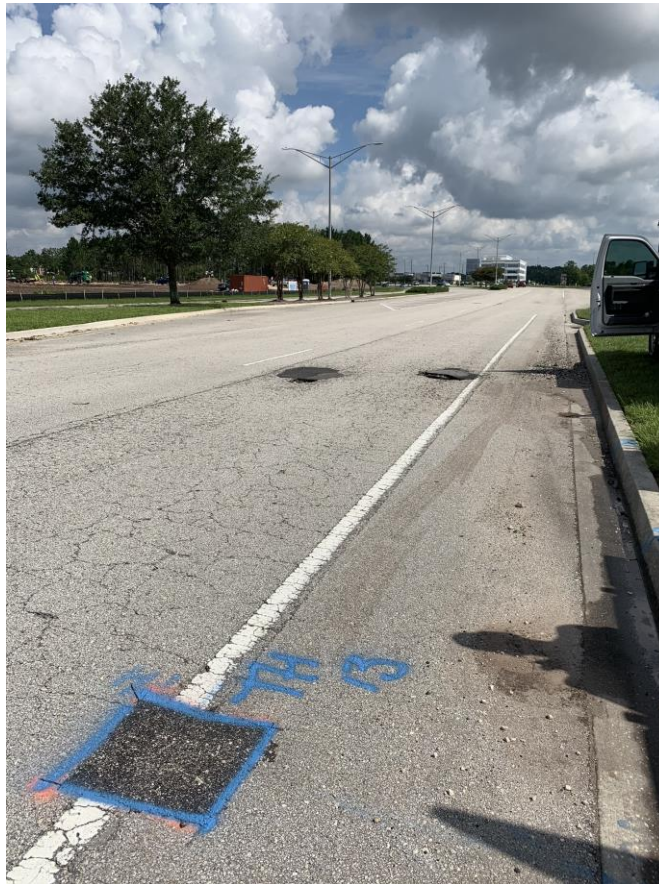
TEST HOLE #13

LOOKING NORTHERLY ALONG GATE PARKWAY, NORTH OF BURNT MILL ROAD

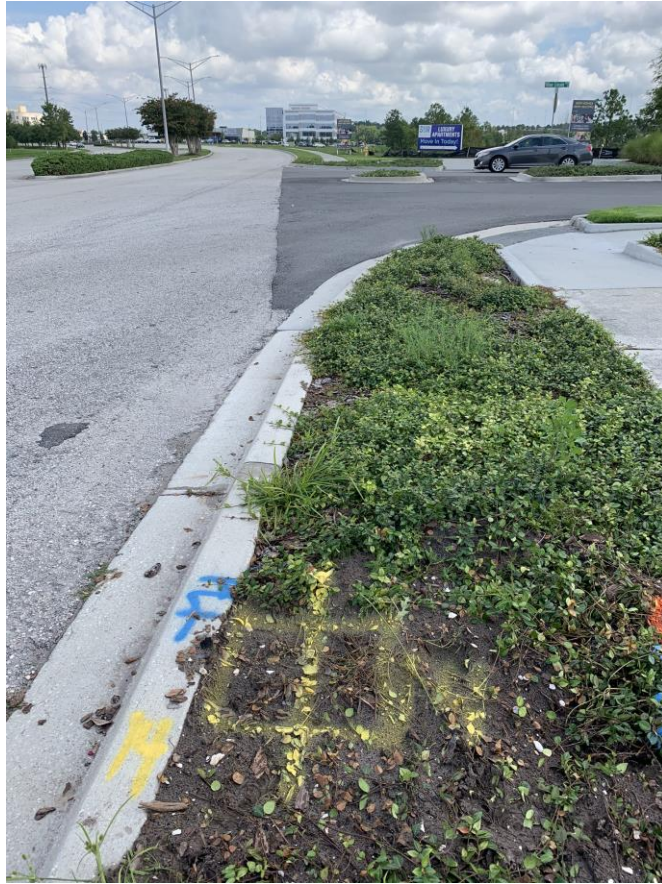
## TEST HOLE #14

LOOKING NORTHERLY ALONG GATE PARKWAY, SOUTH OF VILLAGE CROSSING DRIVE

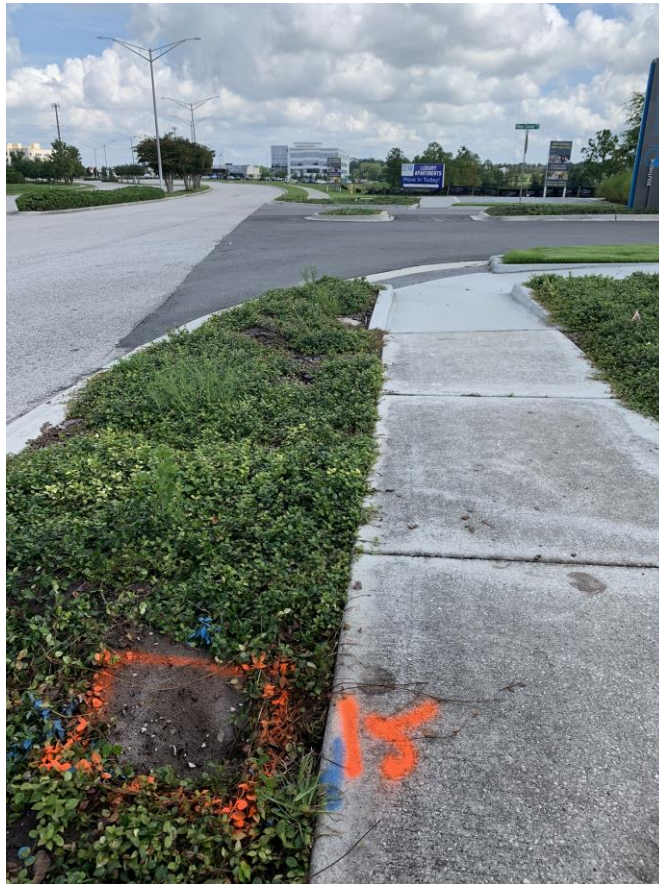
TEST HOLE #15

LOOKING NORTHERLY ALONG GATE PARKWAY, SOUTH OF VILLAGE CROSSING DRIVE

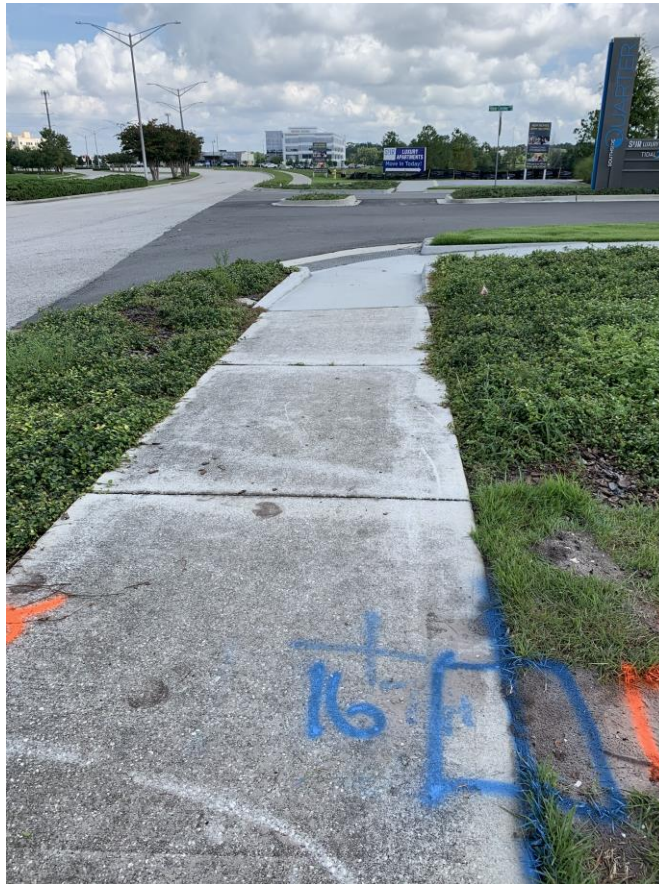
TEST HOLE #16

LOOKING NORTHERLY ALONG GATE PARKWAY, SOUTH OF VILLAGE CROSSING DRIVE

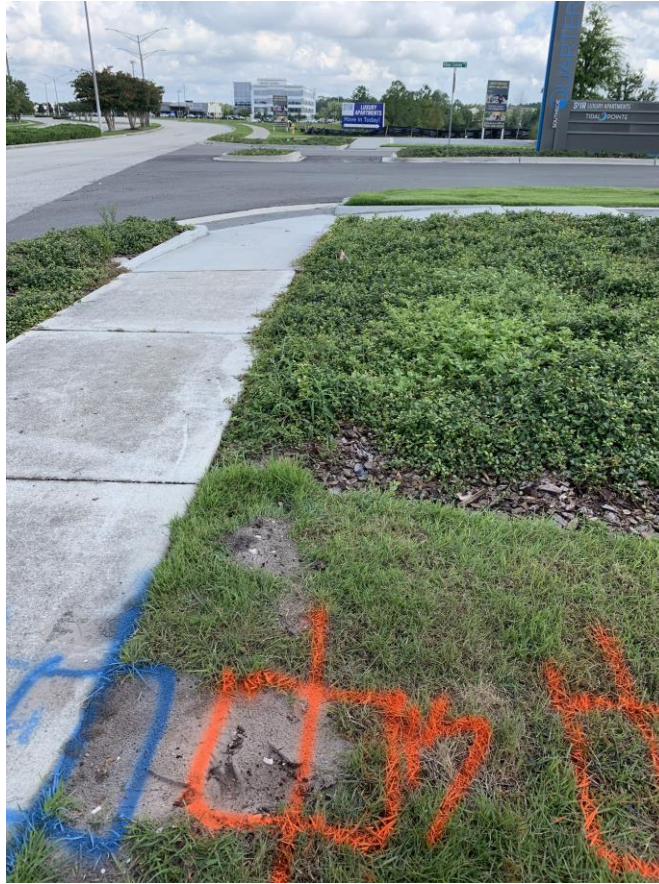
TEST HOLE #17

LOOKING NORTHERLY ALONG GATE PARKWAY, SOUTH OF VILLAGE CROSSING DRIVE

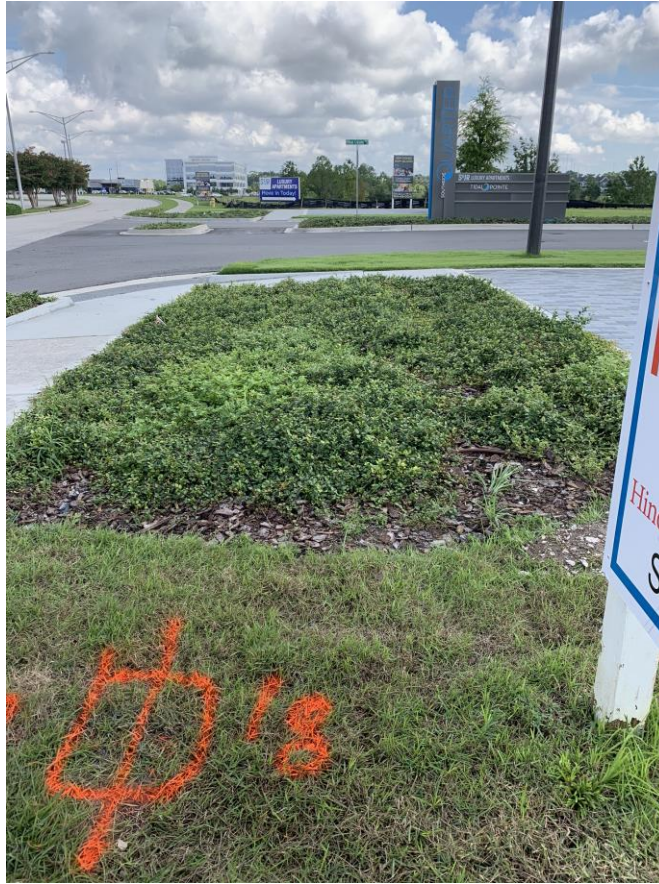
## TEST HOLE #18

LOOKING NORTHERLY ALONG GATE PARKWAY, SOUTH OF VILLAGE CROSSING DRIVE

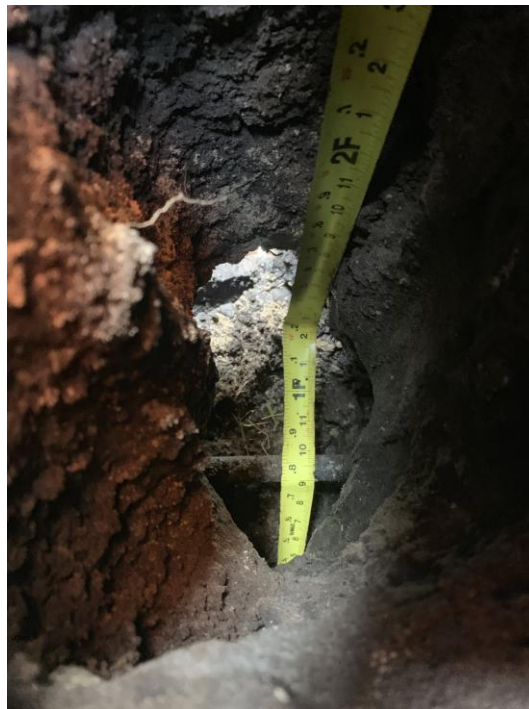
1" COMMUNICATIONS CABLE

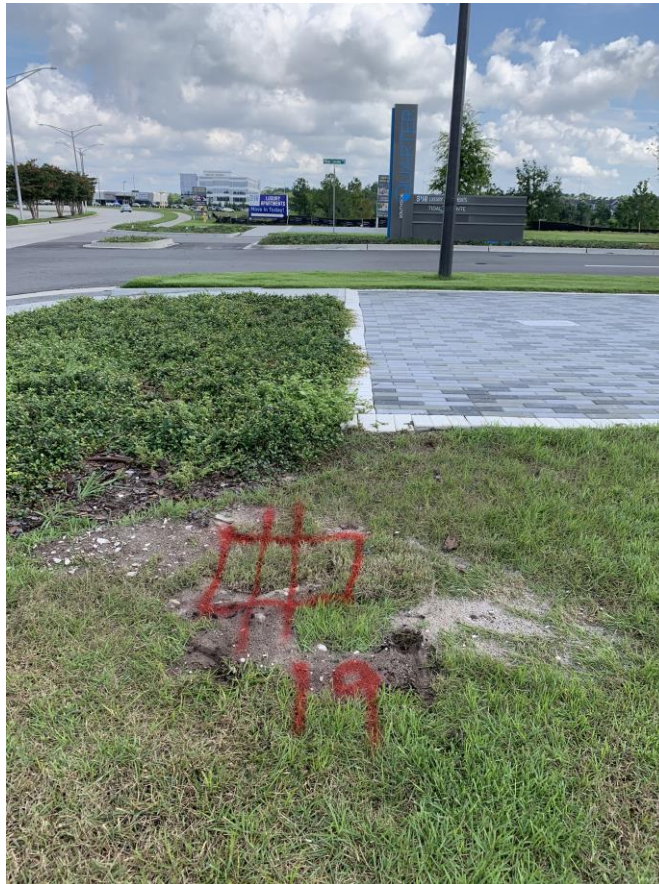
## TEST HOLE #19

LOOKING NORTHERLY ALONG GATE PARKWAY, SOUTH OF VILLAGE CROSSING DRIVE

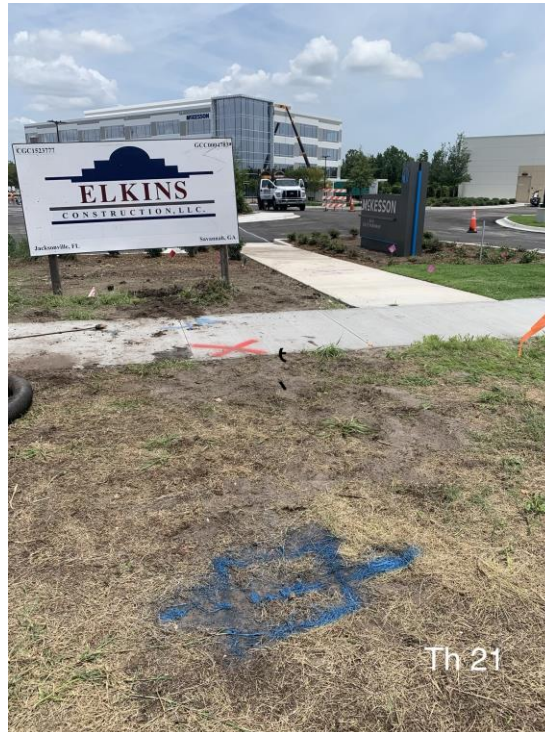
## TEST HOLE #21

LOOKING NORTHERLYEASTERLY FROM GATE PARKWAY – RUNNING PARALLEL WITH  
GATE PARKWAY

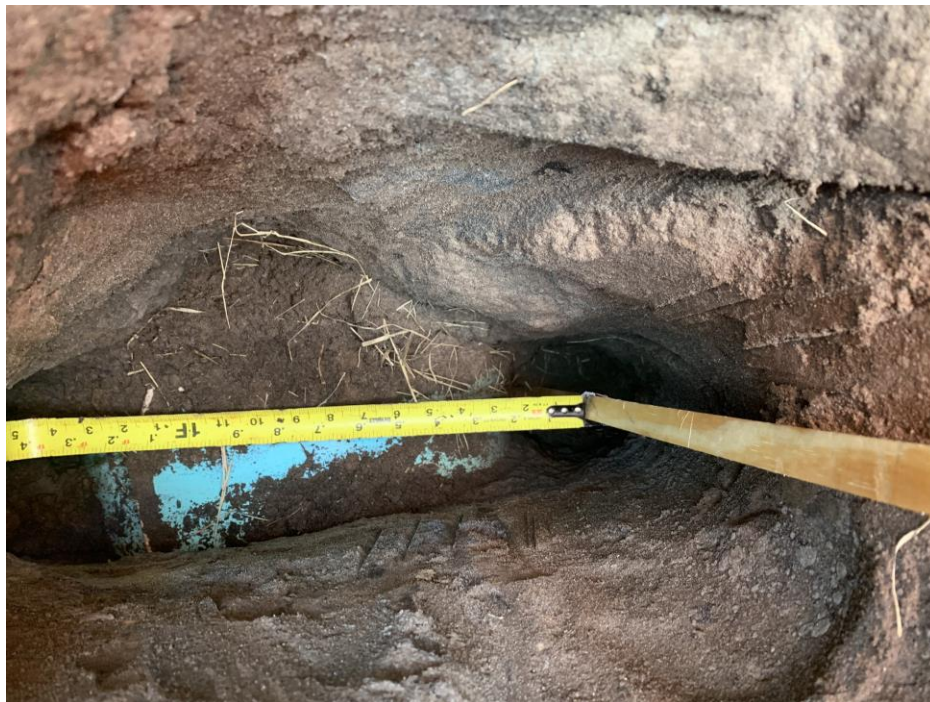
12" PVC WATER LINE

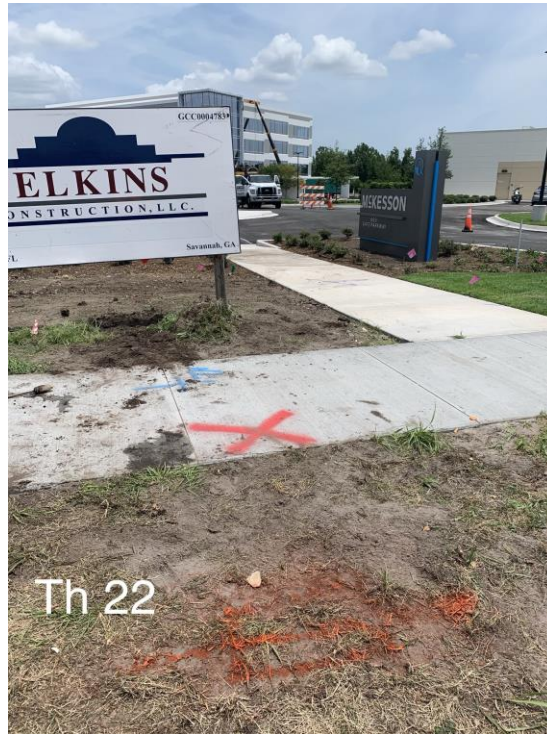
## TEST HOLE #22

LOOKING NORTHERLYEASTERLY FROM GATE PARKWAY – RUNNING PARALLEL WITH  
GATE PARKWAY

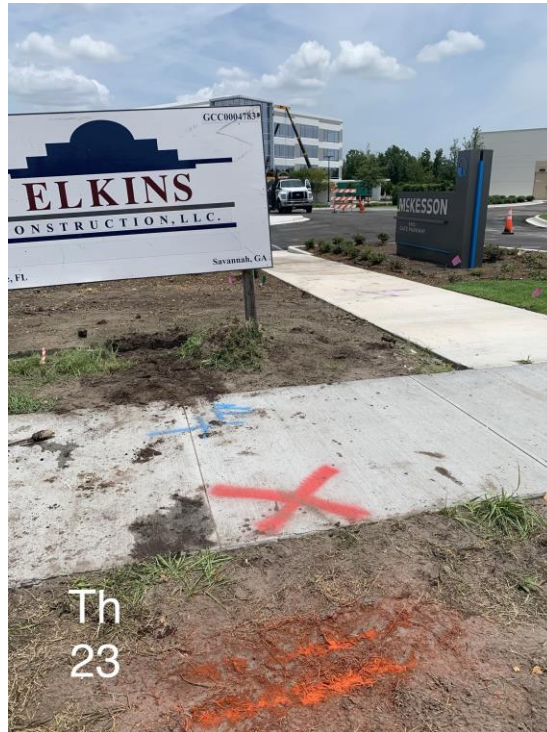
TEST HOLE #23

LOOKING NORTHERLYEASTERLY FROM GATE PARKWAY – RUNNING PARALLEL WITH  
GATE PARKWAY

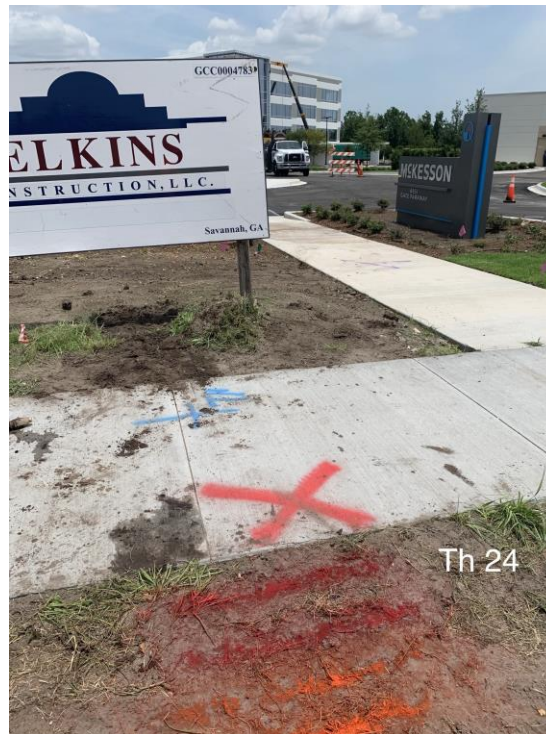
TEST HOLE #24

LOOKING NORTHERLYEASTERLY FROM GATE PARKWAY – RUNNING PARALLEL WITH  
GATE PARKWAY

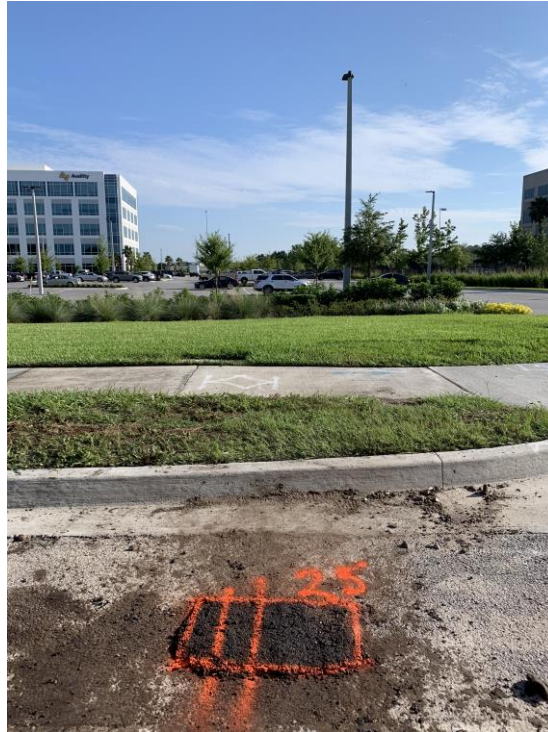
TEST HOLE #25

LOOKING NORTHERLYEASTERLY FROM GATE PARKWAY – RUNNING ACROSS GATE PARKWAY

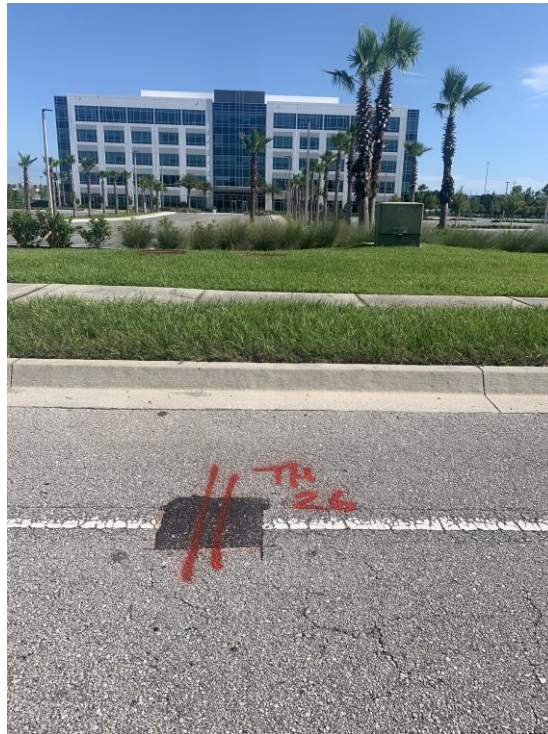
## TEST HOLE #26

LOOKING NORTHERLY FROM GATE PARKWAY – RUNNING ACROSS GATE PARKWAY

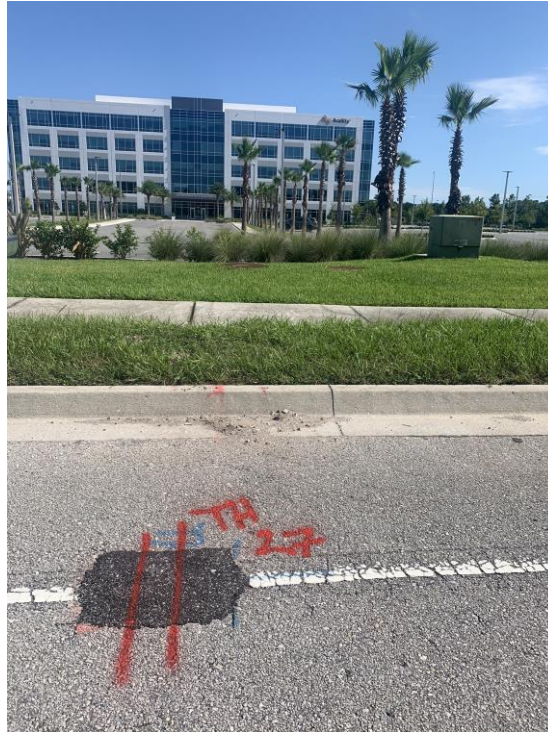
## TEST HOLE #27

LOOKING NORTHERLY FROM GATE PARKWAY – RUNNING ACROSS GATE PARKWAY

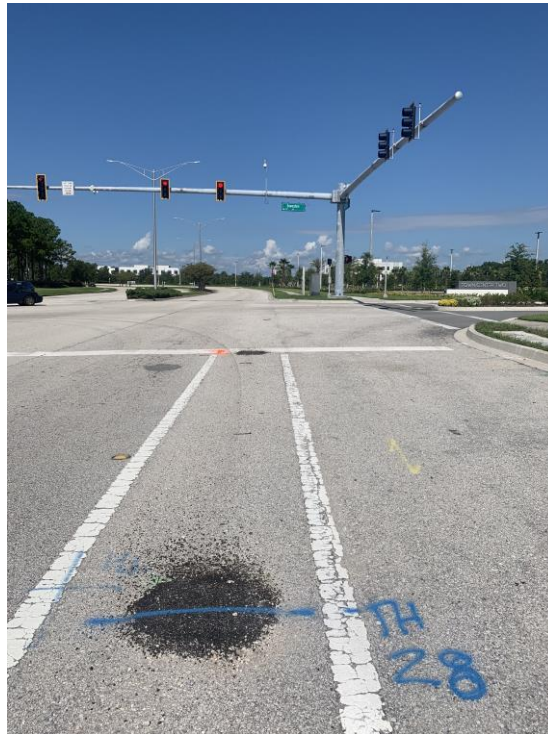
TEST HOLE #28

LOOKING WESTERLY ALONG GATE PARKWAY – RUNNING ACROSS GATE PARKWAY

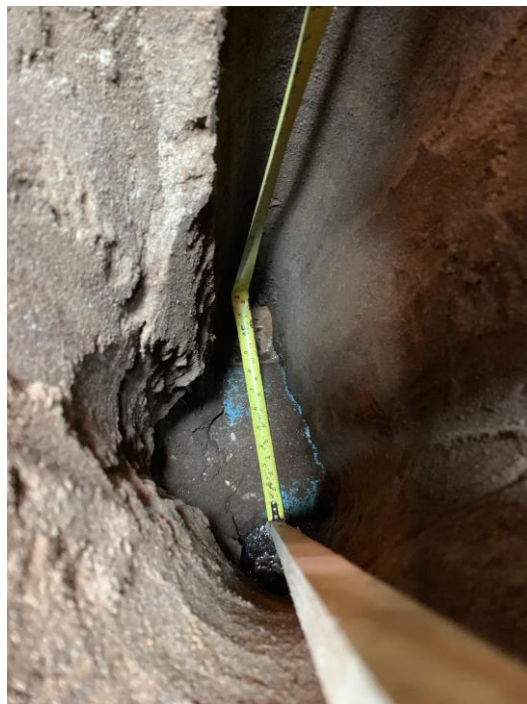
10" WATER LINE

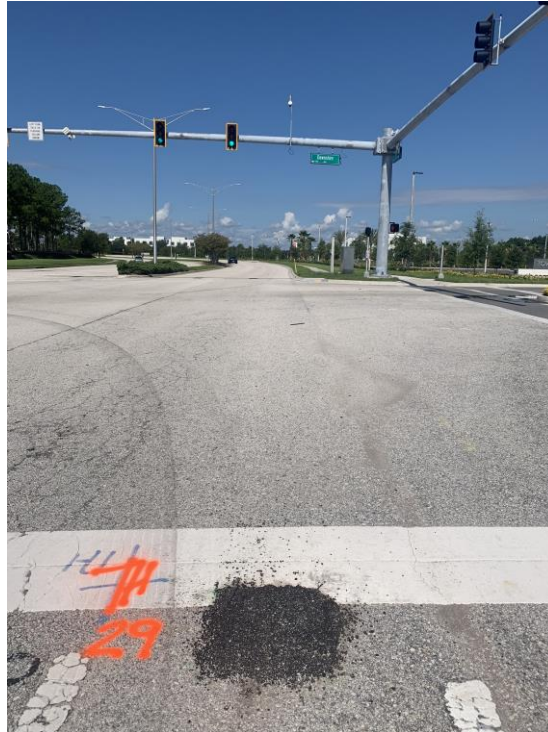
TEST HOLE #29

LOOKING WESTERLY ALONG GATE PARKWAY – RUNNING ACROSS GATE PARKWAY
